Aviation Short Investigations Bulletin

Issue 31

ATSB Transport Safety Report
Aviation Short Investigations
AB-2014-085
Final – 17 June 2014

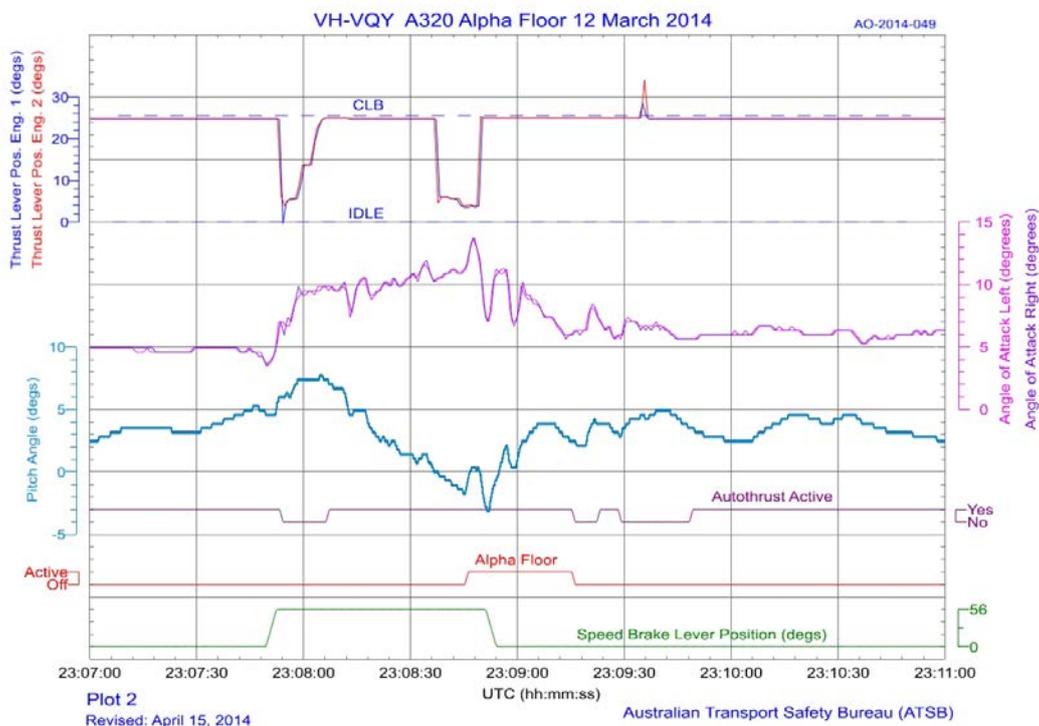
Figure 2: Thrust settings, angle of attack, pitch, speed brake and Alpha Floor

The aircraft then descended and the airspeed slowed below the V_{LS} speed: the lowest selectable speed that autothrust permits. The first officer then applied rearward pressure on the sidestick in an attempt to regain FL 380 and reduced the thrust levers towards idle, but short of the idle stop position. This limited the maximum amount of thrust available. The application of back pressure increased the aircraft's angle of attack. At the Alpha Protection speed,⁴ which corresponds with the angle of attack at which Alpha Protection becomes active, the Alpha Floor function activated. In that mode, the speed brakes retracted⁵ (Figure 2) and the take-off/go-around (TOGA) thrust lock was activated.

The first officer reported that the aircraft changed very rapidly from an overspeed to an Alpha Protection state, and this rate of change may have been due to a combination of the high altitude and the light weight of the aircraft. He observed the TOGA LOCK display on the engine warning flight director, but did not recall an ALPHA FLOOR annunciation on the Flight Mode Annunciator (FMA).

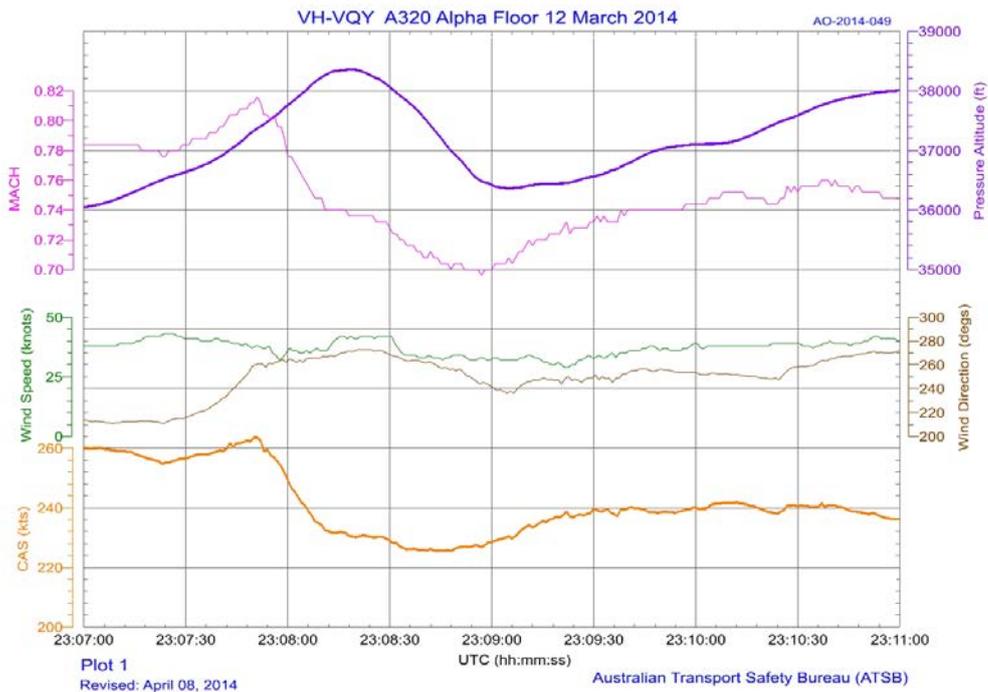
Figure 3: Altitude, Mach, Wind speed and CAS

The flight data indicated the following (Figure 3):

- During the climb, passing about FL 365, the wind shifted from a tailwind of about 20 knots to a headwind of about 15 kt, resulting in an effective 35 kt windshear on the aircraft. This resulted in a rate of climb of 3,005 fpm and a transient Mach increase.
- The computed airspeed (CAS) increased about 6 kt from 256 to 262 kt.
- The Alpha Floor activated when the aircraft was on descent passing about FL 370, at a CAS of 226 kt, thrust levers just above the idle stop with autothrust disconnected, and the aircraft descending at about 4,500 fpm.

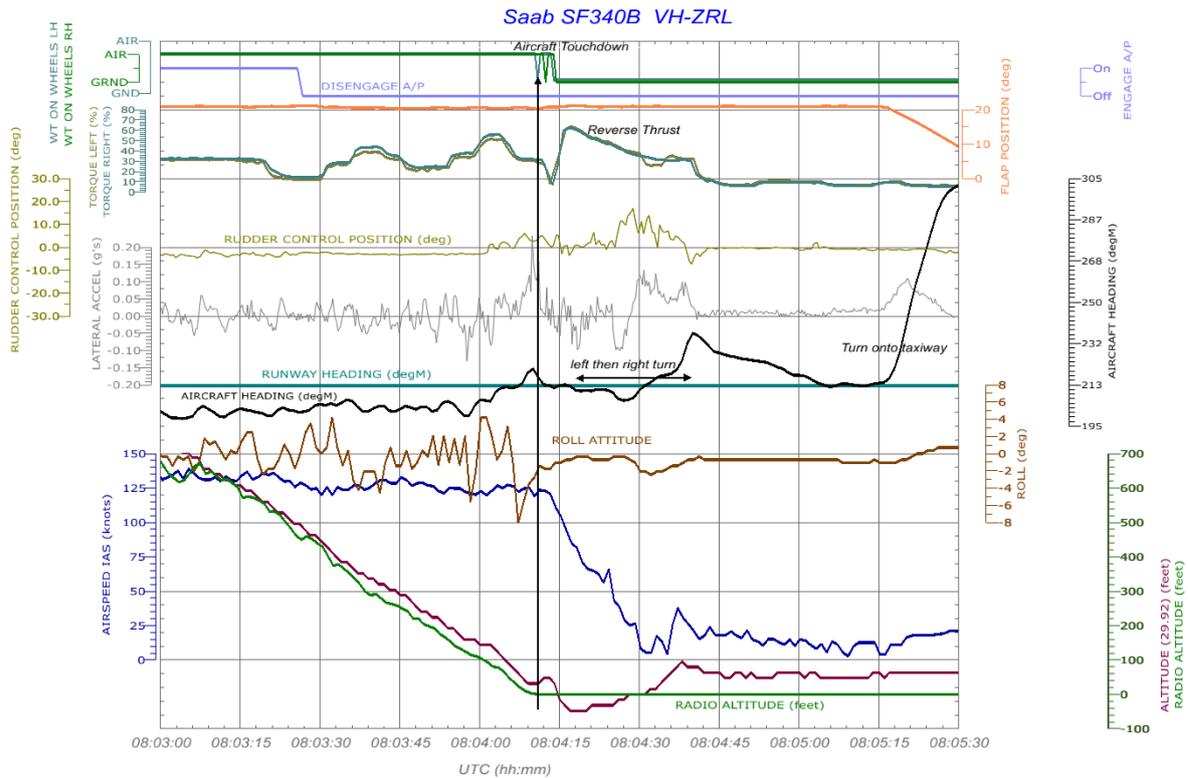
Figure 4: Summary of flight data

The aircraft was fitted with a flight data recorder (FDR) and following the incident, the data was downloaded and provided to the ATSB. The recorded data (Figure 4) showed that, during final approach, the aircraft's heading was less than the published runway heading, indicating that the aircraft was experiencing a crosswind from the left. When at about 800 ft, the calculated crosswind component was about 30 kts and decreased to about 13 kt when at about 100 ft.⁷ At 1904:08, just prior to touchdown, the aircraft rolled left by about 8° and right rudder was applied. The aircraft rolled back to the wings level position.

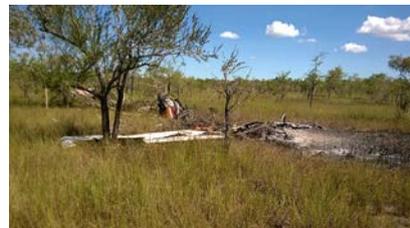
Accident site

The pilot and passenger were rescued about 3 hours later by a helicopter crew. Both sustained serious injuries and the aircraft was destroyed (Figure 1). Due to memory loss incurred as a result of the accident, the pilot had limited recollection of the events.

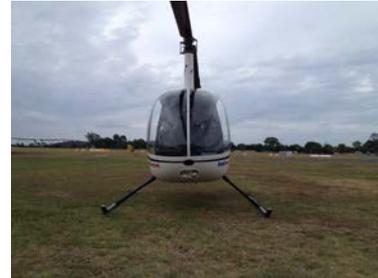
VH-YZO

The instructor again exited the helicopter and conducted a walk-around inspection with no damage observed. After a further demonstration by the instructor, the student completed the sequence twice more. The instructor and student then conducted further training exercises and subsequently concluded the flight. After landing, the instructor detected that the helicopter was leaning to the right. He exited the helicopter and observed that the landing skid was damaged (Figure 1). The instructor then taxied the helicopter to the hangar for an engineering inspection.
