Australian Government Australian Transport Safety Bureau

# Loss of control involving Eurocopter MBB BK117 B-2 VH-VSA

28 km SSE of Port Pirie Aerodrome, South Australia | 15 February 2013

Aviation Occurrence Investigation AO-2013-030 Final – 15 July 2014 Cover photo: Helicopter operator

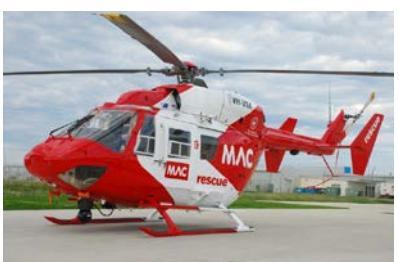
Source: Helicopter operator

back to Port Pirie Aerodrome. No injuries were reported by the occupants and the helicopter sustained minor damage.
