# Derailment of train ST24

near North Melbourne, Victoria | 11 July 2014

**ATSB Transport Safety Report**  
Rail Occurrence Investigation  
RO-2014-013  
Final – 14 May 2015

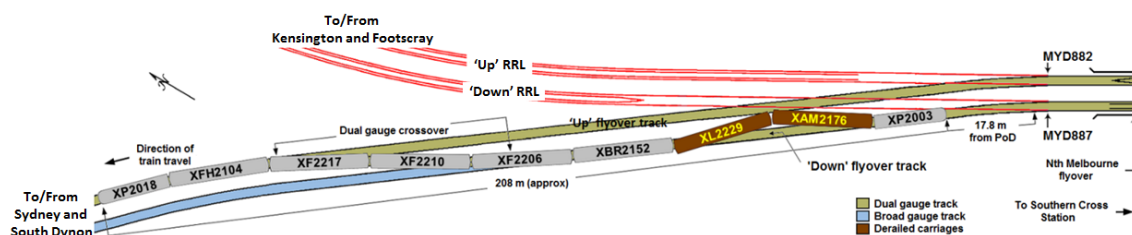
**Figure 6: Site schematic**

An examination of infrastructure near the derailment site (Figure 6) established that there was damage at turnout MYD882 on the up flyover track, and MYD887 on the down flyover track.

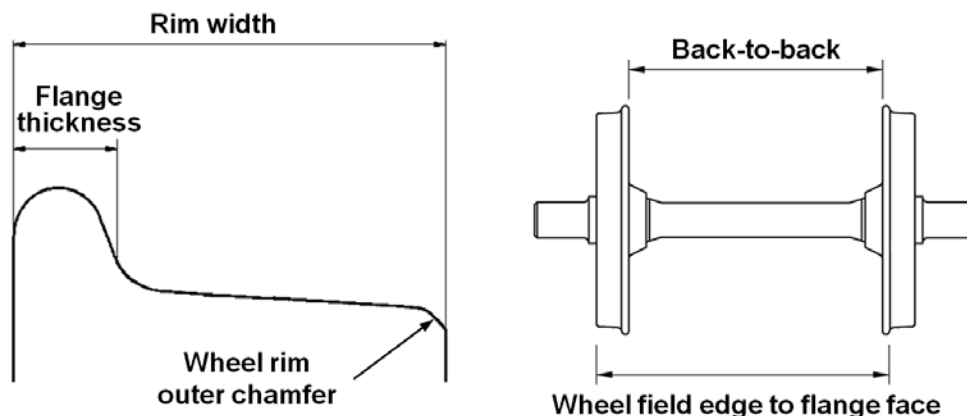
Figure 12: Wheelset dimensions

For rolling stock, the wheelset dimensions that are critical to ensure compatibility with track gauge are rim width, flange thickness and wheelset back-to-back distance (Figure 12). For a wheel to drop in between a track, the *wheel field edge to flange face* distance theoretically must be less than track gauge.<sup>14</sup>

The design and maintenance standards for rolling stock wheelsets and rolling stock wheels are documented in Australian Standard AS7517.3-2009 (Railway Rolling Stock Wheelsets Part 3) and AS7514.3-2010 (Railway Rolling Stock Wheels Part 3). AS7517.3-2009 prescribes back-to-back dimensions of wheelsets as 1,357 mm to 1,360 mm for standard gauge rolling stock. AS7514.3-2010 prescribes rim widths as 127 mm to 140 mm for both broad and standard gauge rolling stock wheels, and recommends a minimum flange thickness of 19 mm.

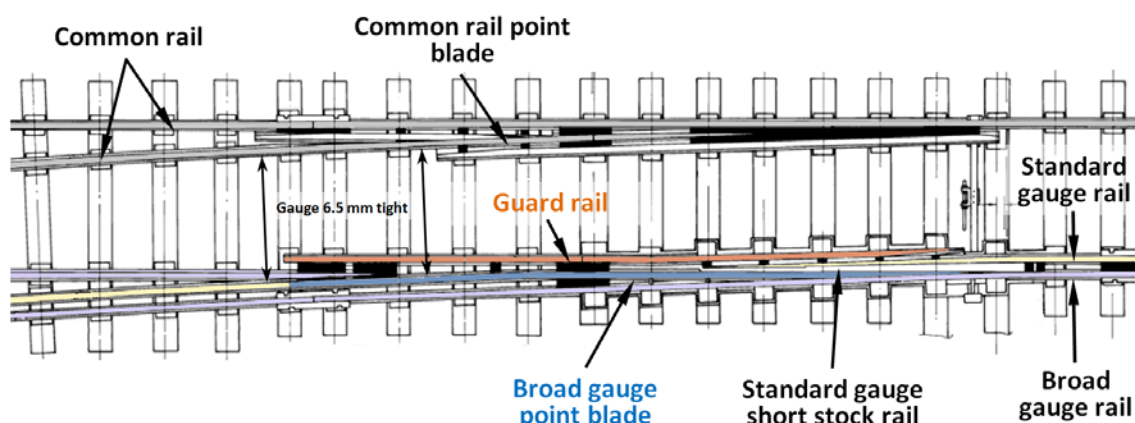
**Figure 13: General schematic – SAR type 37 turnout (Drawing W33037 – See Appendix B)**

The design concept for type 37 mixed gauge turnout was first envisaged by the South Australian Railways<sup>15</sup> (SAR) for use with 47 kg/m rail on timber bearers. The original SAR design (Figure 13 Drawing W33037/Appendix B) incorporated a set to give 6.5 mm tight gauge through areas of the turnout and guard rail<sup>16</sup> protection adjacent the broad gauge point blade.

Based on available information, the SAR type 37 turnout design was never used in operational service.

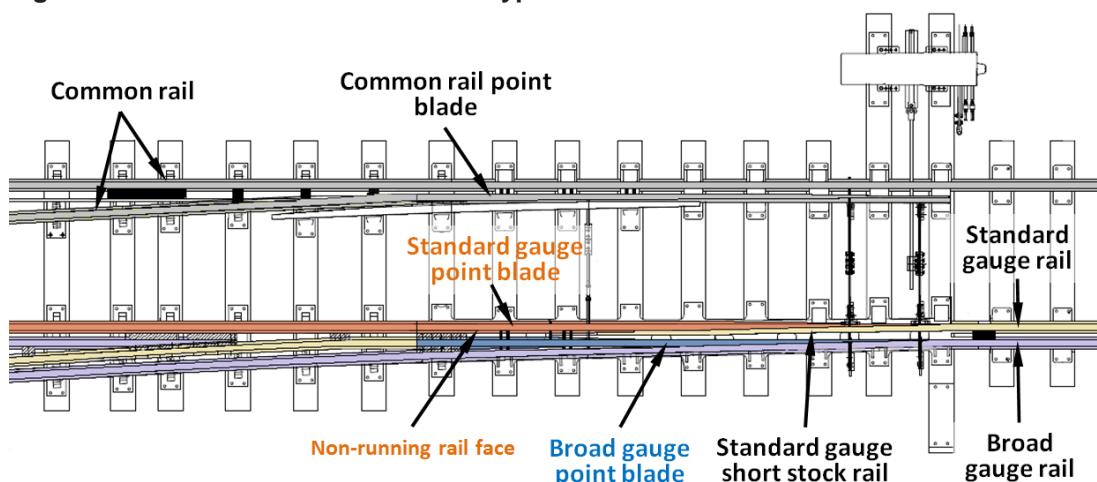
**Figure 14: General schematic – ARTC type 29 turnout**

The two turnouts, MYD887 and MYD882, were designed and manufactured by Vossloh Cogifer Australia Pty Ltd (VCA). They are type 37 mixed gauge turnouts, however, the design was based on the Australian Rail Track Corporation (ARTC) type 29 turnout (Figure 14) which has two dual gauge legs and was specifically developed for 50 kg/m rail on concrete bearers.

V/Line's subsequent provisional type approval of the VCA type 37 turnout was largely on the basis that design and componentry was substantially the same as the ARTC type 29 turnout. The main discernible change introduced by VCA with the type 37 turnout (Figure 15) was the removal the standard gauge point blade and associated (straight) rail section (Figure 14 – shown in orange).

- For the operational type 29 dual gauge turnouts (50 kg/m on concrete bearers, Figure 14) there was evidence, in a number of cases, of flange back contact wear on the non-running rail face of the standard gauge point blade.
