Unintentional release of the freefall lifeboat from *Aquarosa*

Indian Ocean | 1 March 2014

ATSB Transport Safety Report
Marine Occurrence Investigation
307-MO-2014-002
Final – 20 May 2015

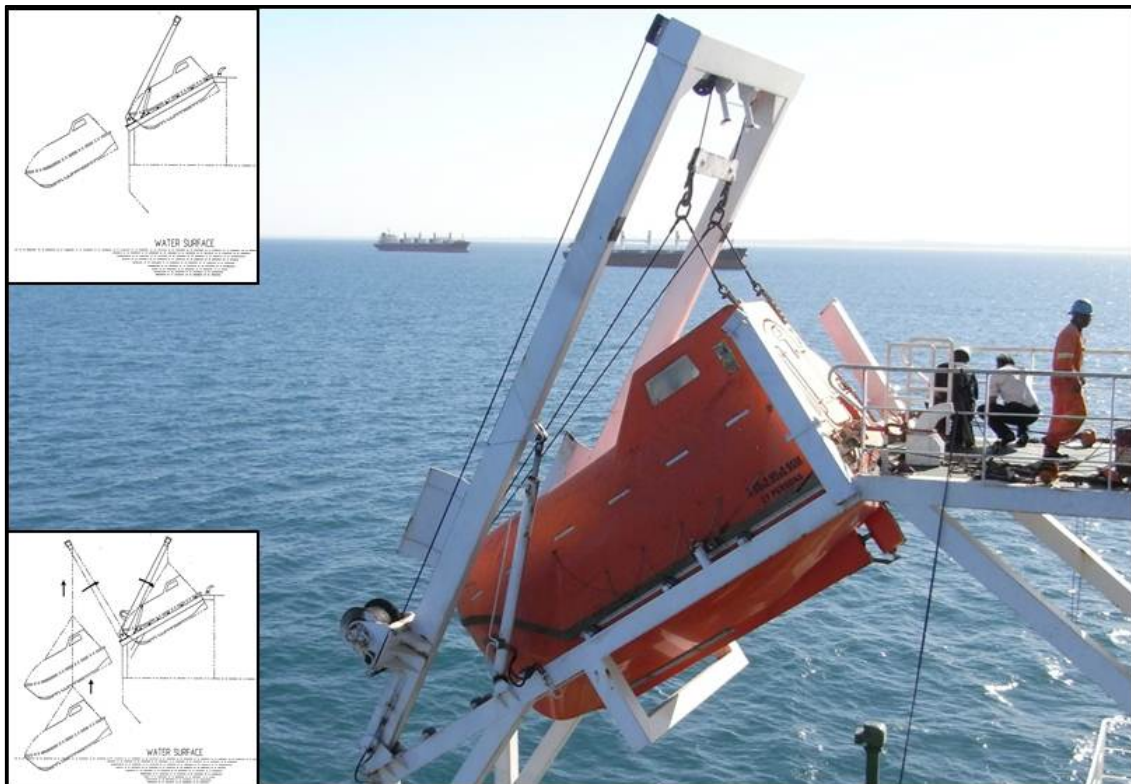
Figure 2: *Aquarosa*'s freefall lifeboat (insets show launch and recovery)

Aquarosa was fitted with a Jiangsu Jiaoyan Marine Equipment Company (JJMEC), model JY-FN-5.80, twenty-seven person fibre-reinforced plastic freefall lifeboat that was manufactured in November 2009. The lifeboat was 5.80 m long, had a beam of 2.55 m and weighed 5,460 kg⁵ with a full passenger and stores load (Figure 2).

Under normal, ready for use, conditions, the freefall lifeboat was positioned with its side rails sitting on rollers on the ramp section of the launching appliance. The lifeboat was retained solely through ring links fitted between a fixed hook on the ship and the on-load release on the lifeboat (Figure 3 and Figure 4).

Once passengers were safely seated with seatbelts fastened, the coxswain would use the hand-operated hydraulic pump to actuate the lifeboat's on-load release, allowing the lifeboat to move down the ramp and freefall to the water, clear of the stern of the ship (Figure 2, inset - top left).
