Controlled flight into terrain involving Aérospatiale AS350B2 VH-HRQ

240 km west of Davis Base, Antarctica | 1 December 2013

ATSB Transport Safety Report

Aviation Occurrence Investigation AO-2013-216 Final – 25 May 2015 Released in accordance with section 25 of the Transport Safety Investigation Act 2003

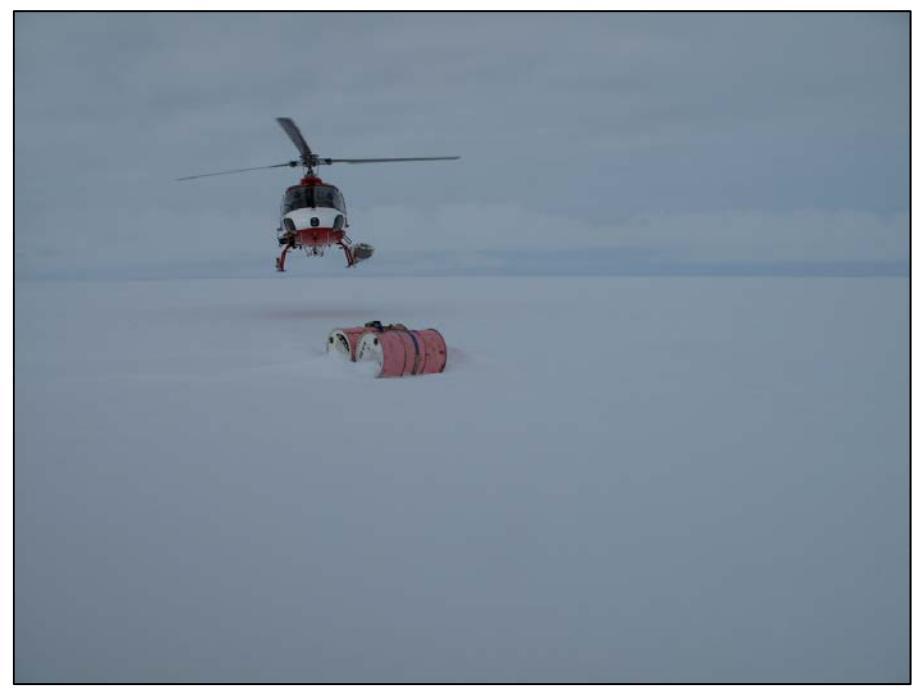
Figure 4: VH-SRB landing at the fuel cache

On descent to the fuel cache, the pilot of HRQ set the decision height selector on the helicopter's radar altimeter (RADALT)² to activate the associated warning light and aural alarm at 120 ft above ground level (AGL) during the approach. The helicopters arrived at the fuel cache at about 2014 (Figure 4).

While refuelling, the occupants of the helicopters noted that the cloud height had reduced, although a definite horizon remained visible. After a discussion about the weather, the pilots decided to continue the flight and loaded the empty fuel drums into SRB.
