Australian Government  
Australian Transport Safety Bureau

# Aerial application safety

2014–2015 year in review

Research  
AR-2015-031

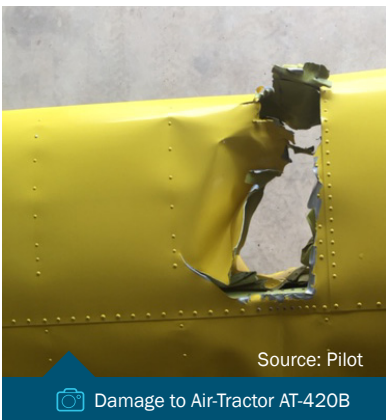
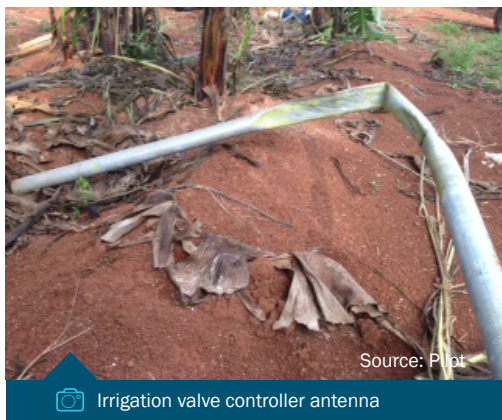
- In Queensland, the pilot of an Air Tractor AT-402B was spraying a banana crop at a new plantation. As the aircraft was descending above the crop for the first run, the left wing struck an irrigation valve controller antenna in the field. The pilot then flew back to the base and landed without incident. The pilot reported that he did not know the antenna was there and did not see it. Pre-operation planning should identify the antenna and aerial reconnaissance should identify any other hazards missed in the pre-flight planning. This incident highlights the importance of asking questions about hazards before flight, especially at new locations, and conducting an aerial reconnaissance as part of pre-operation planning (ATSB occurrence 201500797).
