# Flight path management occurrence involving Boeing 737, VH-YIR

Sydney Airport, New South Wales | 4 June 2013

## ATSB Transport Safety Report

AO-2013-095

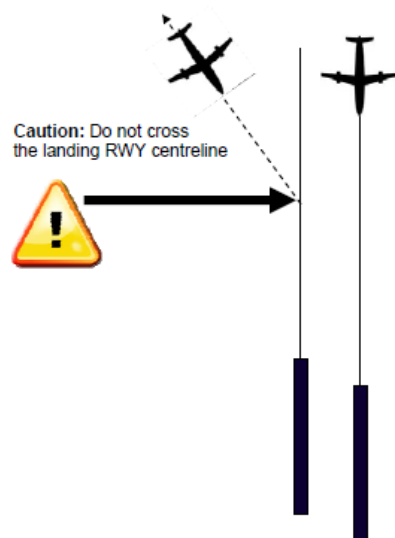
**Figure 8: Extract from Airservices Safety Bulletin – Independent Visual Approaches**

**Pilots must ensure that the runway centreline is not crossed during intercept and that the extended runway centreline is accurately tracked.**

**Note:** Localiser capture may not ensure the landing runway extended centreline is not crossed. TCAS RA may be received.
