# Wirestrike involving a Robinson R44, VH-LOL

142 km WSW of Adelaide, South Australia, 10 April 2015

**ATSB Transport Safety Report**  
Aviation Occurrence Investigation  
AO-2015-037  
Final – 27 August 2015

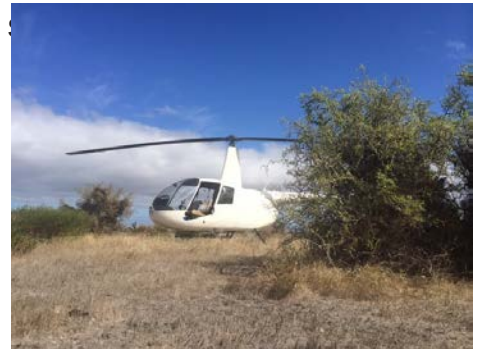
Also on board were client representatives who were directing the noxious weed management operation and manually dispensing the chemical into each bush. In the course of traversing the field at low level in search of the weed, the helicopter struck a previously unidentified power line. The helicopter's main rotor blade made initial contact with the power line and during the avoidance manoeuvre, the tail rotor blades also made contact, severing the blade tips (Figure 1). The pilot landed the helicopter safely. The helicopter was substantially damaged but the occupants were uninjured.

Figure 1: Tail rotor blade damage to VH-LOL
