Aviation Short Investigations Bulletin

Issue 37

AB-2014-176

Final – 23 December 2014

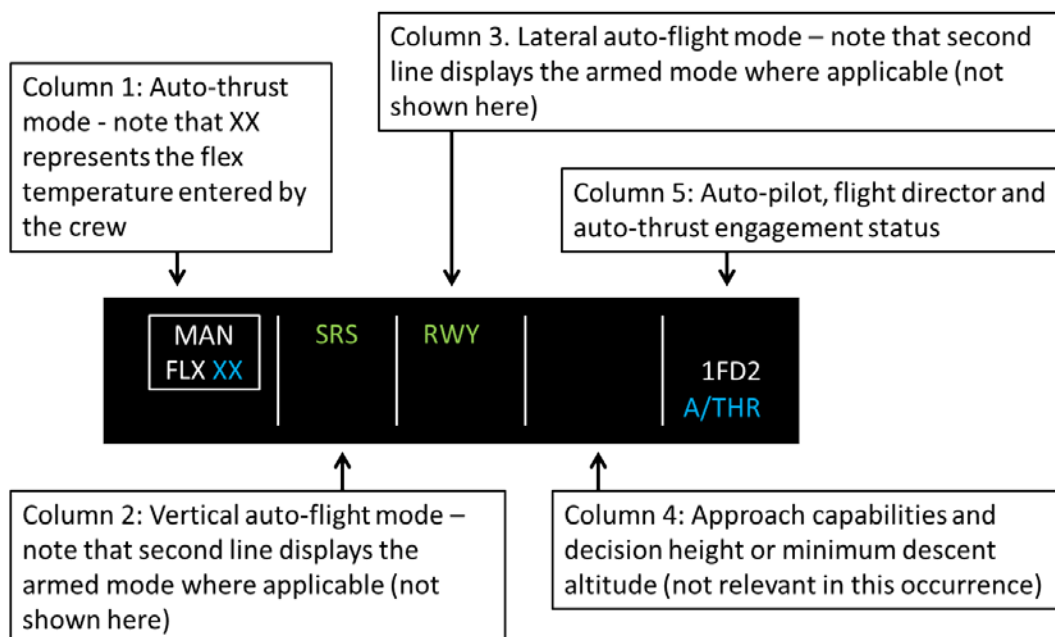
Figure 4: Representation of typical FMA indications during a flex temperature take-off when the thrust levers are set to the FLX/MCT detent

- The crew noticed that flight mode annunciator (FMA)⁸ indications were not as they would normally appear during a flex temperature take-off when the thrust levers are set to the FLX/MCT detent (Figure 4):

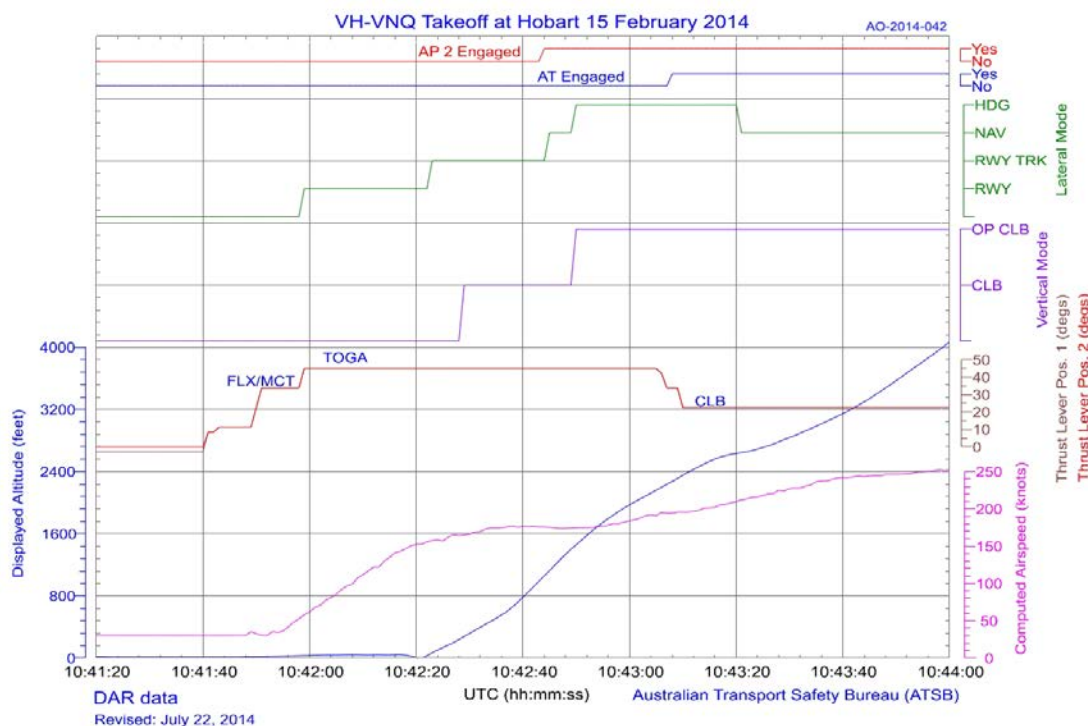
Figure 5: Flight data illustrating selected parameters and auto-flight guidance modes

During the initial part of the climb, the aircraft continued to accelerate, before the speed stabilised at about 175 kt. While the initial climb speed of the aircraft was higher than the speed that would have been commanded by SRS guidance had that mode been active, the initial climb angle still substantially exceeded the minimum climb performance requirements. The crew allowed the aircraft to accelerate further passing about 2,000 ft, following which the thrust levers were retarded to the climb (CLB) detent. The auto-thrust system was armed by the crew as the thrust levers were retarded, and sequenced to active when the thrust levers reached the CLB detent.¹¹ The crew re-engaged NAV mode as the aircraft climbed through about 2,700 ft and the flight to Melbourne continued uneventfully. A graphical representation of some relevant flight parameters, thrust lever position and auto-flight system modes is included below (Figure 5).
