Collision with terrain involving Cessna 182, VH-KKM

19 km WSW of Mount Hotham Airport, Victoria | 23 October 2013

ATSB Transport Safety Report
Aviation Occurrence Investigation
AO-2013-186
Final – 16 April 2015

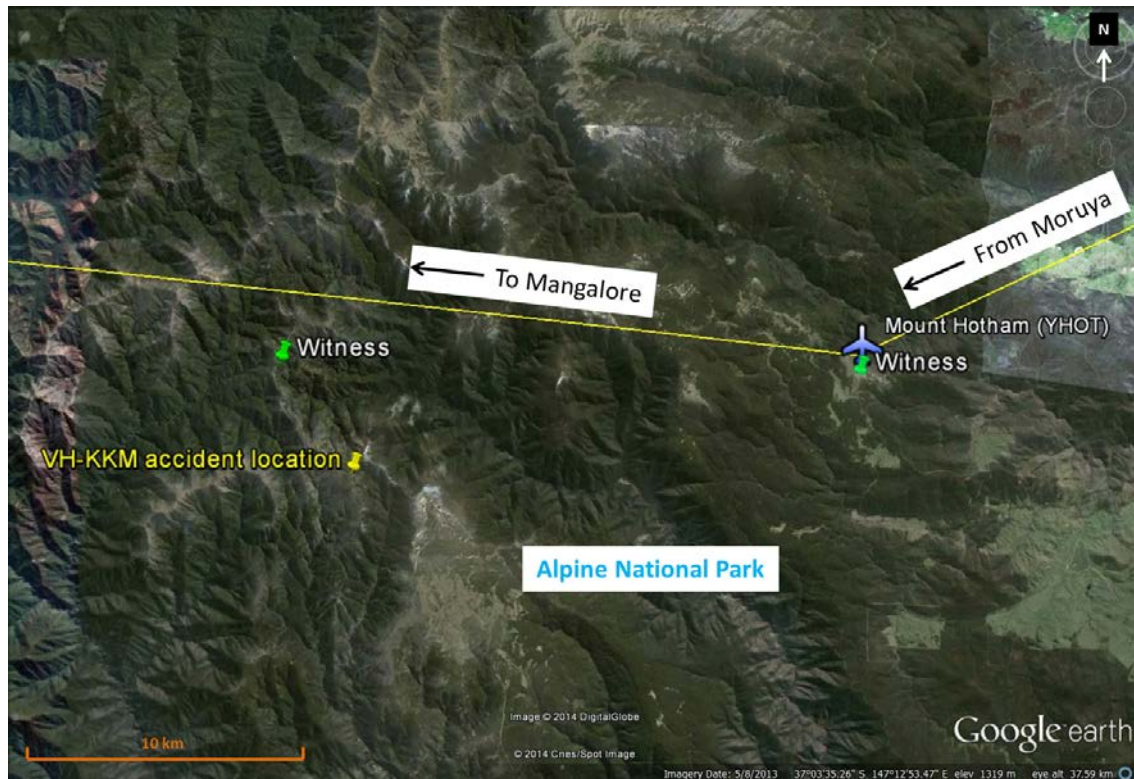
Figure 2: Accident and witness locations

At about 1015–1030, a witness at Mount Hotham Airport observed an aircraft, the description of which was consistent with the look of KKM, pass nearby. At about 1030, another witness located about 22 km west of Mount Hotham Airport heard an aircraft operating nearby (Figure 2).

19 km west-south-west of Mount Hotham Airport (Figure 2). The pilot sustained fatal injuries and the aircraft was destroyed.

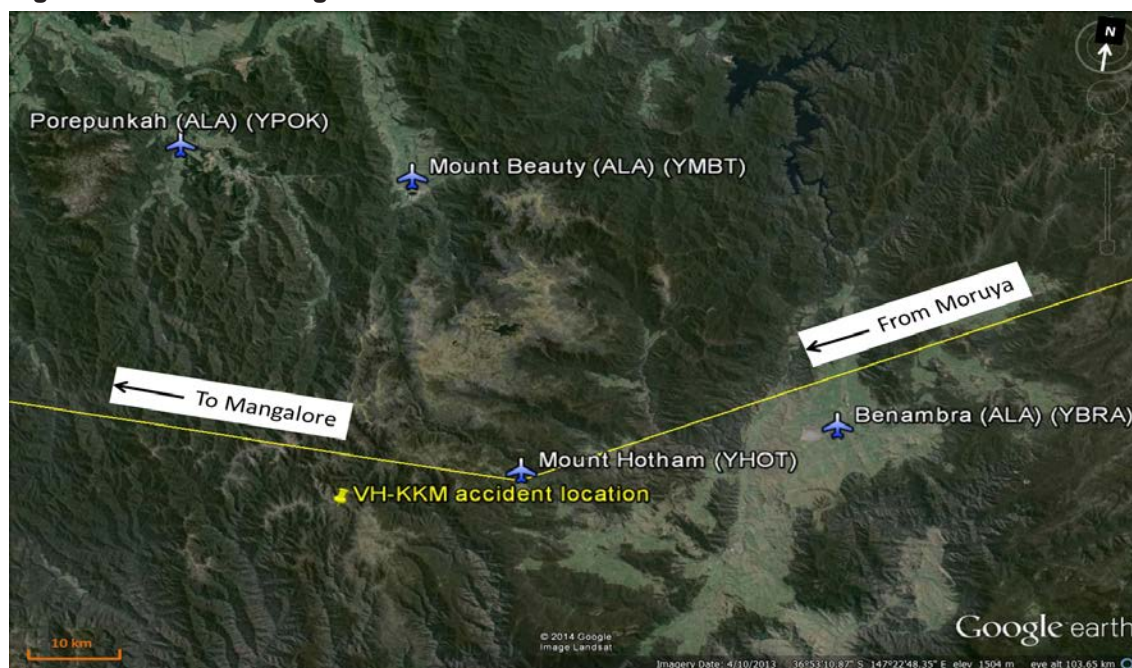
Figure 6: Nearest landing areas

The nearest airport was Mount Hotham Airport, about 19 km to the east-north-east of the accident. Other potential landing areas in the area were the Mount Beauty aeroplane landing area (ALA) about 40 km to the north-north-east, Porepunkah ALA about 46 km to the west-north-west and Benambra ALA about 53 km to the north-east (Figure 6).

The landing areas were available for an unscheduled landing. There was no evidence that the pilot had or had not considered diverting to one of these aerodromes. However, the apparent route taken and location of the accident site suggests he did not initiate a diversion at any time.
