VFR flight into dark night involving Aérospatiale AS355F2 VH-NTV

145 km north of Marree, South Australia | 18 August 2011

ATSB Transport Safety Report
Aviation Occurrence Investigation
AO-2011-102
Final – 14 November 2013

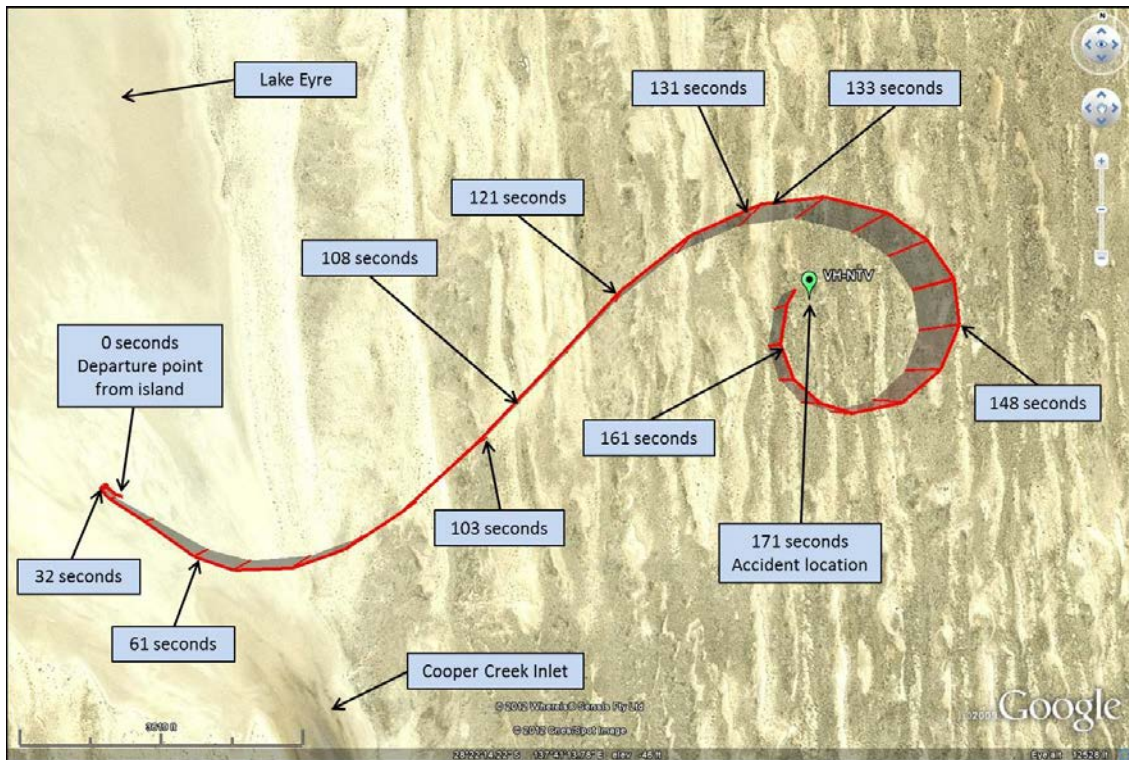
Figure 3: Flight path derived from recovered GPS data-plan view

The GPS data indicated that the helicopter took off at about 1859, climbed and levelled off at an altitude of 1,500 ft above mean sea level on a heading of 035° before commencing a turn to the right. Twelve seconds after initiation of the turn, the helicopter started descending with the bank angle increasing. Based on the GPS data and flight path estimations, it was calculated that the helicopter impacted terrain at about 1902, about 38 seconds after it started descending. Wreckage examination indicated that the helicopter impacted terrain in a 90° right-side low attitude. Table 1 provides a list of key events derived from the GPS data, and Figure 3 and Figure 4 provide an overview of the helicopter's flight path.

171	estimated time of impact (based on extrapolated data and simulations), easterly heading, bank angle 90° (based on wreckage information)

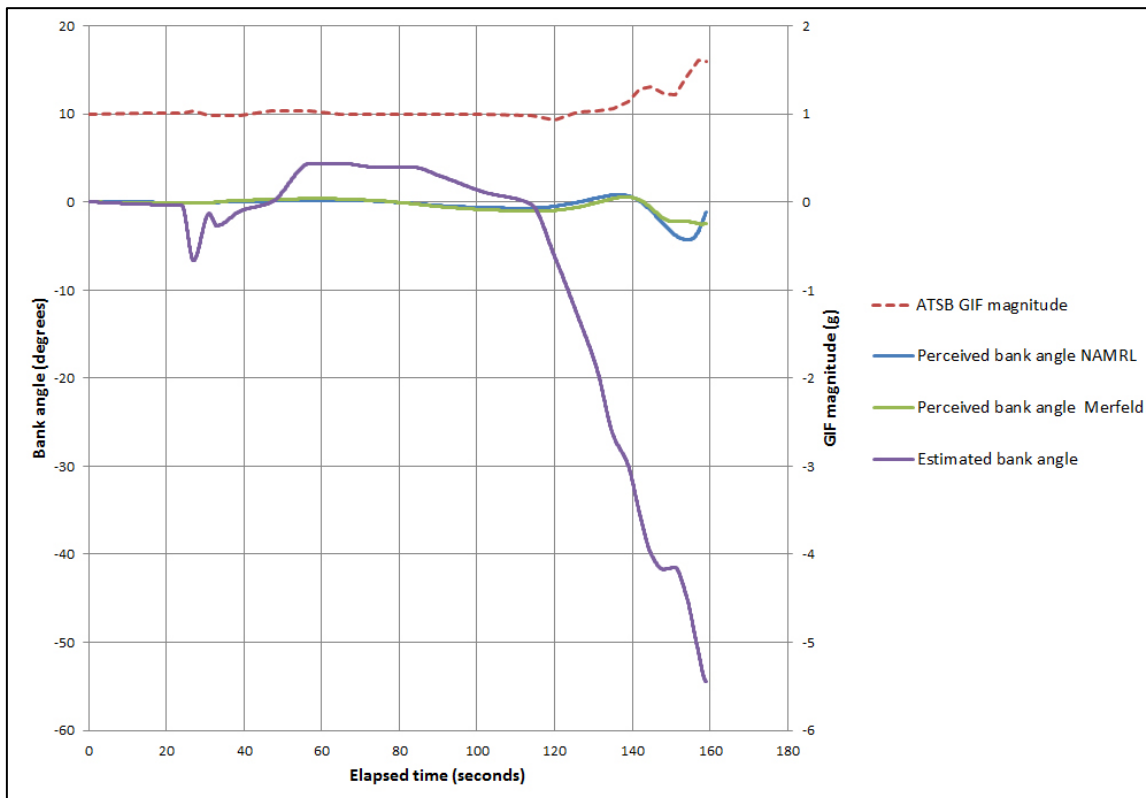
Figure 20: Estimated bank angle and perceived roll

Figure 20 provides details of the helicopter's bank angle estimated by the ATSB (appendix A), and the two models' estimates of the pilot's perceived roll. As indicated in the graph, the perceived roll during most of the right turn was very low in comparison with the actual roll. The specialists advised:

The estimation of parameters such as bank angle assumed that the flight was in coordinated flight, which meant that the GIF vector angle would be relatively low. Figure 20 also provides the estimated GIF magnitude based on accelerations estimated by the ATSB. As can be seen in the figure, during the period of descent (from 133 seconds) the magnitude increased gradually.

In summary, if it is assumed that the helicopter was in or close to coordinated flight, the orientation modelling shows that the pilot would have had very limited nonvisual cues of the increasing bank angle and descent.

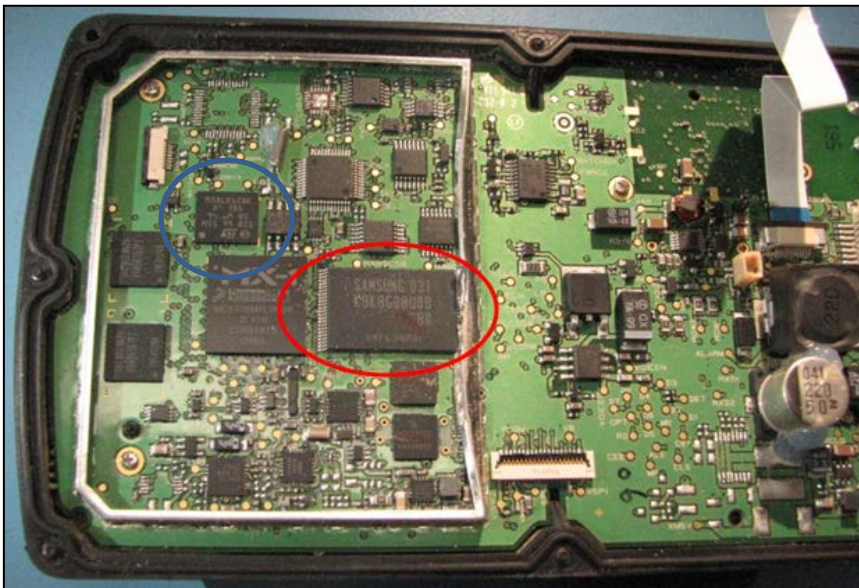
Figure A3: FBGA (blue) and TSOP (red) chips on VH-NTV GPSMAP 495 circuit board

Disassembly and examination of the unit revealed that the FBGA chip was undamaged but the TSOP memory chip (Figure A3) was cracked through the outer casing (Figure A4 and Figure A5) with the pins crushed by the protective surrounding.

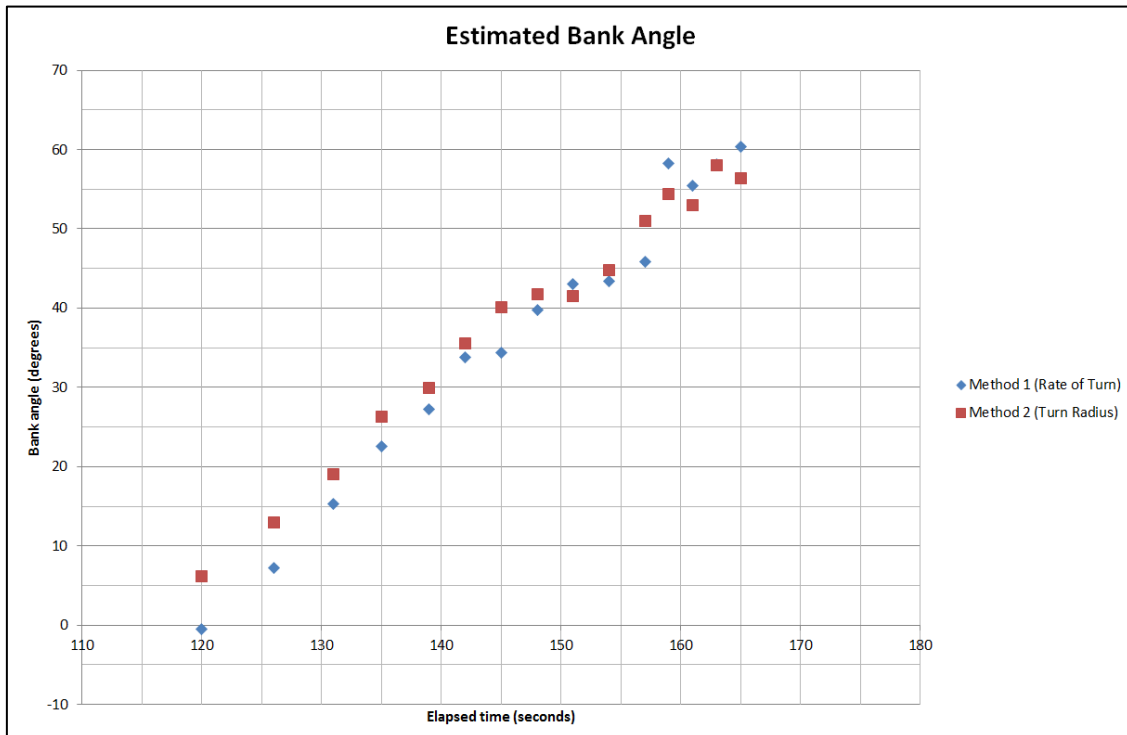
Figure A16: Estimated bank angle

The ATSB also estimated the time of impact by extrapolating various parameters. Using rate of descent, the time of impact was estimated to be 7 to 14 seconds after the last reliable data point (163 seconds after take-off). Using distance to run from the last reliable data point to the accident site, the time of impact was estimated to be 4 to 9 seconds after the last reliable data point. The overlap of 7 to 9 seconds was consistent with the results of ATSB simulator trials, which provided an estimate of 7 to 9 seconds. The time of impact was therefore concluded to be about 171 seconds after take-off.
