Aviation Short Investigations Bulletin

Issue 42

ATSB Transport Safety Report
Aviation Short Investigations
AB-2015-085
Final – 27 August 2015

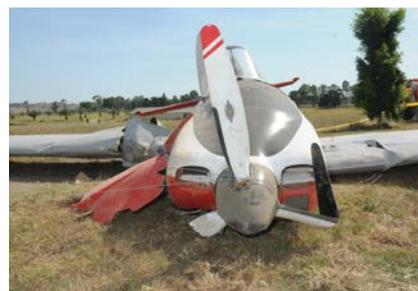
VH-RVY

he was unable to provide any physical assistance. After a short time, the passenger exited the aircraft. The pilot and passenger sustained serious injuries and the aircraft was substantially damaged (Figure 2).

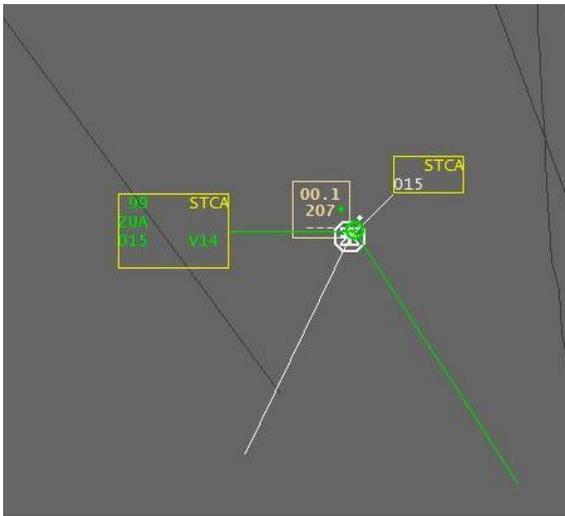
Figure 3

Time: 2.21.37 ZUA at 1,500 ft; SWX 1,500 ft ; about 100 m horizontally

STCA – Short term conflict alert

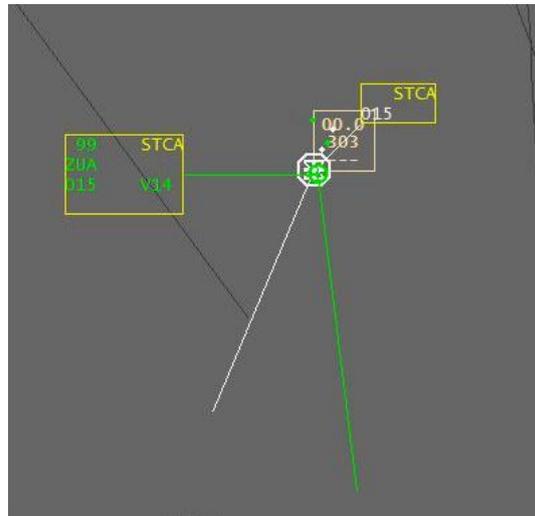
Figure 4

Time: 2.21.42 Near collision

ZUA at 1,500 ft; SWX 1,500 ft; Nil horizontal distance showing on radar

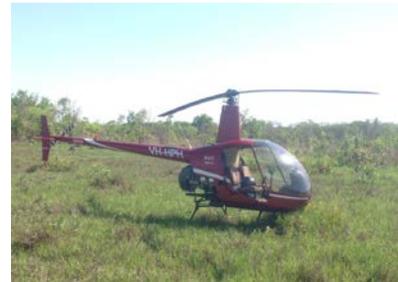
VH-HPH

About two minutes into the flight, on climb and at about 300 ft above ground level, the pilot felt a vibration through the tail rotor pedals. The pilot decided to return to La Belle Downs station, turned the helicopter to the right and started a descent. The pilot was unable to stop the turn and the helicopter continued to descend and turn to the right. The helicopter started to spin in a tight circle and completed between five and six rotations before landing hard, bouncing once and then coming to a stop. The pilot performed the shutdown procedure and the pilot and passenger exited the helicopter. The pilot and passenger were uninjured. The helicopter was substantially damaged, including damage to the tail boom and both skids.

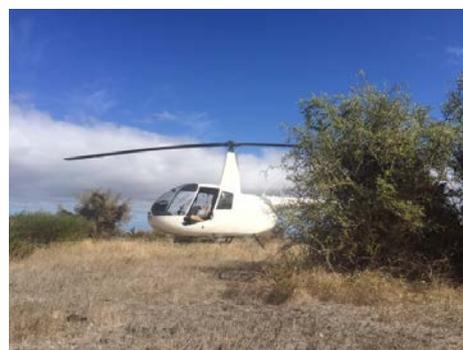
Figure 1: Tail rotor blade damage to VH-LOL

Also on board were client representatives who were directing the noxious weed management operation and manually dispensing the chemical into each bush. In the course of traversing the field at low level in search of the weed, the helicopter struck a previously unidentified power line. The helicopter's main rotor blade made initial contact with the power line and during the avoidance manoeuvre, the tail rotor blades also made contact, severing the blade tips (Figure 1). The pilot landed the helicopter safely. The helicopter was substantially damaged but the occupants were uninjured.

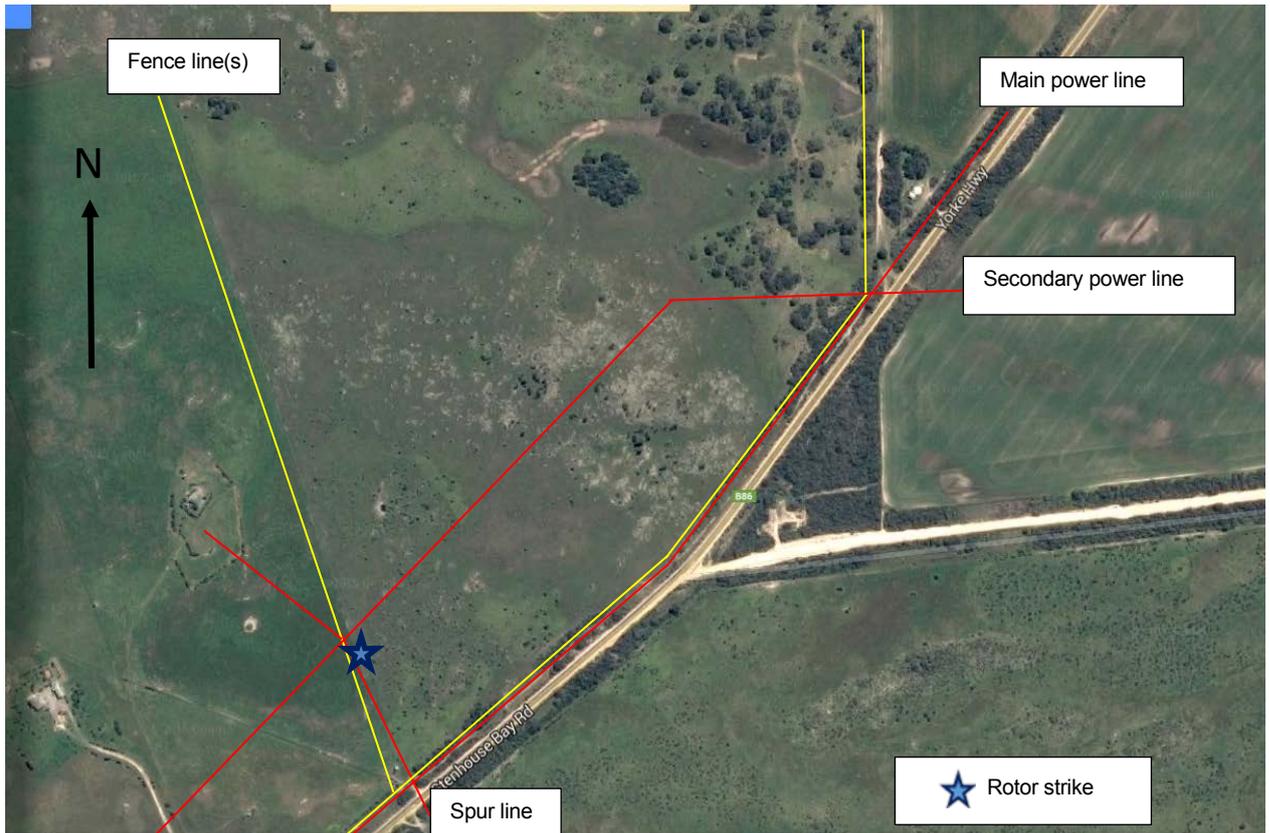
Figure 2: Powerlines and boundary fencing

The unidentified powerline was a single wire that was strung between the poles supporting the main and secondary powerlines and traversed, unsupported, through the southern boundary of the operational area. It was not mentioned by the locals, nor marked on the data logger map. It was not readily discernible from the air although additional support poles did lead the wire away from the secondary power line towards a distant building.
