Derailment of freight train 2AD1

Near Hugh River, Northern Territory | 23 December 2014

ATSB Transport Safety Report

RO-2014-025

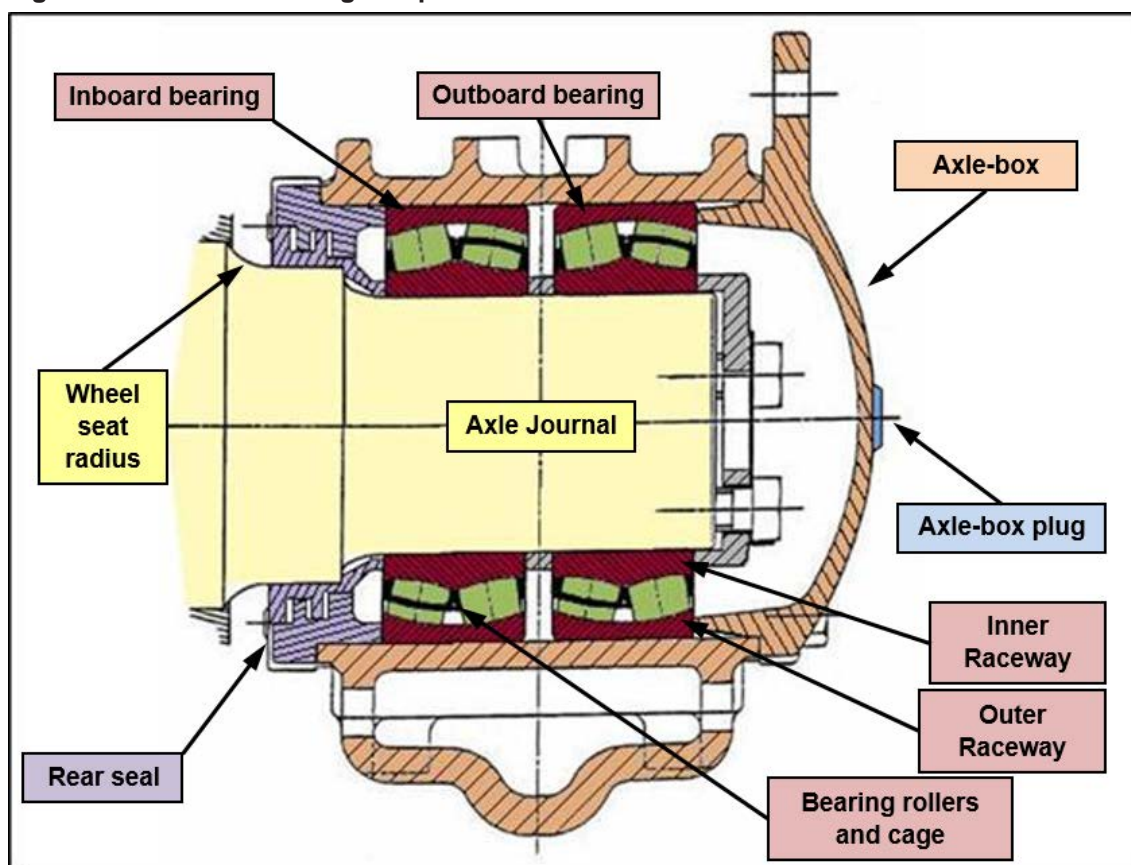
Figure 2: Axle Box Bearing components

The bearings on wagon PTMY 6-T were of an axle box type, each axle box housing two spherical rolling element bearings (Figure 2).

Schematic illustrating the components of an axle box bearing. Source: AS/RISSB 7516 *Railway Rolling Stock - Axle Bearings* coloured and annotated by ATSB
