Derailment of track maintenance vehicles

Singleton, NSW | 11 June 2015

ATSB Transport Safety Report
Rail Occurrence Investigation
RO-2015-010
Final – 6 January 2016

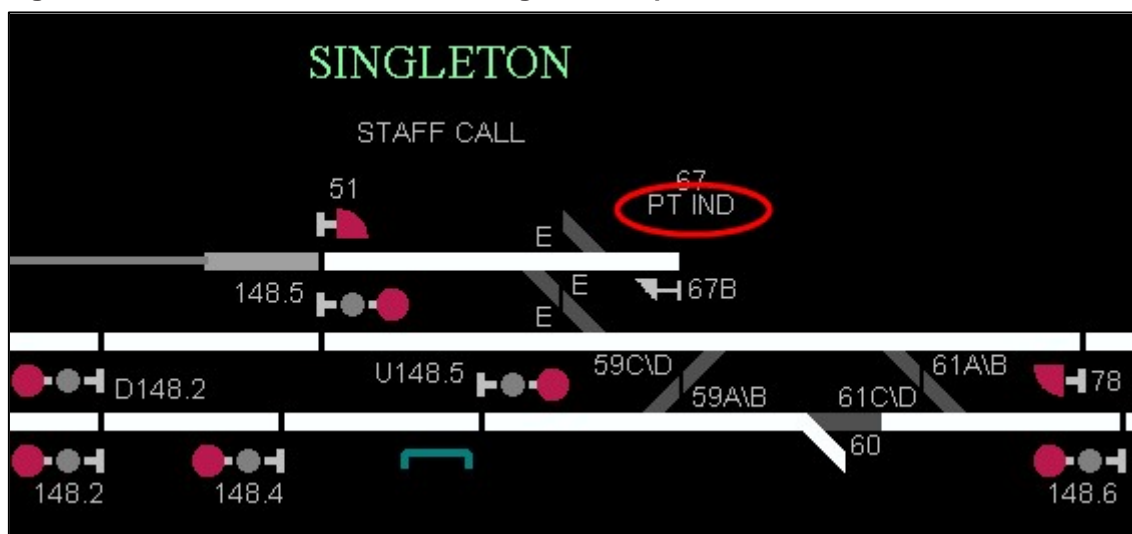
Figure 6: Phoenix screen extract showing E Frame points detected normal

Normally, the track indication for the E Frame points showed them as set for straight-through on the Down main line (Figure 6) and the text 'PT IND' was displayed. This indicated to the NCO that the points were set and detected in the normal position.

The E Frame indication (circled) seen by the NCO when the E Frame points were in the normal position. The indications of the tracks over the points show as straight through. This corresponds to the position of the E Frame points. Source: Australian Rail Track Corporation

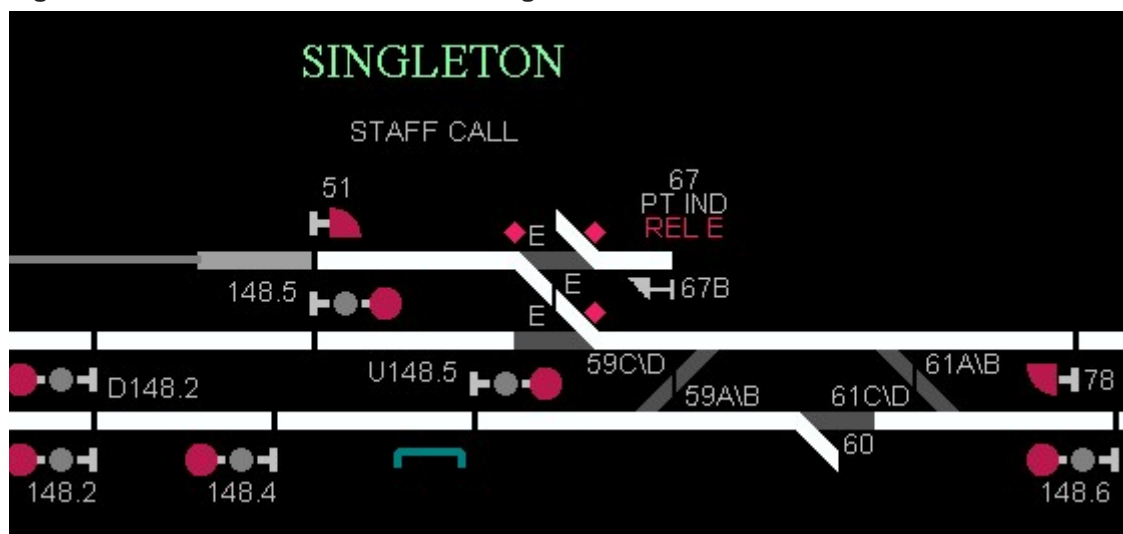
Figure 7: Phoenix screen extract showing E Frame released

When the NCO provides a 'release' for the operation of the E Frame by a qualified worker at Singleton, the track indication for the E Frame points changes to show them released for movement to access the Down siding, and the text 'REL E' is displayed (Figure 7). This indicates to the NCO that the points release has been set. Although the Phoenix graphic for the E Frame points was now orientated to represent the points in the reverse position, a qualified worker (at Singleton) may be yet to actually move the points to the reverse position (via the local E Frame panel). That is, when the points release is set, the Phoenix track display graphic at the control centre shows the E Frame crossover in the reverse orientation – regardless of their *actual* position at Singleton.

The 'REL E' indication displayed to the NCO after setting the control that allows the qualified worker at Singleton to operate the E Frame. The indications of the tracks over the points show as set for the crossover but the E Frame points may still be set as straight through. Source: Australian Rail Track Corporation

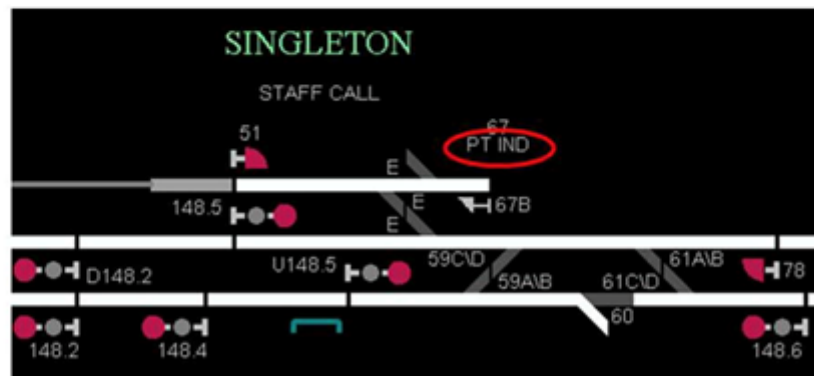
- Display of 67 points in the normal position together with "PT IND" on the screen.

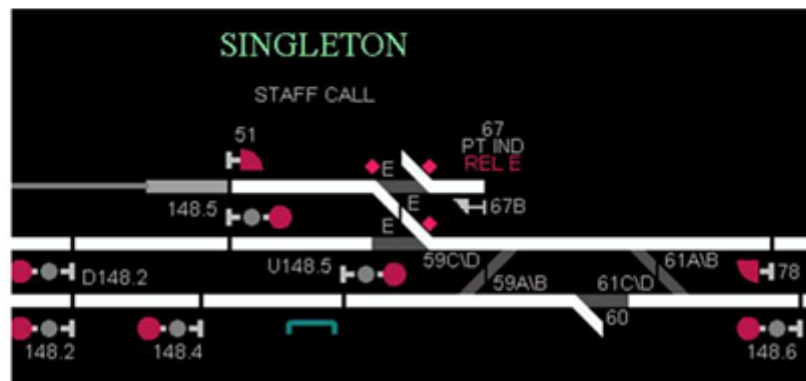
- When E-frame Release is first taken by the PO, 67 points displays in the reverse position together with "PT IND" and "REL E". The 67 points however may still be in the normal position until operated from "E Frame".

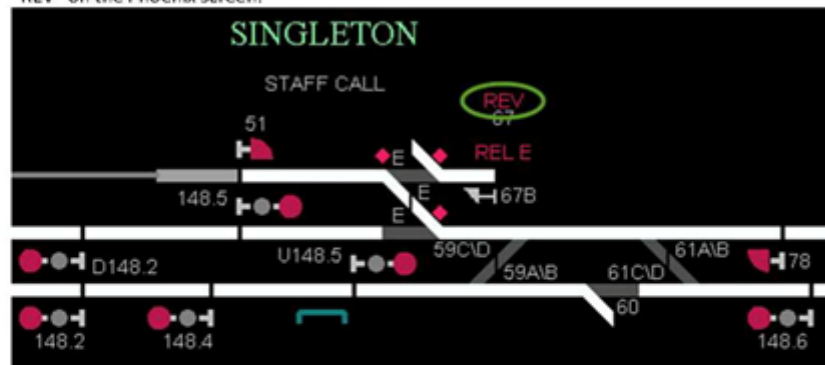
- When 67 points have been operated from the Ground Frame at Singleton, and detected in the reverse position, the Network Controller is provided an indication "REV" on the Phoenix screen.

If the points have been reversed but "REV" does not appear, OR the light does not come on at the panel, then the points must be regarded as failed, and no rail traffic to travel over.
