Australian Government
Australian Transport Safety Bureau

Flight preparation event involving Kavanagh E-260 balloon, VH-FSR

near Alice Springs, Northern Territory | 13 July 2013

ATSB Transport Safety Report
Aviation Occurrence Investigation
AO-2013-116
Final – 9 December 2015

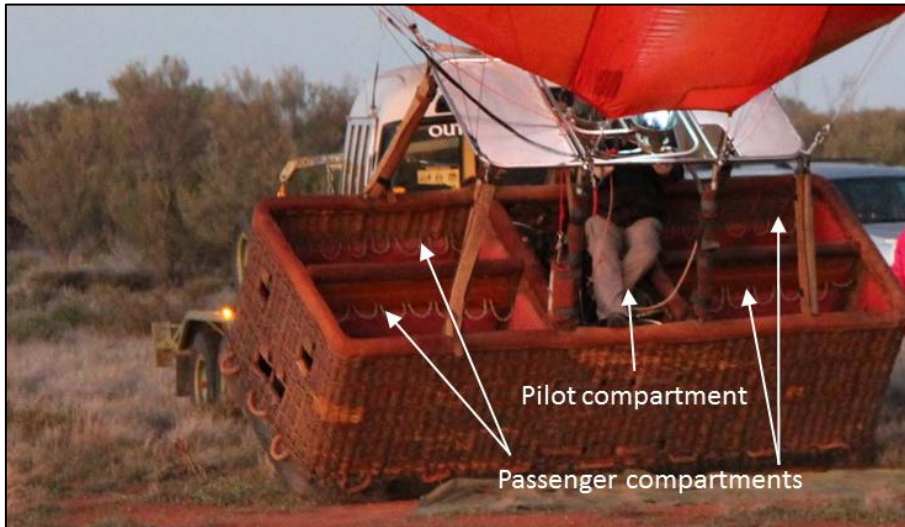
Figure 1: Balloon basket passenger and pilot compartments

The passengers were also informed that, due to the wind, they would be pre-loaded into the basket while it was positioned on its side and before the balloon was fully inflated (see the section titled *Passenger loading procedure*). The passengers were divided into two groups of five and allocated their positions in the basket. Due to the basket configuration, with the pilot and gas bottles occupying the centre area, passenger loading was only possible from either end of the basket (Figure 1).

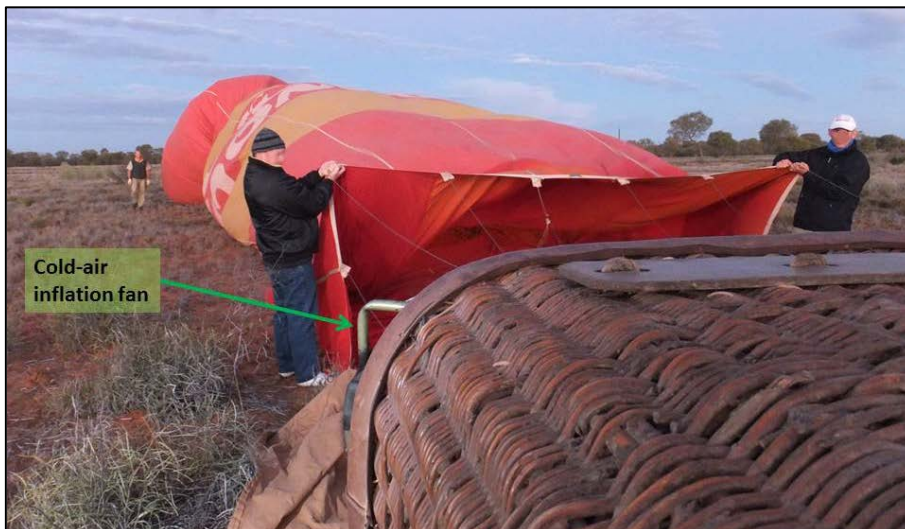
Figure 2: Passengers assisting with the initial balloon inflation

Following assessment that the wind speed was within the allowable limits, the balloon inflation process commenced at about 0700 using the cold-air inflation fan. Two of the passengers assisted with the inflation, under the supervision of the crew, by supporting the balloon's mouth (Figure 2).

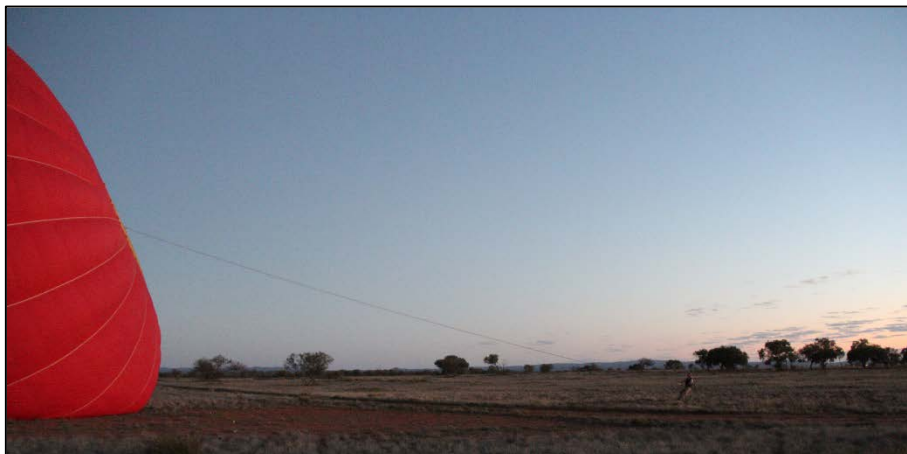
Figure 3: Example of a ground crew member controlling the balloon crown line

As the balloon inflated the ground crew member repositioned to take control of a long rope (crown line) that was attached to the top of the balloon envelope (Figure 3). The crown line ensured that the balloon envelope remained stable as it inflated and did not contact the basket, burner or inflation fan. Operation of the crown line resulted in the ground crew member being over 50 m away from the basket and out of sight of the pilot and passengers. The pilot remained at the basket to conduct pre-flight checks on the balloon and supervise the loading of the passengers.

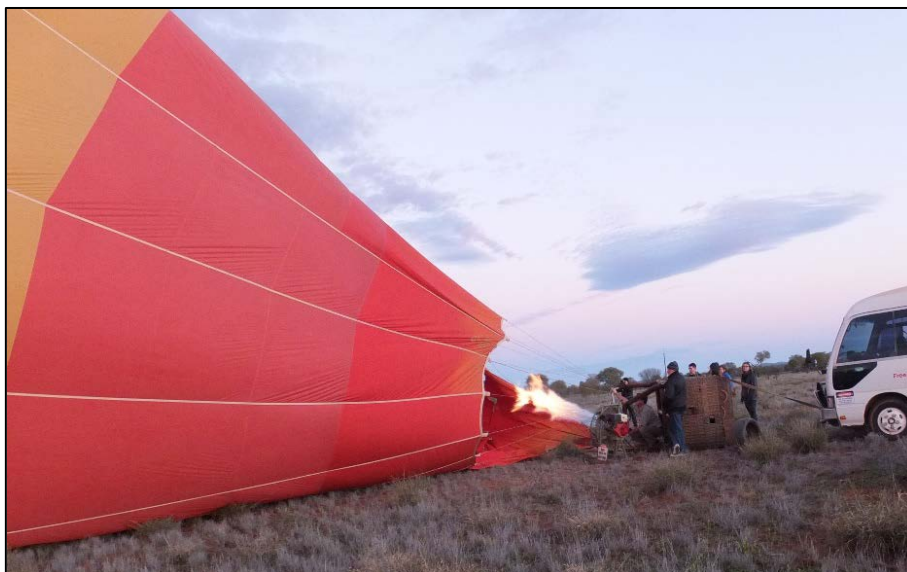
Figure 4: Balloon inflation was assisted by the application of burner heat once the assisting passengers had moved clear of the balloon mouth

Once the balloon was inflated sufficiently for the balloon mouth to support itself, the assisting passengers moved to their allocated end of the basket ready for loading. Once they were clear of the mouth, the pilot accelerated the inflation process by using the burners positioned on the frame mounted above the basket to heat and expand the air within the envelope (Figure 4).

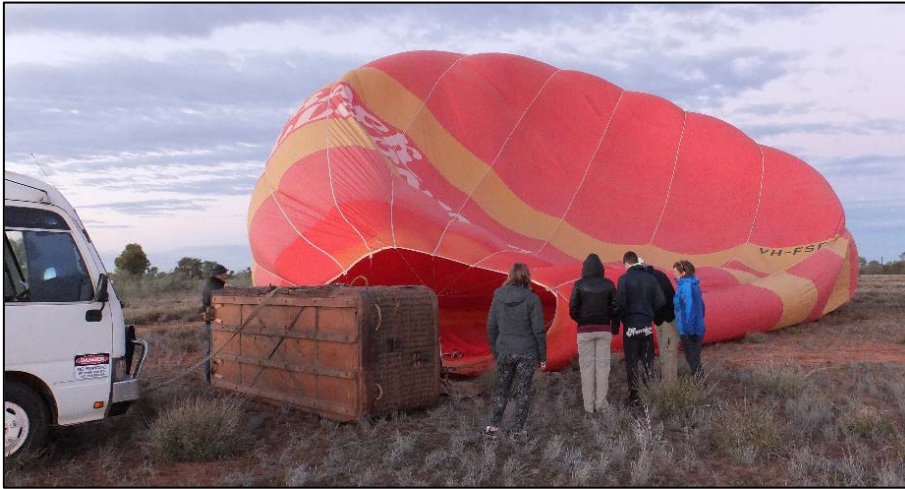
Figure 5: Balloon basket originally positioned parallel to the front of the bus

As the balloon envelope inflated it gradually rotated to the left and aligned itself with the wind. As a result of that movement, the basket connected to the balloon was pulled around closer to the inflation fan (Figures 5 and 6). In response, the pilot repositioned the fan away from the basket a number of times to ensure continued efficient inflation of the balloon.

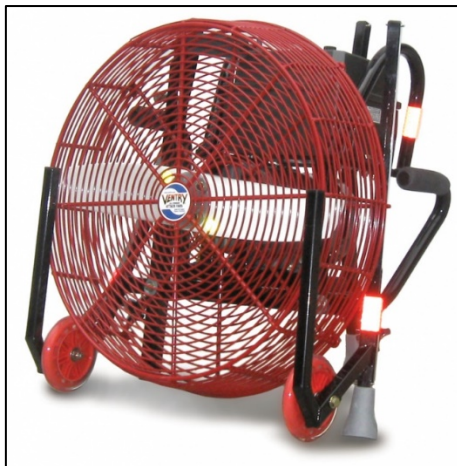
Figure 11: Concentric ring-style fan guard

Standard number 1910.212(a)(5) stated that when a fan is less than 7 ft (2.1 m) above the working floor, the blades shall be guarded and that the opening in the guard shall be less than half an inch (12.5 mm). An accompanying document clarified that the use of concentric rings (Figure 11) with spacing between them not exceeding half an inch was considered to be acceptable providing that sufficient radial spokes and firm mountings were used to make the guard rigid.

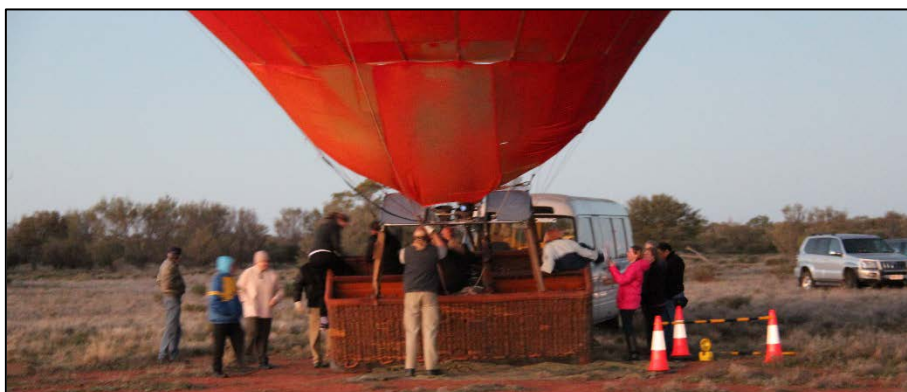
Figure 13: Passenger loading in calm conditions

Under conditions of little or no wind passengers would normally enter the basket once it and the balloon envelope were upright (Figure 13). Due to the wind conditions that existed on the morning of the accident however, the pilot decided to pre-load the passengers into the basket while it was on its side.
