In-flight break-up involving modified PZL Mielec M18A Dromader, VH-TZJ

37 km west of Ulladulla, New South Wales | 24 October 2013

ATSB Transport Safety Report
Aviation Occurrence Investigation
AO-2013-187
Final – 15 February 2016

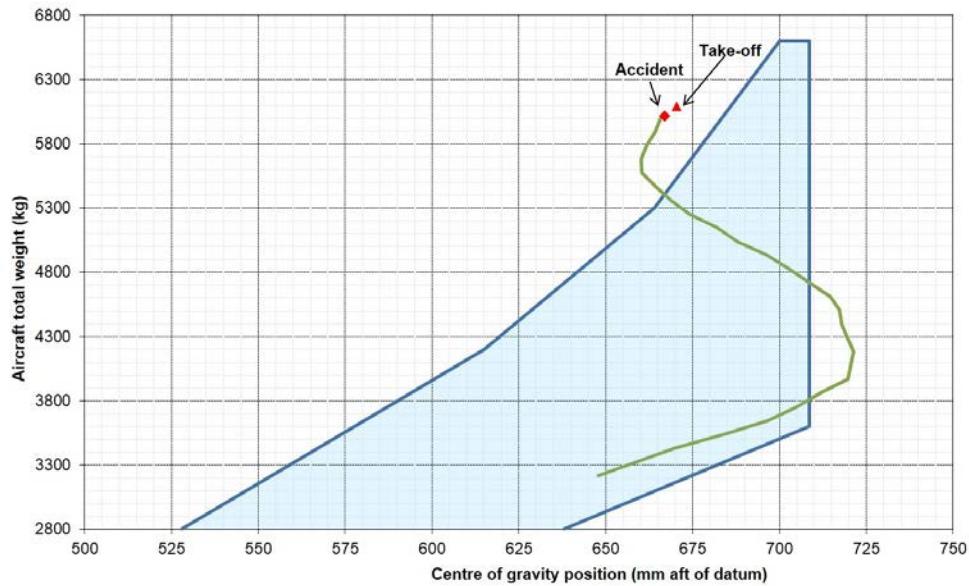
Assuming that the pilot's estimate of weight was correct,¹³ the ATSB estimated that the aircraft's centre of gravity (c.g.) would have been about 15 mm forward of the forward c.g. limit at take-off, and similarly forward of the limit at the time of the accident (as shown by the red marks in Figure 4). The green line shows the projected c.g. shift if a retardant dump had been made at that point.

Figure 4: Estimated aircraft centre of gravity, showing that it was outside of the limits at take-off (red triangle) and at the time of the accident (red diamond)

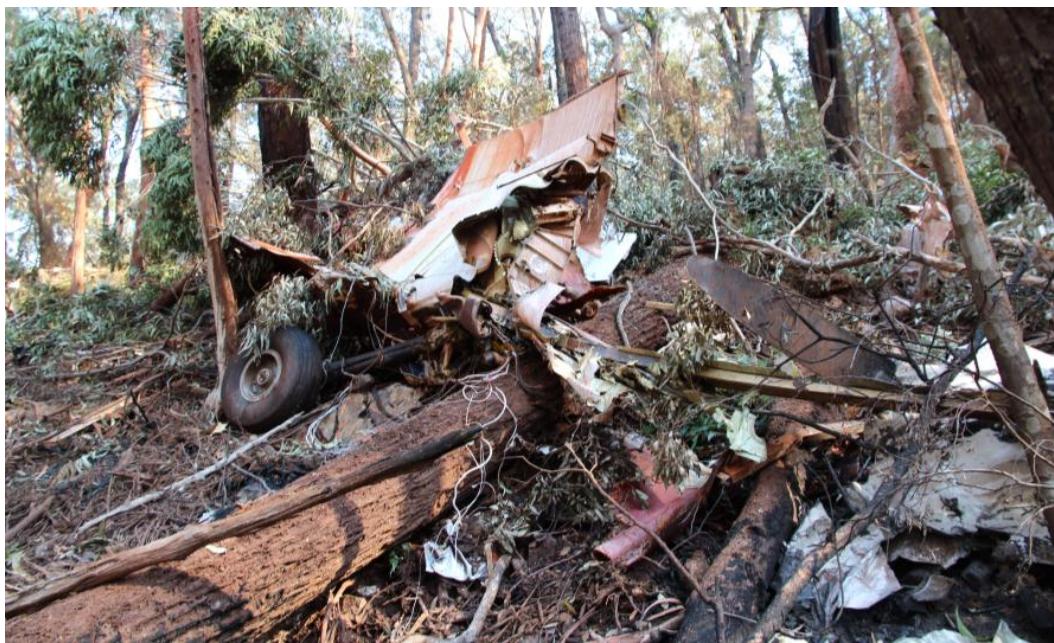
The main wreckage was contained within a small area and included all major components, except for the left-outboard wing and a section of the left stabiliser/elevator. Those components were located about 130 m and 150 m respectively back along the aircraft's flight path as reported by the crew of the support helicopter (Figure 2). The left stabiliser and wing showed impact marks consistent with the left wing striking the stabiliser during the break-up. The aircraft was significantly damaged from contact with the trees and the impact with the terrain (Figure 10). Some parts of the wreckage sustained additional damage as a result of the bushfire passing through the accident site.

Figure 10: Main wreckage

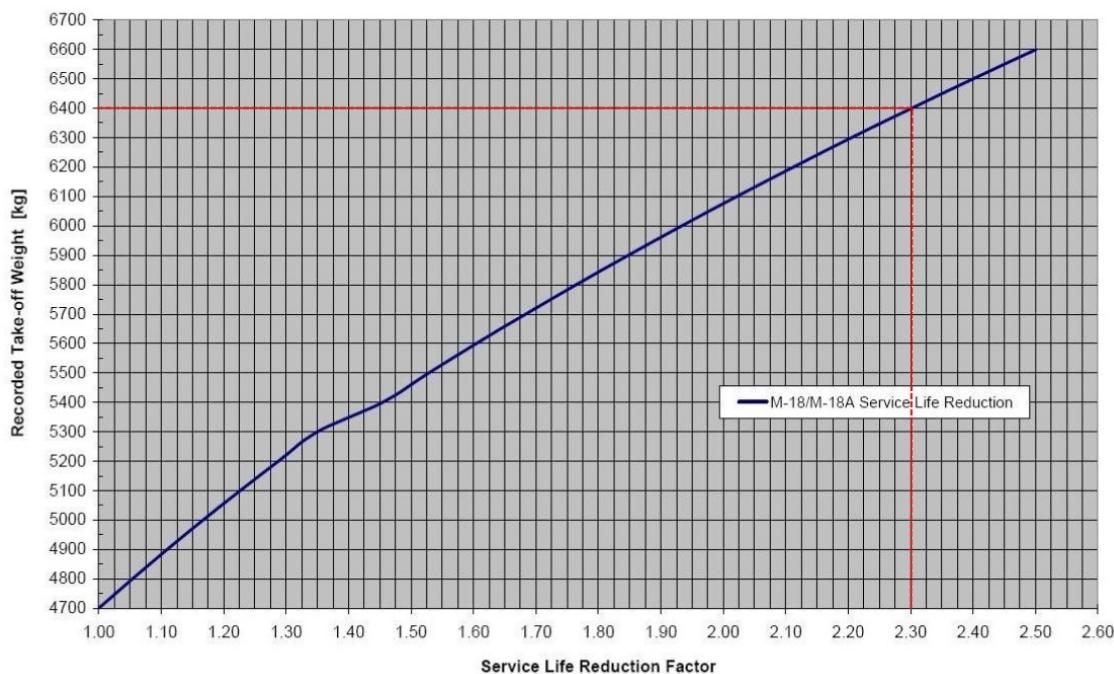
Figure 19: Service life factor chart from the STC SVA521 Maintenance Manual Supplement. The example (red lines) shows that, for a take-off weight of 6,400 kg, the applicable service life factor²⁹ is 2.3

In the case of TZJ, the aircraft was fitted with the smaller of two possible fuel tank configurations. This configuration resulted in a maximum practical take-off weight of 6,400 kg. Thus, the maximum applicable service life factor that could be applied to TZJ was 2.3 (see Figure 19).

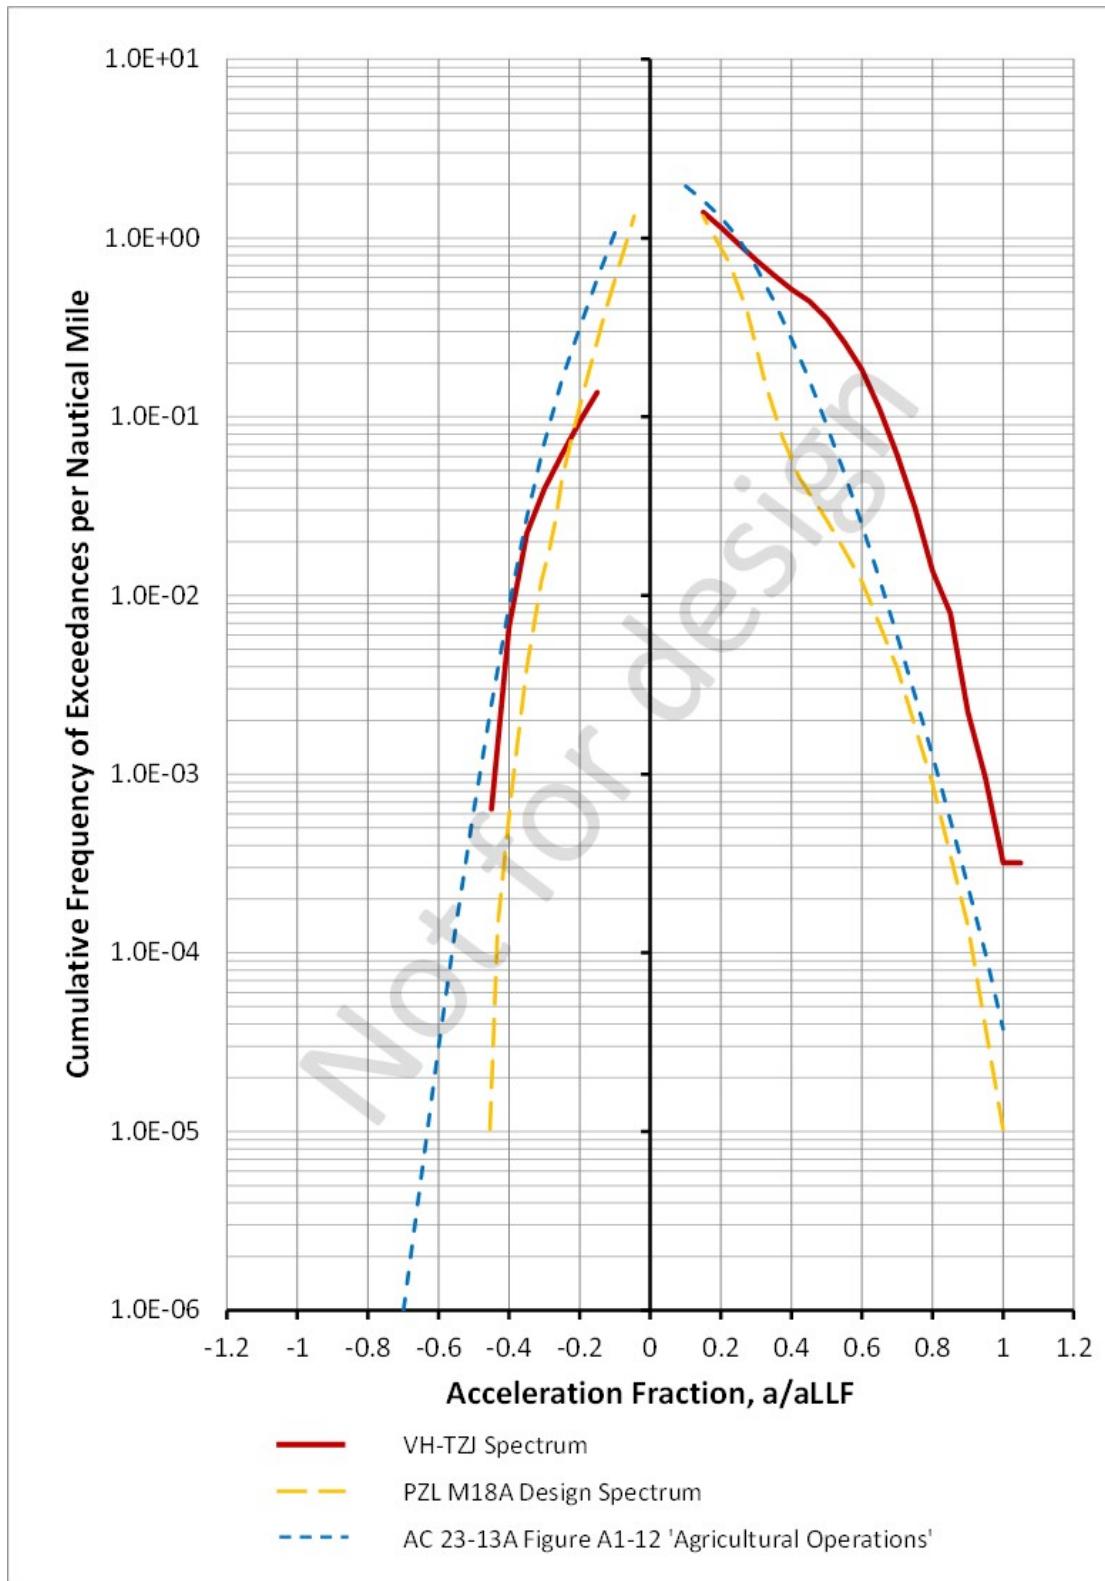
In addition, firefighting operations made up only a small fraction of the aircraft's total operating time. Thus, the effect on the aircraft's fatigue life from firefighting operations was likely to be small compared to agricultural operations.

Figure 20: Comparison of TZJ's manoeuvre load spectrum as derived from recorded DAAM data (in red), the PZL M18A design spectrum (in yellow) and US FAA AC23-13A Figure A-12 *Agricultural Operations* (in blue)

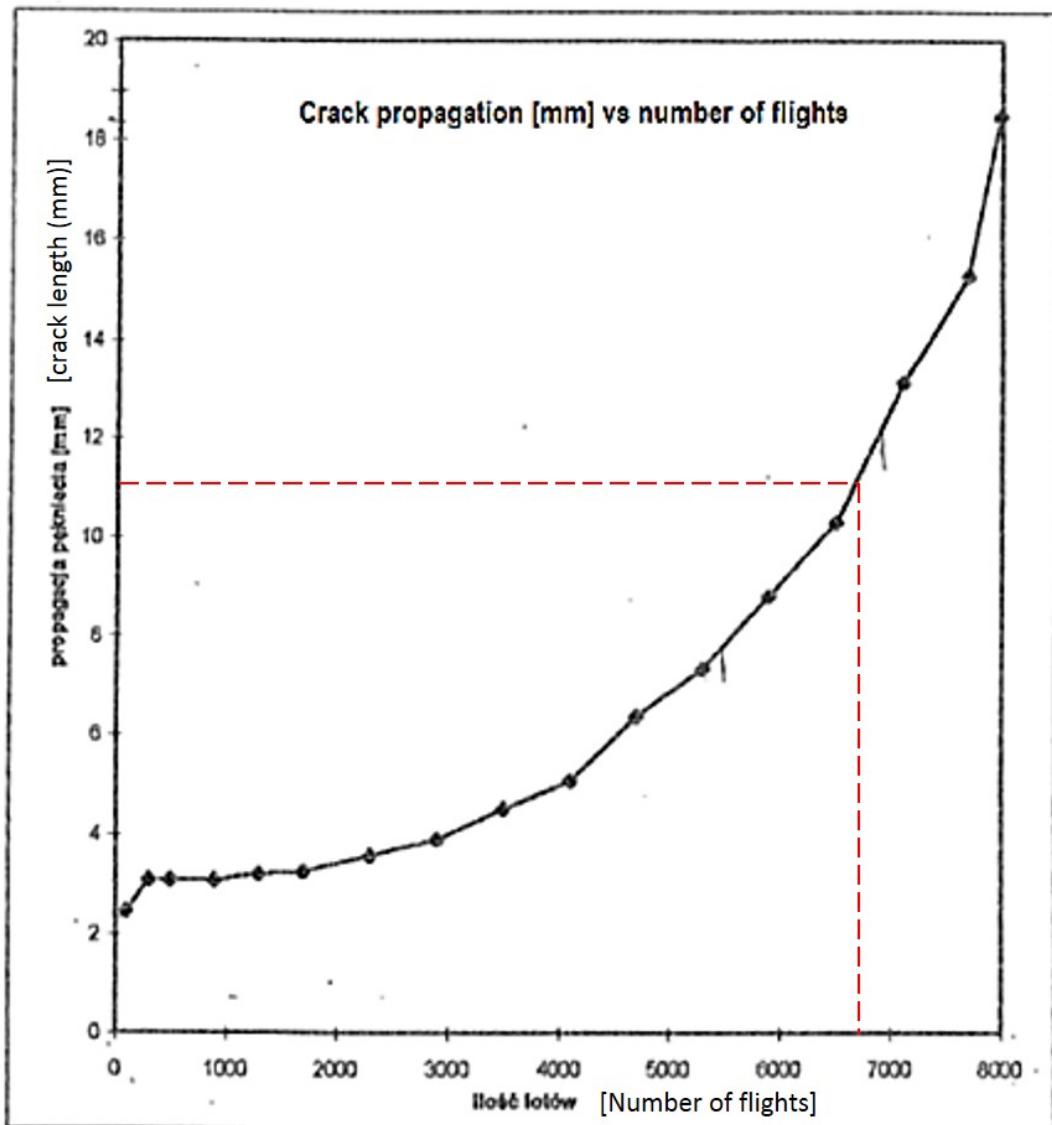
Figure 22: Basic M18 crack growth rate as determined by the manufacturer, with the size of the crack in the centre-to-outboard wing attachment fitting in TZJ applied to the manufacturer's data (dashed red lines) to estimate the number of flights before failure

The corrosion pitting damage in the image provided by the manufacturer is significantly greater than that observed in the bore of TZJ's failed centre-to-outboard wing attachment fitting. Based on information provided by the manufacturer, and in the absence of other factors that affect the rate of crack growth, the ATSB estimated that it would take between 6,000 and 7,000 flights for a crack to grow to the 11 mm before failure as observed in TZJ (dashed line in Figure 22). Based on recorded data, for which the average flight was about 30 minutes, the ATSB estimated this equated to between 3,000 and 3,500 flight hours.

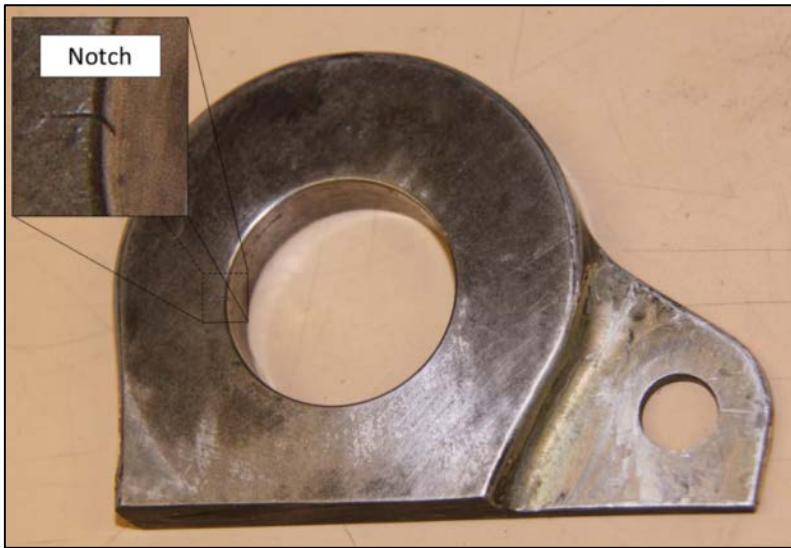
The reference standard reportedly used by the NDT organisation to calibrate the equipment for each inspection was constructed from a retired M18 wing attachment fitting (Figure 23). The reference standard contained a corner notch that was 2.4 mm long, 2.4 mm deep (maximum) and about 0.18 mm wide at the edge of the bore. An apparent identifying mark (engraving) had been made on the reference standard but, when examined in December 2013, the mark was very worn and unreadable.

Figure 23: Eddy current reference standard used by the NDT organisation for its M18 wing attachment fitting inspections (inset showing the corner notch)

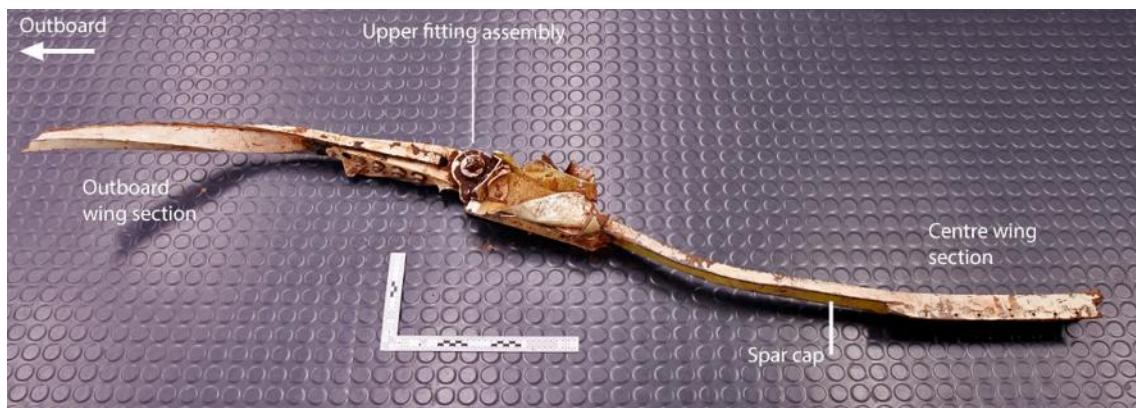
Figure B2: Left wing main spar upper fitting and spar cap – as recovered from the accident site

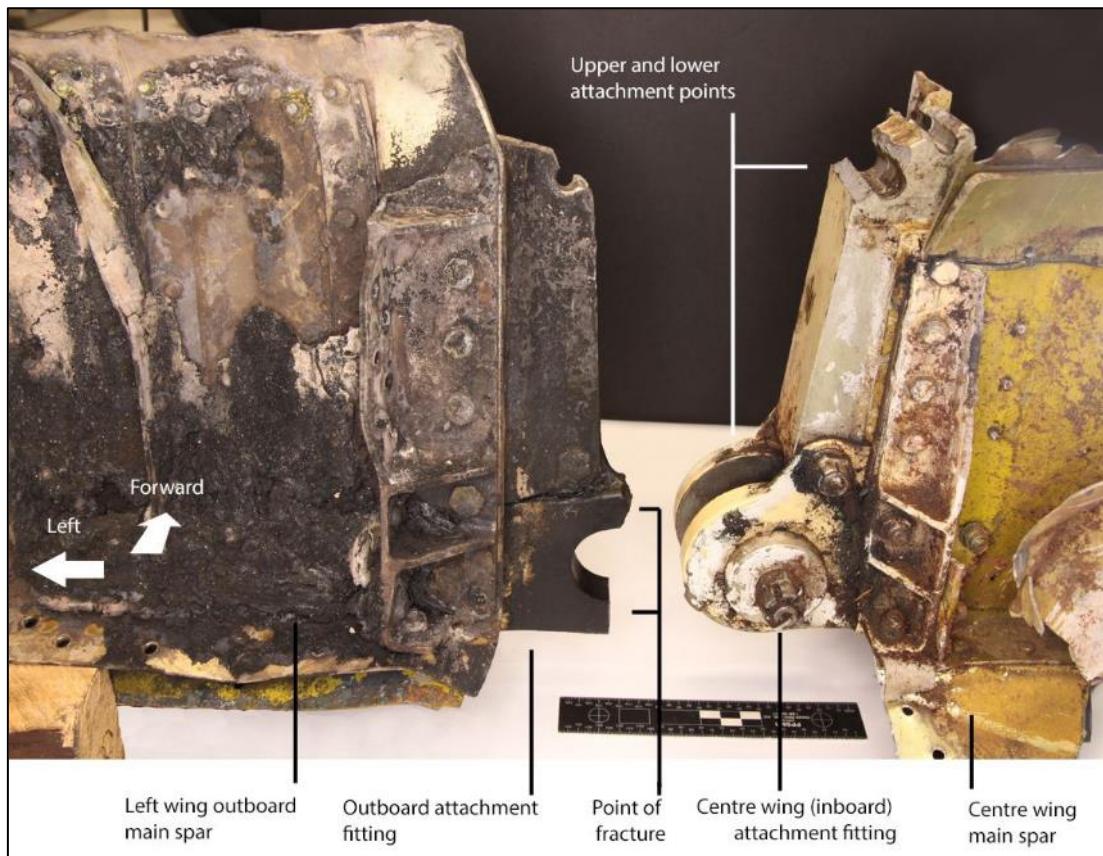
Figure B4: Left wing main spar outboard to centre wing structure, as recovered from the accident site

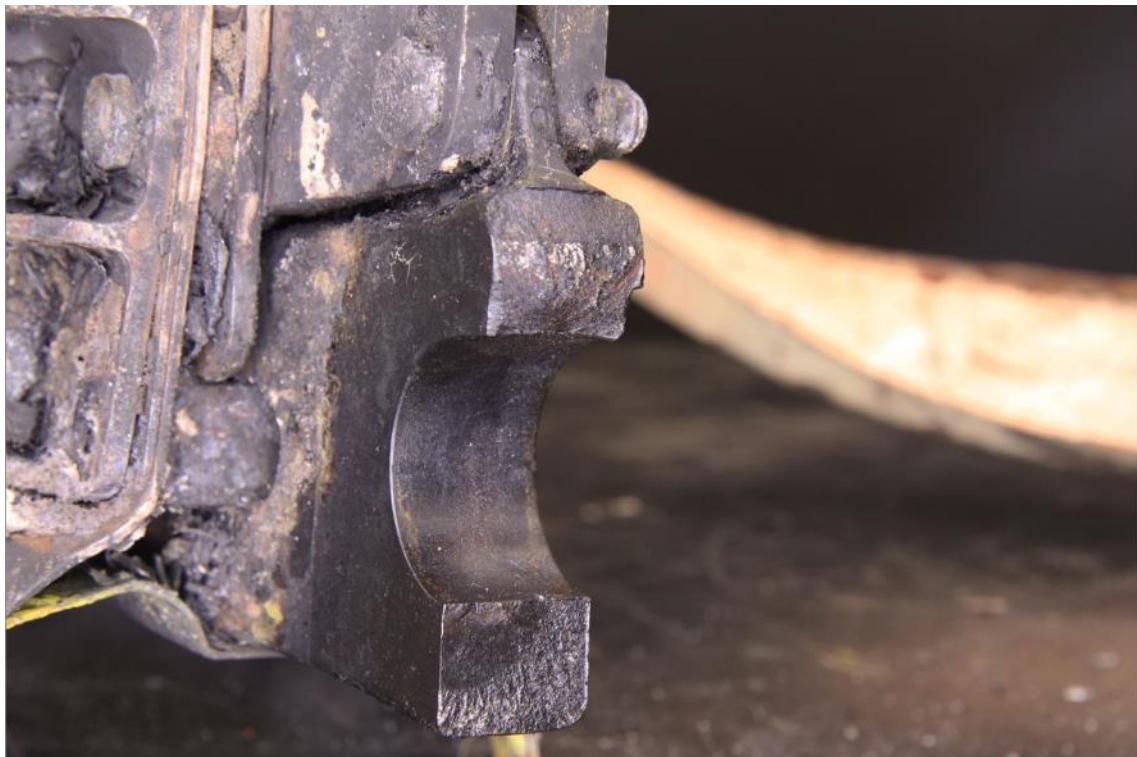
Figure B6: Outboard view of the fractured lower attachment fitting at the left wing main spar interconnection

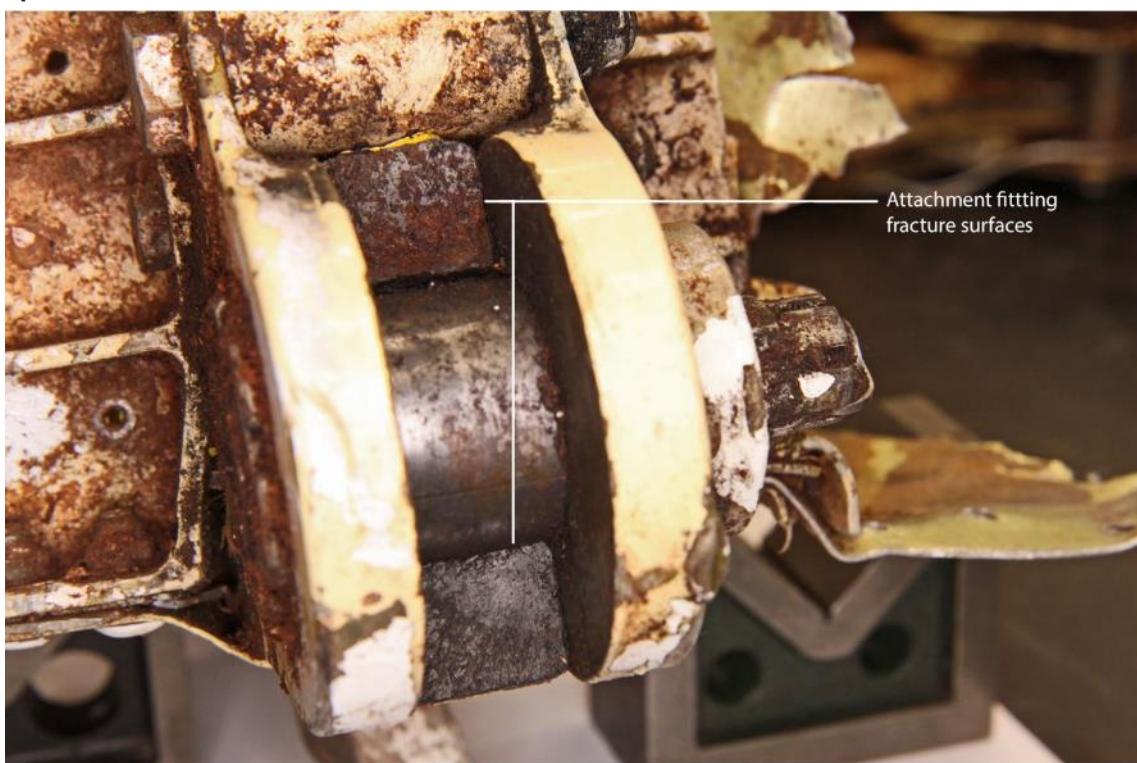
Figure B7: Inboard view of the fractured lower attachment fitting at the left wing main spar interconnection

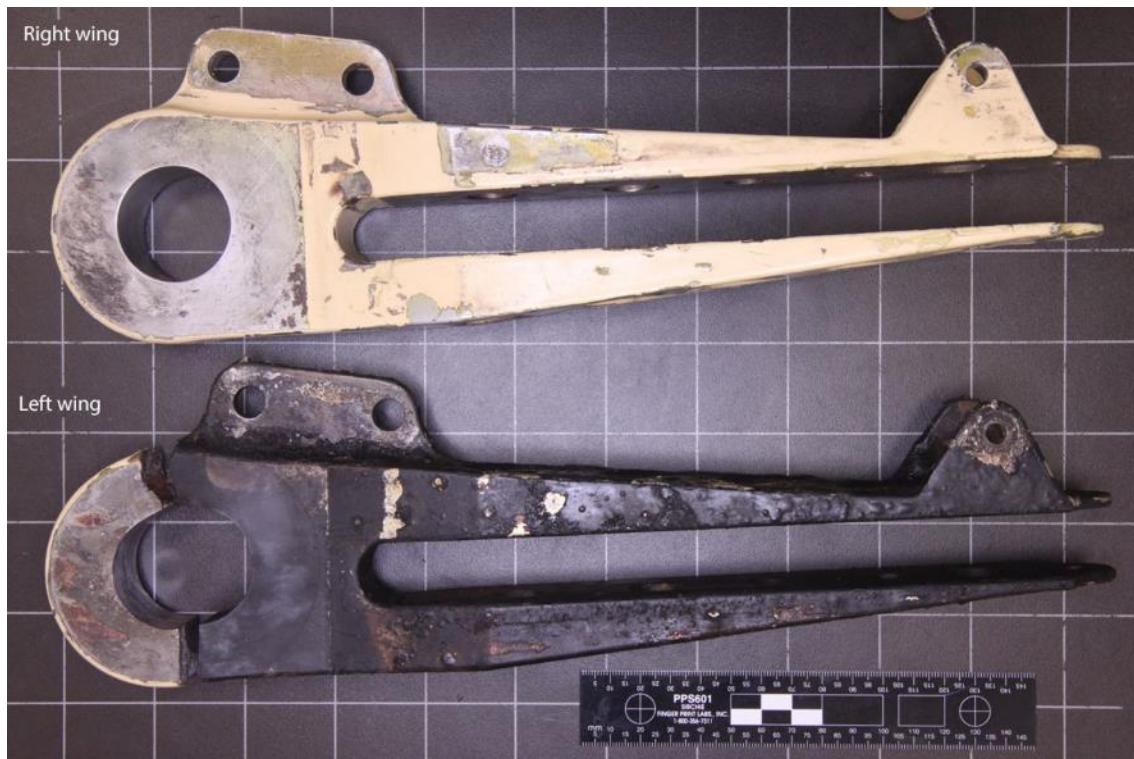
Figure B8: Comparison of the left and right main spar lower outboard attachment fittings from VH-TZJ (post disassembly)

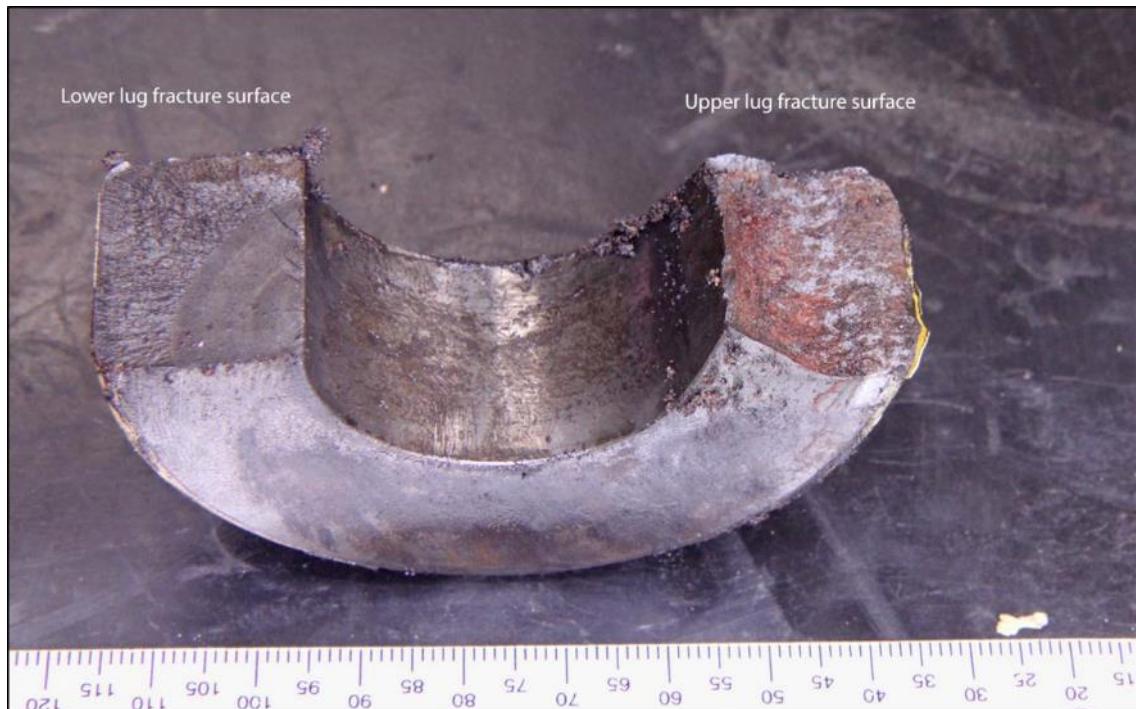
Figure B9: The fractured lug section from the left wing main spar outboard lower attachment fitting. The lug is shown uncleared as disassembled

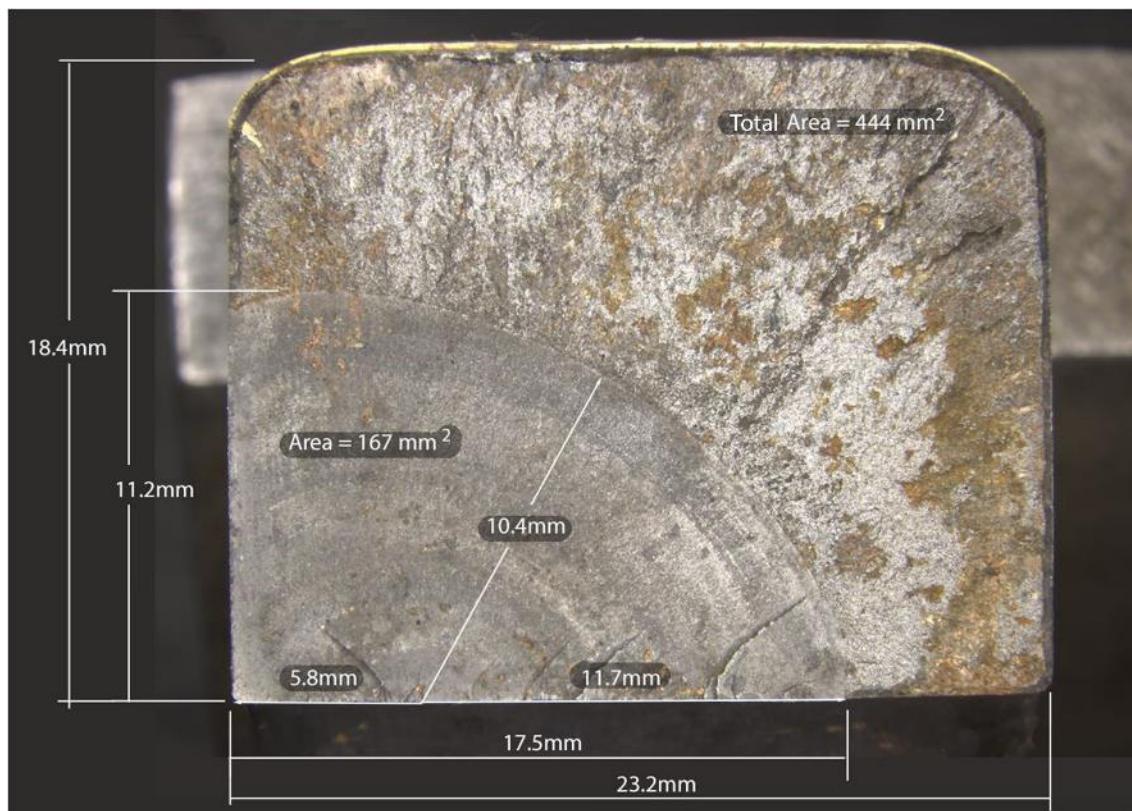
Measurements were taken of the significant features from the fractured lug, as shown in Figure B14. The fatigue cracking had extended from the 6-o'clock (lower) portion within the bore before reaching a critical length of 10.4 mm. The crack origins extended approximately three-quarters across the bore surface. The extent of fatigue cracking represented close to 38 per cent of the overall cross-sectional area of the lower lug ligament.

Figure B14: Critical measurements of the fracture detail

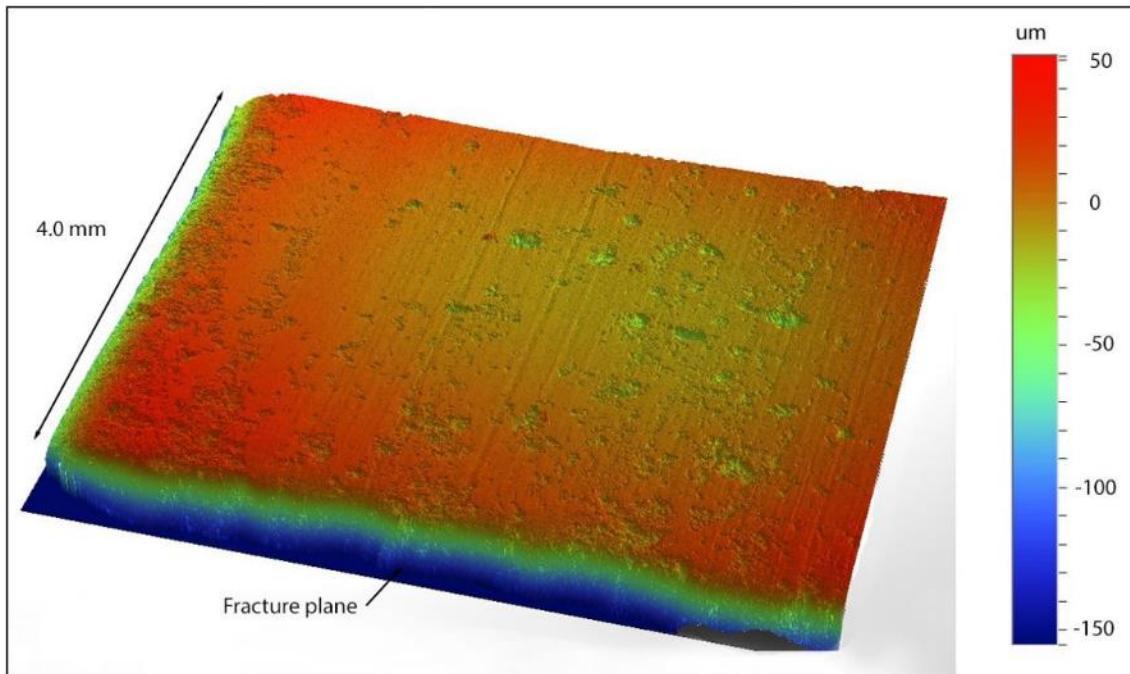
Figure B17: Representation of the pitting corrosion damage within the bore of the separated lug in a 4 mm band across its section

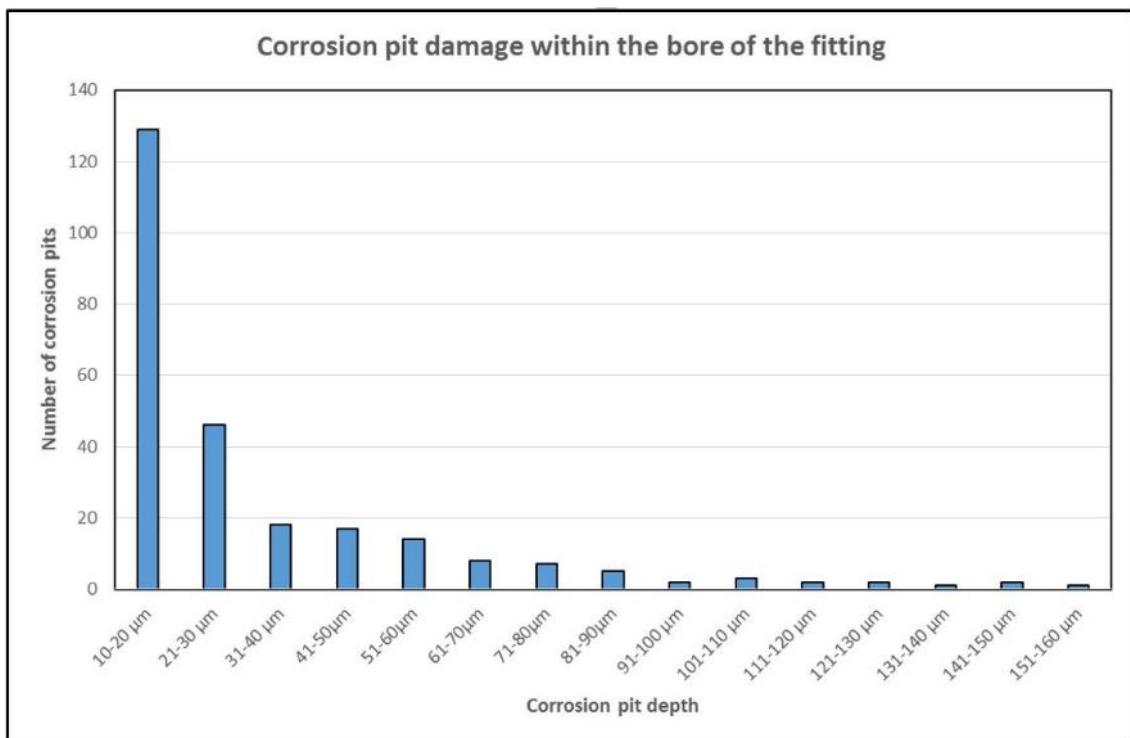
Figure B18: Histogram of pit depths within the bore of the separated lug in a 4 mm band across its section

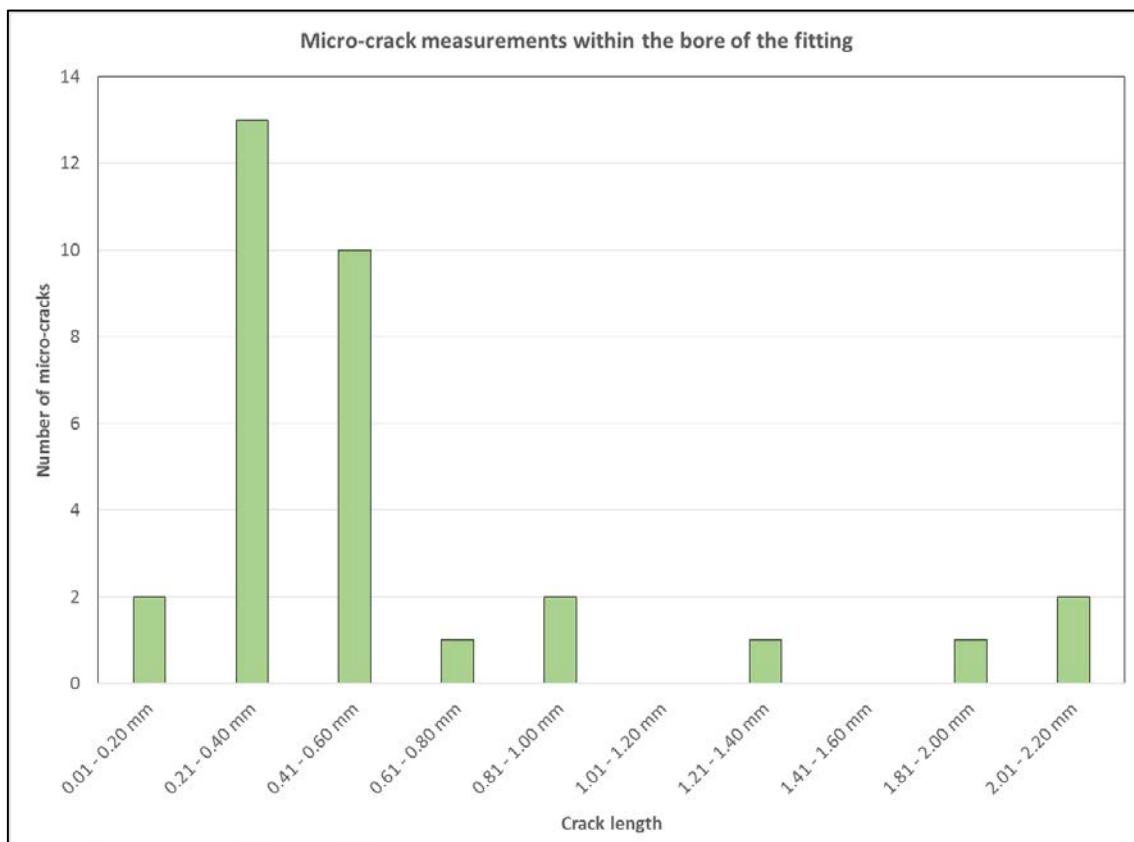
Figure B20: Histogram of secondary cracks within the bore of the fitting

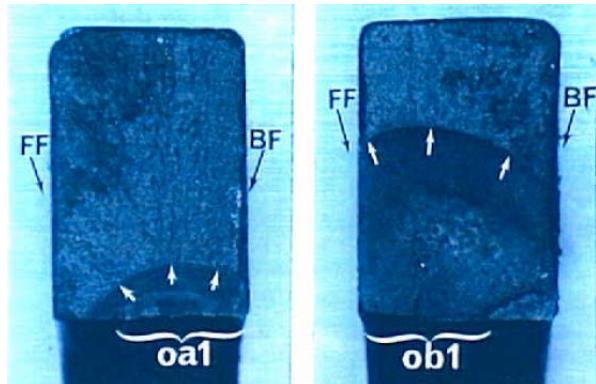
On 18 June 1999, a PZL Mielec M18A with about 4,700 hours time in service (TIS) was substantially damaged when its right wing separated in flight while manoeuvring in Louisiana, US. The pilot received minor injuries. Examination of the aircraft revealed that both lugs of the right wing main spar lower centre attachment fitting had failed due to fatigue cracking. The larger crack developed to about 60 per cent of the lug area (Figure E1). There was also a crack in the left wing inboard attachment fitting's forward lug. Severe pitting corrosion was noted in the bores and on the faces of the lugs, as well as on the other wing fittings. The fittings were found to contain insufficient lubricating grease.

The NTSB found that although the aircraft records showed that all required inspections had been completed, including a fluorescent dye penetrant inspection of the wing attachment fittings, 'metallurgical examination disclosed no trace of dye penetrant residue on any of the examined components.'

Figure E1: M18 wing fitting, NTSB investigation FTW99LA170

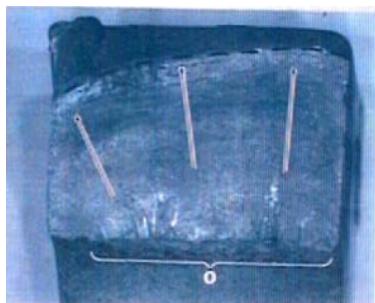
On 22 May 2000, a PZL Mielec M18A with about 5,000 hours TIS was destroyed when its right wing separated in flight while manoeuvring in Louisiana, US. The pilot received serious injuries. Examinations showed that the right wing main spar lower outer attachment fitting had failed due to fatigue cracking through about 90 per cent of the lug area (Figure E2). The wing attachment fittings displayed a line of heavy corrosion pitting on the inside circumference. The fatigue cracking in the lug initiated at multiple origins located in the bore of the lug, corresponding with areas of severe pitting corrosion.

Figure E2: M18 wing fitting, NTSB investigation FTW00LA149

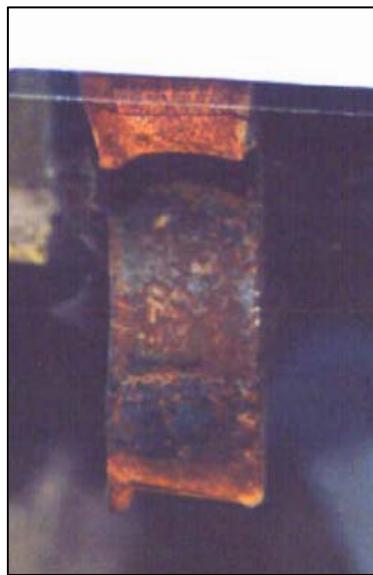
On 21 September 2000, a PZL Mielec M18A with about 5,000 hours TIS was destroyed when its right wing separated in flight while manoeuvring in Arkansas, US. The pilot received minor injuries. The NTSB found that the right wing main spar lower outer attachment fitting lug had failed due to fatigue cracking through about 90 per cent of the lug area (Figure E3). There was a line of deep corrosion pits on the inner circumference of the lug near the fracture line. Each of the wing attachment fitting lugs displayed a line of heavy corrosion pitting on their inner circumference. The fittings were found to contain no lubricating grease. The NTSB found no evidence that the required 3,000-hour wing attachment fitting inspection had been conducted, and that the right lower mandrel and bolt had no grease or anticorrosive agents.

Figure E3: M18 wing fitting, NTSB investigation FTW00LA267
