Australian Government
Australian Transport Safety Bureau

Collision with terrain involving Cessna T210N, VH-ZFW

near Inverell Airport, New South Wales | 4 July 2014

ATSB Transport Safety Report
Aviation Occurrence Investigation
AO-2014-119
Final – 7 March 2016

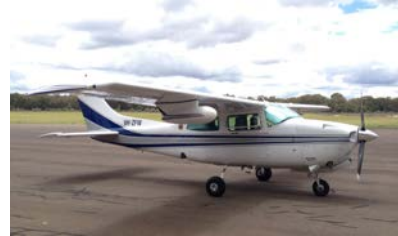
VH-ZFW

The pilot and a passenger were hospitalised with serious injuries and the second passenger received minor injuries. The seriously-injured passenger later succumbed to their injuries. The aircraft was destroyed by the impact forces and a post-impact fuel-fed fire.
