# Engine failures and malfunctions in light aeroplanes

2009 to 2014

**ATSB Transport Safety Report**  
Aviation Research Statistics  
AR-2013-107  
Final – 9 March 2016

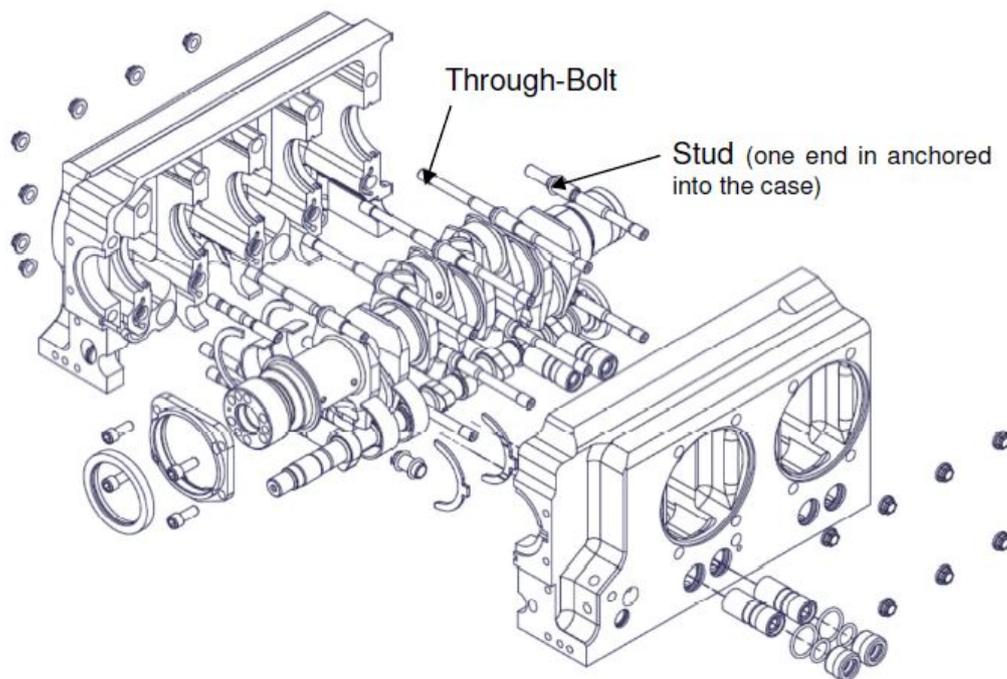
**Figure 8: Schematic showing the general layout of a Jabiru four cylinder engine**

For the set of engines analysed in this investigation, Jabiru engines are somewhat unique in their design. Conventionally, the crankcase is bolted together with separate bolts to those that are used to bolt the cylinders to the crankcase. In contrast, in Jabiru engines the same through-bolts that hold the crankcase together also fasten the cylinders to the block. Figure 8 shows the typical layout of a Jabiru four cylinder engine showing the location of the engine through-bolts.

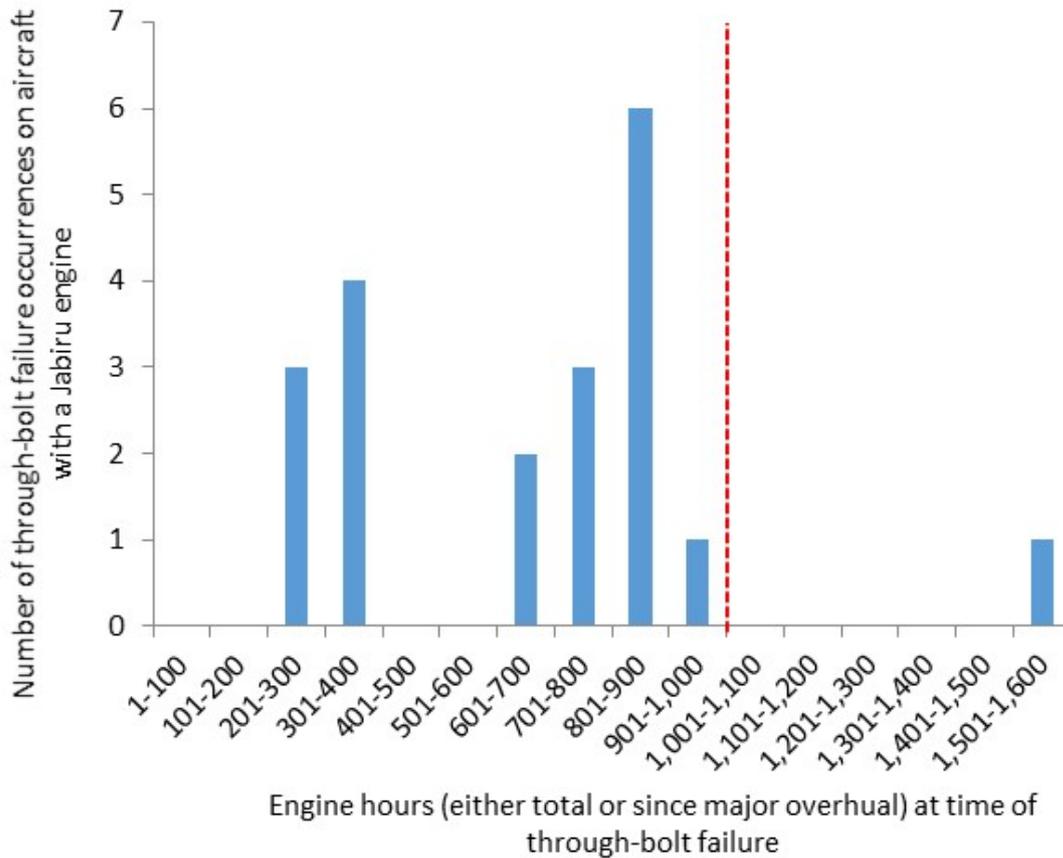
For 20 of the 21 Jabiru through-bolt failures, the total engine hours was reported at the time of the failure. For these 20 occurrences, the average total engine hours was reported to be 672 hours (median 710 hours).<sup>11</sup> The distribution of total engine hours at the time of the through-bolt failure is shown in Figure 10. The two reported failures of studs (data not shown in Figure 10) were reported at 1,183 and 438 hours in service. Jabiru overhaul manuals currently require a top end overhaul after 1,000 hours and a full overhaul after 2,000 hours, with the engine through-bolts and studs being replaced at both overhauls. It can be seen from Figure 10, however, that most of the failed through-bolts (19 of 21) did not make it to the 1,000-hour mark.<sup>12</sup> Furthermore, seven through-bolts (and one stud) failed before 500 hours.

**Figure 10: Histogram showing the frequency distribution of total engine hours<sup>11</sup> at the time of the through-bolt failure on aircraft with Jabiru engines. The red dotted line indicates the 1,000 hour mark at which point at which through-bolts were originally required to be replaced**

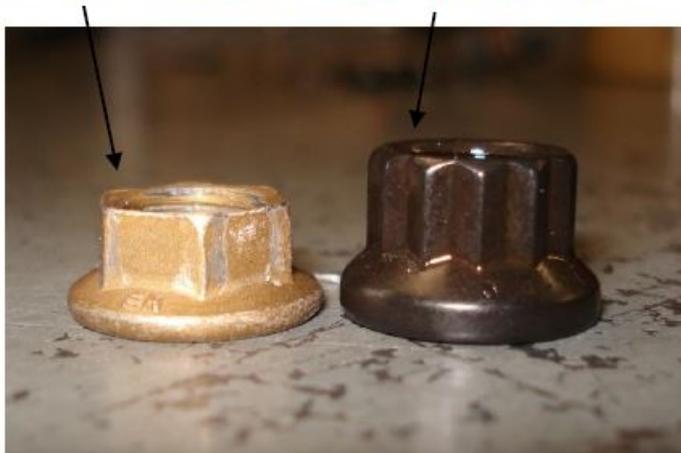
Of the 21 through-bolt failure occurrences, four reports detailed which through-bolts and/or nuts were in use. All four stated that the 12-point ARP through-bolt nuts (as per JSB031-1) were

3/8" MS21042-style nut

3/8" 12-Point nut
