# Runway excursion involving a Fairchild Metro 23, VH-UUB

Portland, Victoria | 20 February 2014

**ATSB Transport Safety Report**  
Aviation Occurrence Investigation  
AO-2014-028  
Final – 22 March 2016

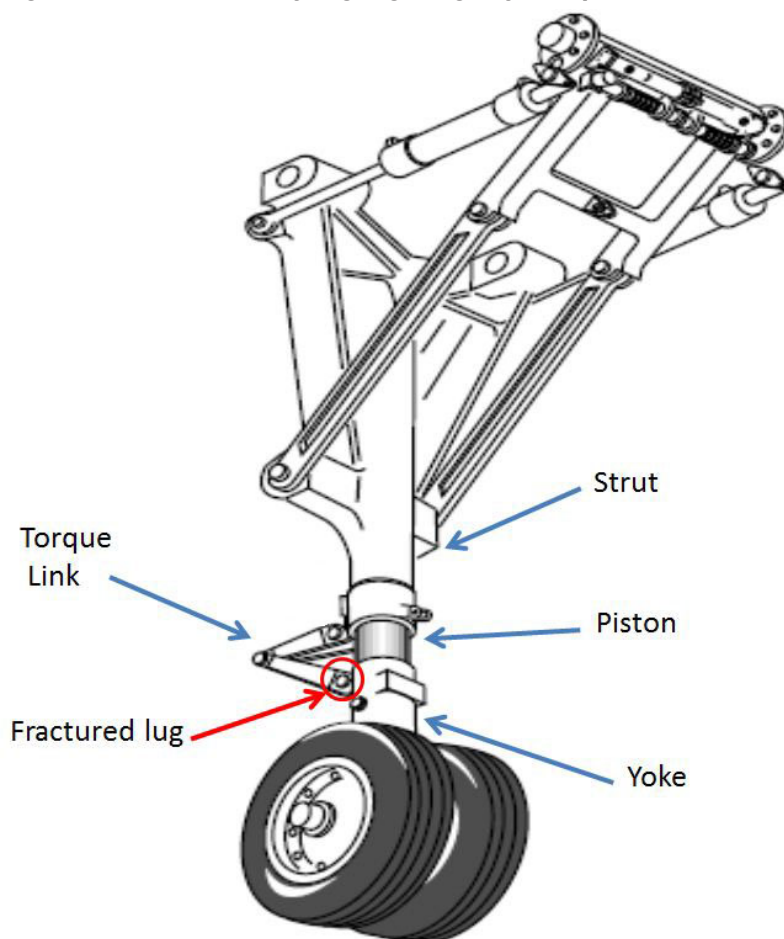
**Figure 3: MLG assembly highlighting key components**

The main landing gear assembly is composed of a telescoping upper cylinder (strut), a piston assembly and, at the lower end, the yoke (Figure 3). A torque link assembly connects at lugs on the strut and the yoke, allowing compression of the assembly while preventing rotation of the yoke. In this occurrence, the lug on the yoke had fractured.

Yokes in the MLGs of earlier SA227 models were manufactured by Ozone Industries as part number (P/N) OAS5453005-5<sup>3</sup>. In later models, manufacture was by another landing gear vendor, Klune Industries, and started with the fabrication of the 27-series part numbers. The fractured yoke from VH-UUB was identified as P/N 27-51505-005, manufactured by Klune Industries.
