Australian Government
Australian Transport Safety Bureau

Aviation Short Investigations Bulletin

Issue 47

ATSB Transport Safety Report
Aviation Short Investigations
AB-2016-014
Final – 13 April 2016

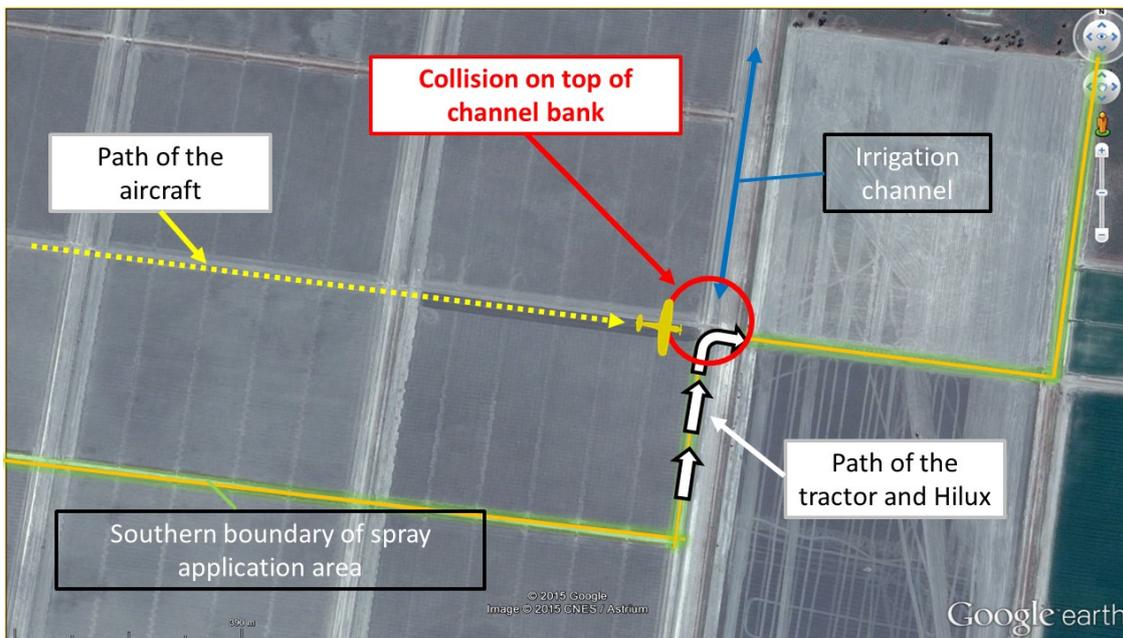
During this run, the pilot reported seeing a white Toyota Hilux Double Cab utility vehicle turn onto an irrigation channel crossing ahead of the aircraft (Figure 2). However, the Hilux appeared to the pilot to be slowing to a stop, short of the intersection/irrigation channel crossing. The pilot assumed that the driver of the Hilux had seen the aircraft, and was stopping to allow the aircraft to continue its run over the channel crossing.

Figure 2: Layout of accident site, showing path of the aircraft, path of the tractor and Hilux along the irrigation channel bank, the south-eastern border of the spray application area, and the point where the collision occurred

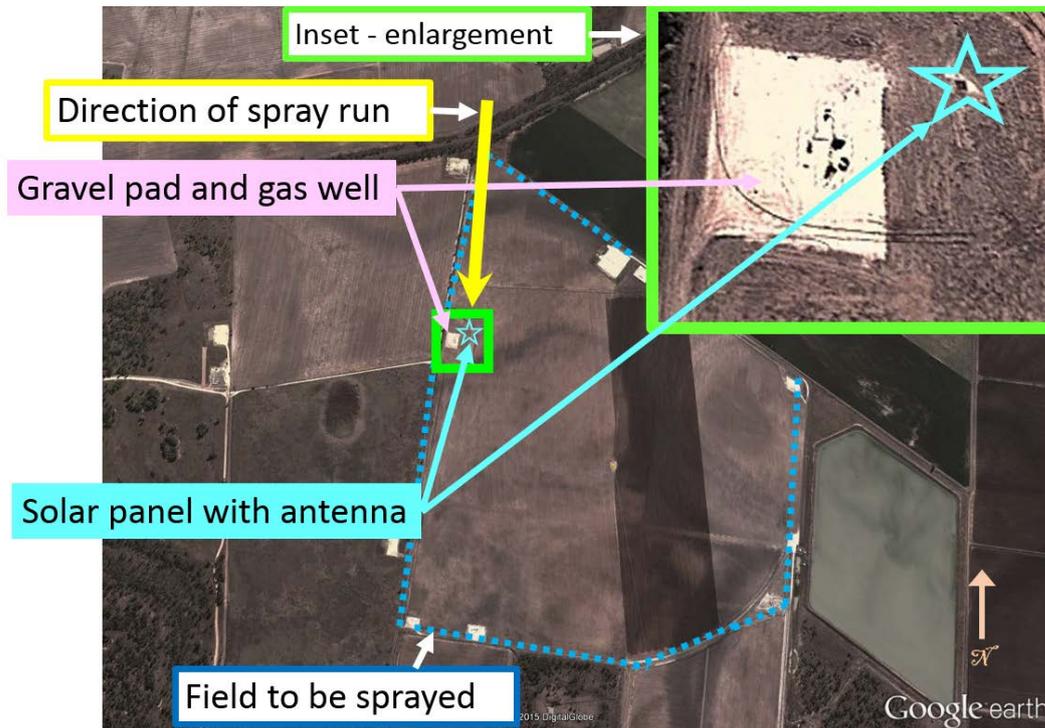
Figure 3: Field showing well on gravel pad and solar panel

The aircraft was fuelled and 1,600 L of liquid chemical loaded into the aircraft hopper. The aircraft departed at about 1210, and tracked towards the field to be sprayed, which was about 13 NM to the south-west. The pilot then overflow the area to inspect the field, first at about 100 ft above ground level (AGL), then at about 50 ft AGL. The pilot noted the wells on the gravel pads, and verified that there were no powerlines in the treatment area. The pilot also saw a solar panel a short distance from a well, located in the crop and not on a separate pad (Figure 1). The pilot did not see an antenna at the site of the solar panel at that time.

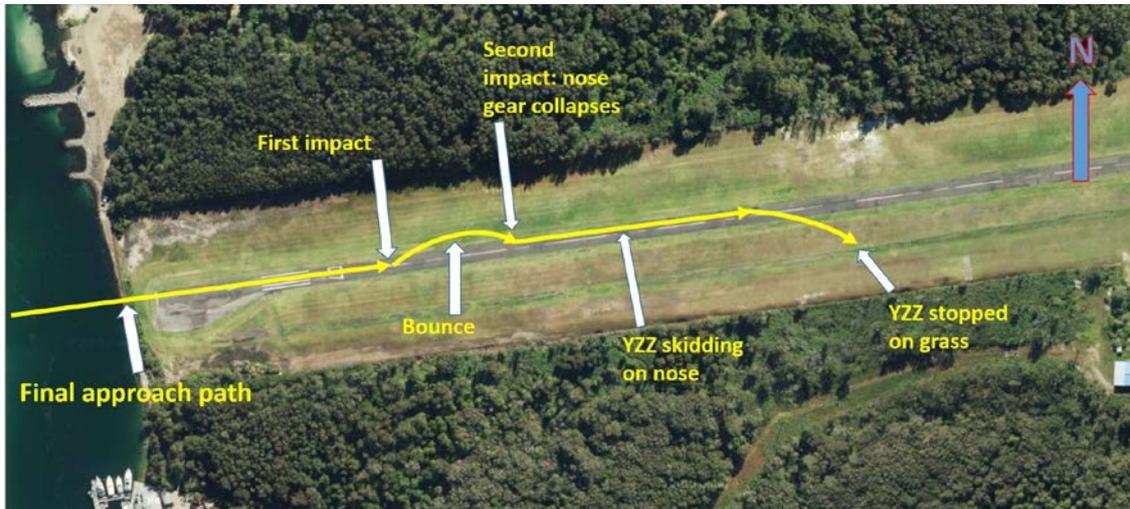
When YZZ was on short final, the pilot began to feel ‘woozy’ and, shortly after, lost consciousness. Closed circuit television footage showed the aircraft descended onto the runway and bounced before impacting the runway in a nose-low attitude to the left of runway centreline. The nose-low impact collapsed the nose gear and caused the forward section of the aircraft to strike the runway, bending all four propeller blades. It was at this time that the pilot regained consciousness, approximately 5 to 10 seconds after losing consciousness. The aircraft then skidded on the runway before veering to the right, and onto the grass (Figure 2). The aircraft eventually stopped on the grass area next to the runway (Figure 3).

Figure 2: Final approach path of YZZ to runway 07 with the approximate positions the aircraft first impacted the runway, bounced, the second impact and the approximate path YZZ skidded along, and across, the runway before coming to a stop on the grass

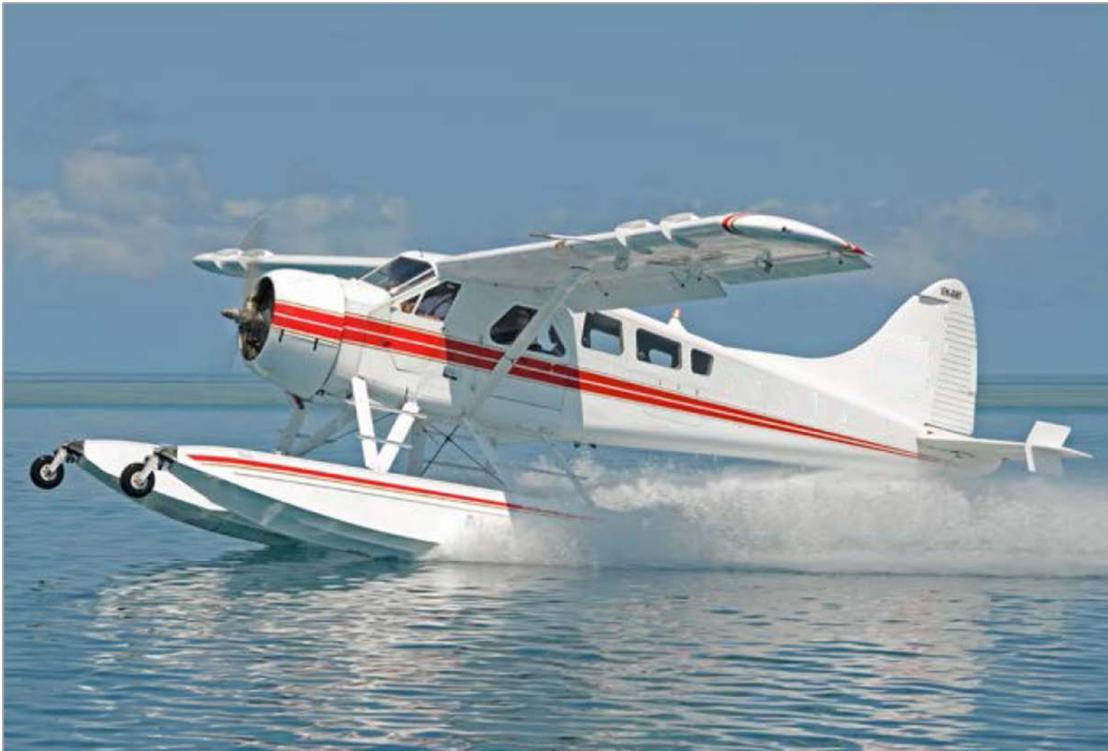
Figure 2: AWI conducting a water take-off (not the occurrence take-off). Note the high nose attitude, skids sitting up out of the water as the aircraft is ploughing through the water. AWI has not gained enough speed in the take-off to reach the step, where the nose would be lower and the aircraft would glide along the water on the floats.

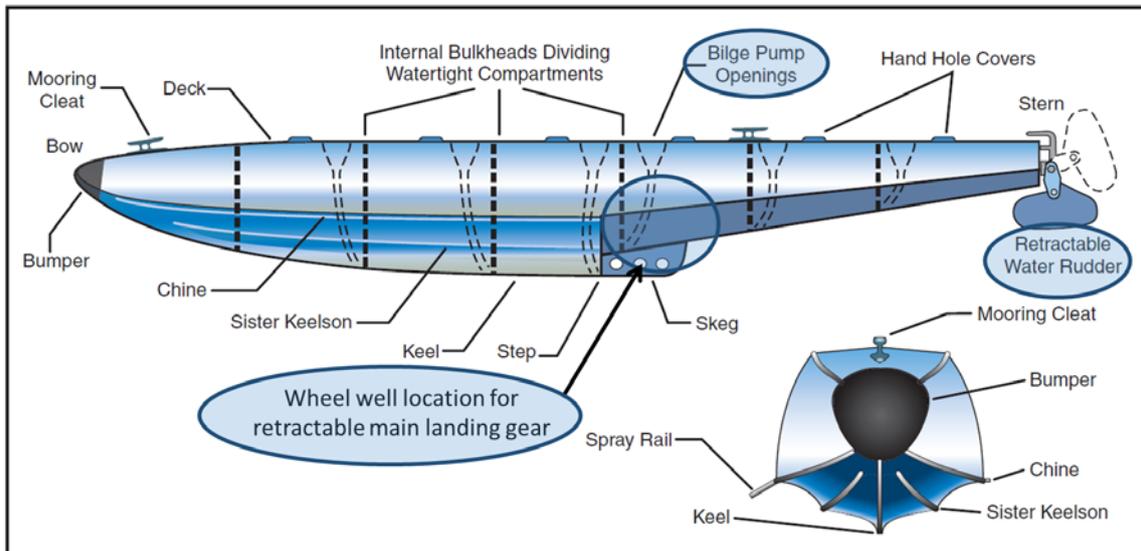
After consultation with the chief pilot, who was also at Hardy Lagoon, the pilot attempted a second take-off on the orange run, without any passengers on board. The pilot aborted the take-off at about buoy E, as the aircraft would normally be on the step at this point. The pilot taxied back to the moored boat, shut the aircraft down, and then pumped out water from the compartments in the floats (Figure 4). They then attempted another take-off on the orange run, again without success.

Figure 4: Example cross-section view of the float compartments. Note the bilge pump openings to remove water from the float compartments during the pre-flight inspection, the retractable water rudder used for directional control while taxiing and the location of the wheel well for the retractable main landing gear.

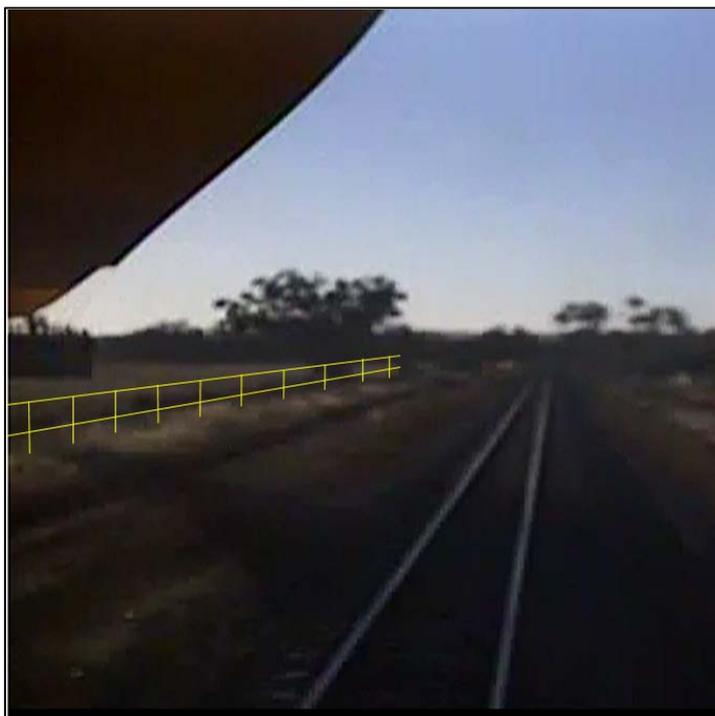
The driver estimated that the balloon was approximately 200–300 m in front of the train and applied full service brakes. However, the driver realised there would be insufficient distance for the train to come to a complete stop before passing the balloon. At the same time as applying the brakes, the driver also sounded the train’s horn to warn the balloon that the train was approaching. The driver slowed the train to about 20 km/hr as it passed the balloon.

Figure 3: Picture from the train driver’s cabin just before the train passed the balloon’s position with the approximate position of the fence on the left side (yellow)
