# Collision with terrain involving One Design DR-107, VH-EGT

Goolwa Airport, South Australia | 10 October 2014

**ATSB Transport Safety Report**  
Aviation Occurrence Investigation  
AO-2014-163  
Final – 14 April 2016

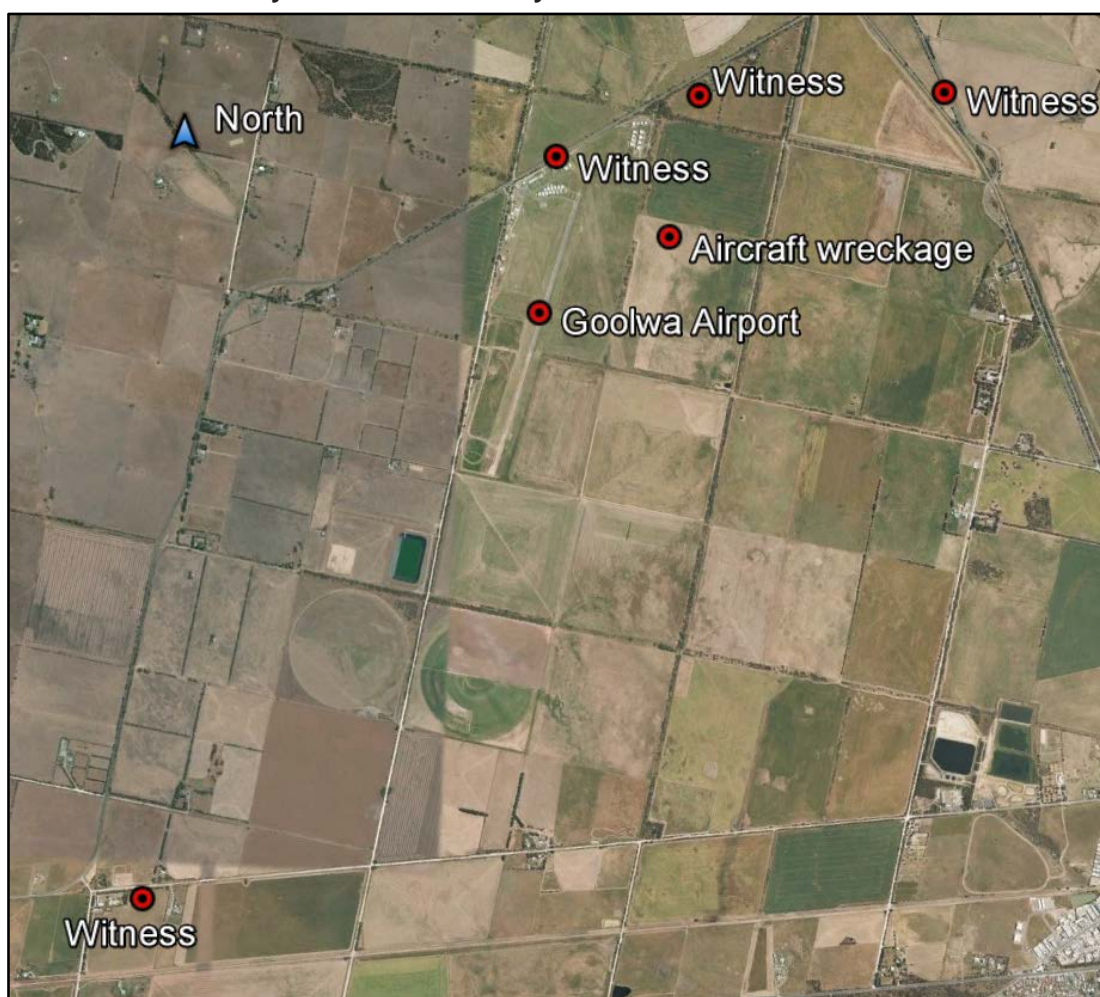
**Figure 1: Goolwa Airport showing the location of the aircraft wreckage and witness locations. The runway is oriented basically north/south**

The collision occurred at about 1430 Central Daylight-saving Time<sup>1</sup> in a paddock to the east of Goolwa Airport (Figure 1). Emergency services received a telephone call from a witness to the accident at 1431. Police, fire and ambulance personnel arrived at the accident site by 1443. The aircraft was destroyed by the impact and the pilot was fatally injured.
