# In-flight engine fire involving AVRO 146-RJ100, VH-NJI

Departing Perth Airport, Western Australia | 29 April 2014

**ATSB Transport Safety Report**  
Aviation Occurrence Investigation  
AO-2014-076  
Final – 2 May 2016

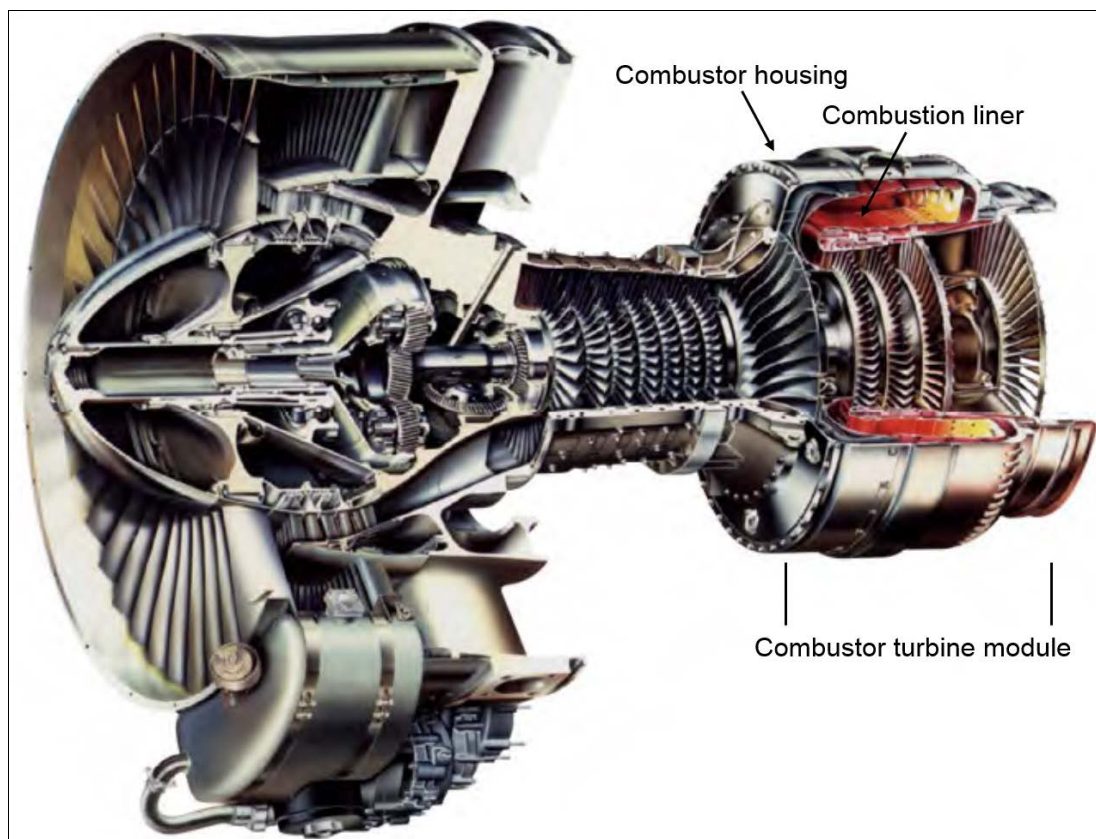
**Figure 2: Left-side cut-out view of an exemplar LF507 engine showing the locations of the combustor housing, combustion liner and combustor turbine module**

The aircraft was powered by four Honeywell International Inc (Honeywell) LF507-1F (LF507) dual-spool, high-bypass turbofan engines. For maintenance and serviceability, the LF507 engine is divided into four modules: the fan assembly, gas producer, combustor turbine and accessory gearbox. This occurrence related to the combustor section of the combustor turbine module (CTM) (Figure 2).

The CTM consists of the combustor and the low-pressure turbine that are retained within the combustor housing (housing). The housing has four welded bosses located at the two, four, eight and ten o'clock positions (looking forward from the rear of the engine). A spigot pin is screwed into each welded boss to locate and retain the combustion liner. During normal operation, the fuel/air mixture is ignited in the combustion liner and supplies energy to the low-pressure turbine.
