Breakaway of *Grand Pioneer* and *AAL Fremantle*

Fremantle, Western Australia | 17 August 2014

ATSB Transport Safety Report
Marine Occurrence Investigation
313-MO-2014-009
Final – 4 May 2016

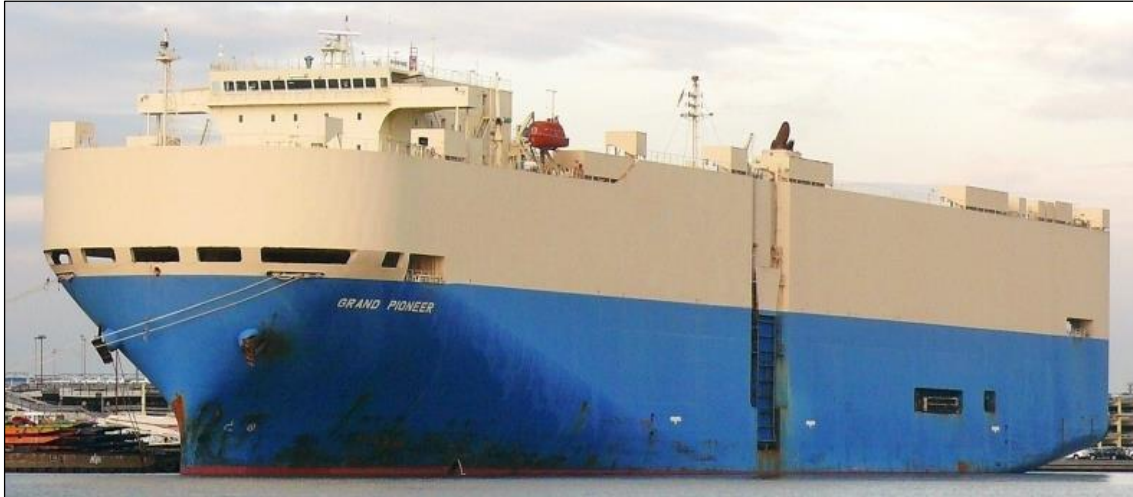
Figure 1: *Grand Pioneer*

At 1712¹ on 17 August 2014, the 190 m long car carrier, *Grand Pioneer* (Figure 1), berthed in the port of Fremantle at berth 11 (Figure 3). Berthed astern of the car carrier was the 140 m long general cargo ship, *AAL Fremantle* (Figure 2). It had been in port for the past 10 days, unloading and then loading cargo using its two, port-side mounted cranes.

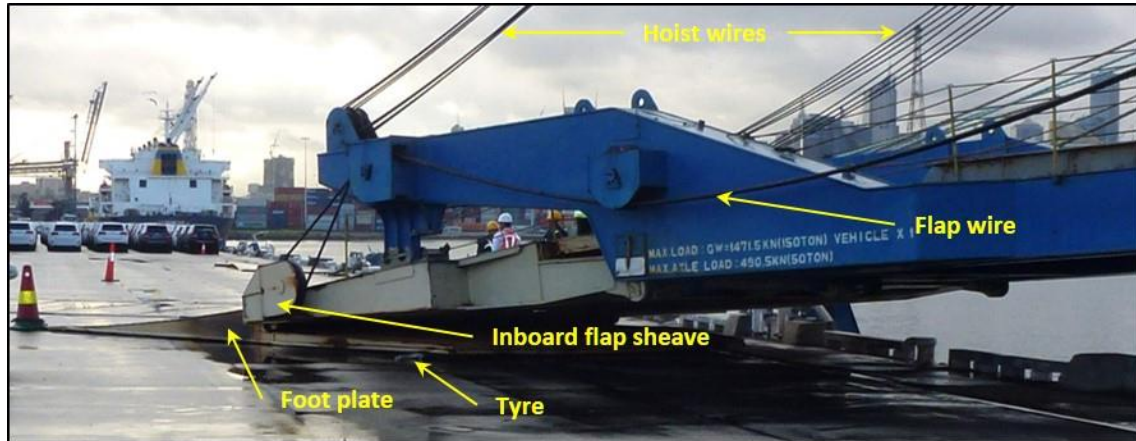
Figure 9: Ramp set up

The main vehicle ramp was about 9 m wide and 30 m long. The ramp comprised three sections, and weighed approximately 90 t. When landing it on the wharf, the standard practice of the ship's crew was to place two automotive tyres under the ramp's footplate (Figure 8 and Figure 9). The ramp had no float⁷ function, which meant its entire weight was on the wharf apron. The wires to fold/unfold and hoist/lower the ramp were left slack. The slack wires allowed for the vertical movement of the ship relative to the wharf without the need for continuous adjustment.

When the ramp dropped off the wharf, it fell about 4 m to the water's surface. The size and shape of the groove and burr (Figure 10, left) was consistent with being caused by the wire rope jumping off the sheave and rubbing on the cheek plate under heavy load as the ramp dropped. Further, the damage was recent. When examined a few days after the event, it only had a covering of light surface rust (Figure 9 and Figure 10) which is consistent with having happened in Fremantle.
