Australian Government
Australian Transport Safety Bureau

Aviation Short Investigations Bulletin

Issue 48

ATSB Transport Safety Report
Aviation Short Investigations
AB-2016-044
Final – 27 May 2016

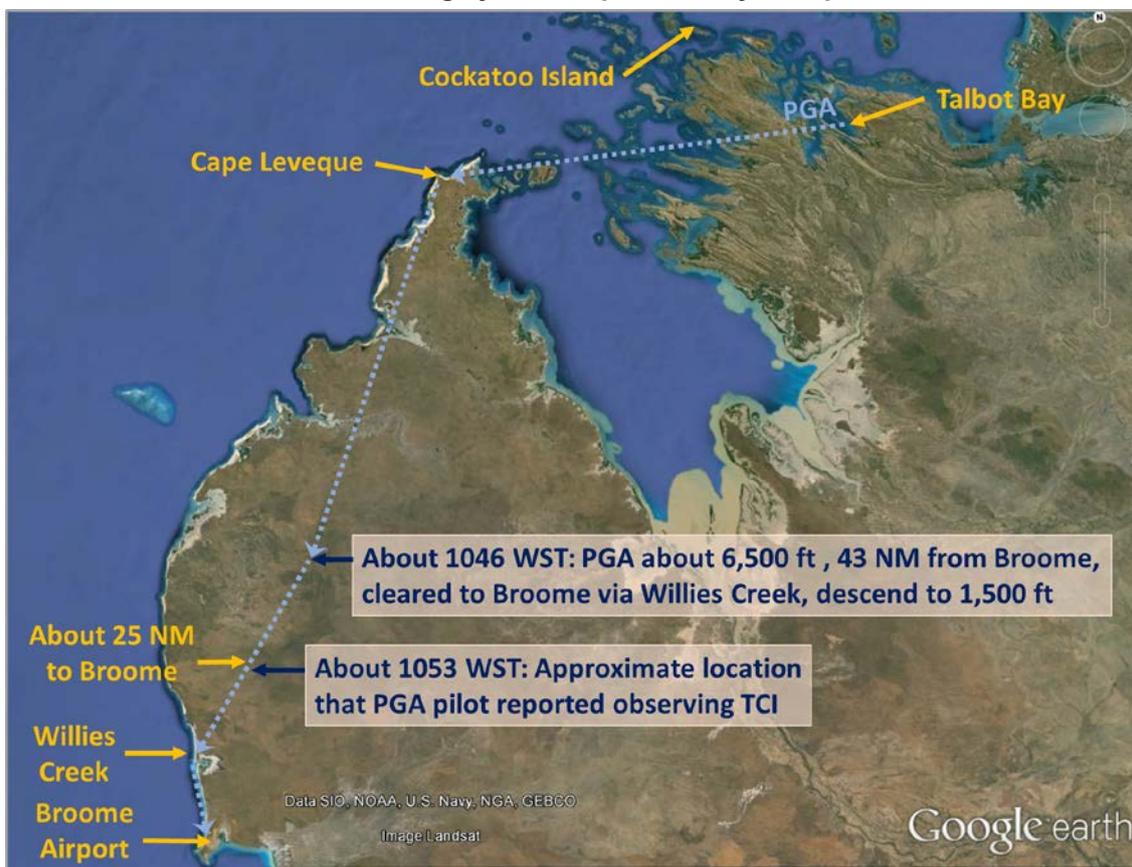
Note: The pilot of TCI recalled holding over land, near James Price Point, outside of Class D airspace. Communications between ATC and the pilot of PGA immediately following the point at which the aircraft passed, suggested that the incident occurred further to the east, at about 26 NM from Broome. A later communication between ATC and the pilot of PGA suggested that the incident occurred about 23 NM from Broome. Information provided to the ATSB by the pilot for the incident flight from the tracking data from PGA’s real-time satellite tracking system also suggested that the incident occurred near the latter location (Figure 2).

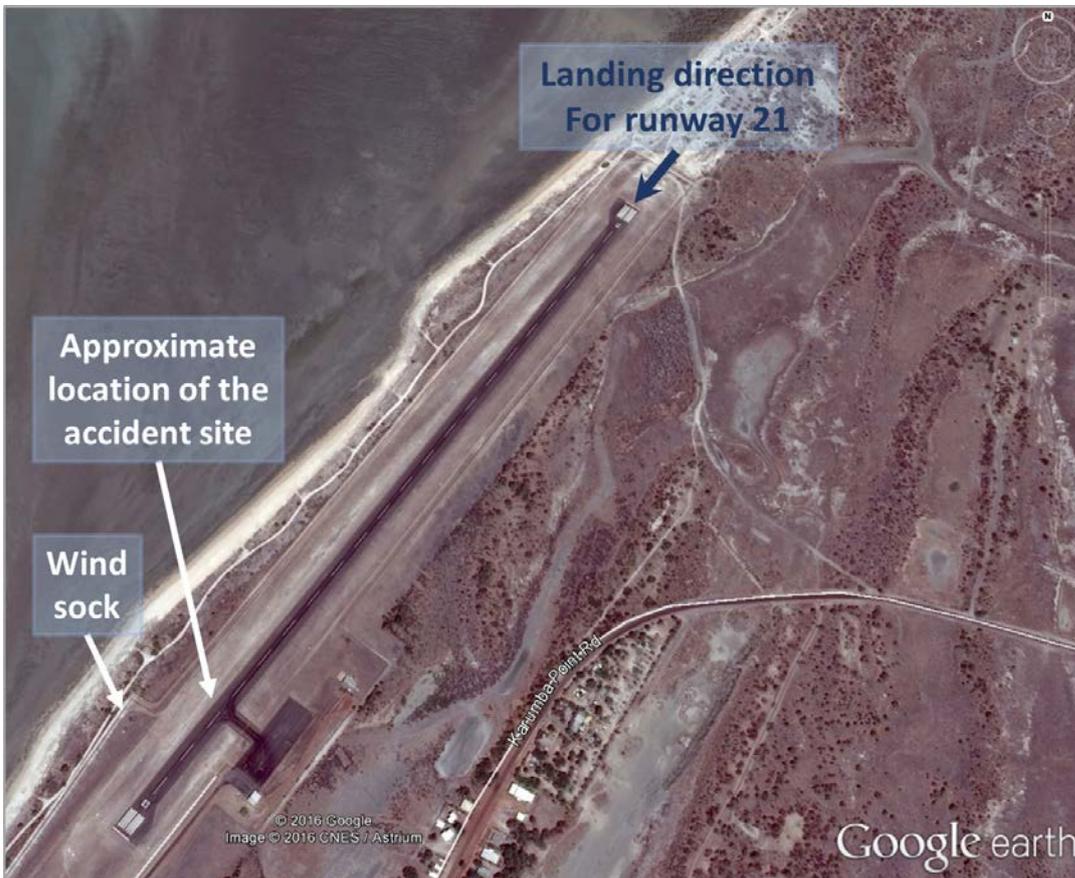
Figure 1: Map of Karumba Airport

The aircraft was established in a stable final approach and the pilot determined that there was no crosswind correction required. The main wheels touched down firmly on the runway and the aircraft bounced about 3 to 4 feet. The pilot moved the control column forward slightly to stop the tail from touching the runway. The main wheels touched again at about the same time as the pilot noted that the nose started to move to the right (turning into wind). The pilot moved the aircraft controls to straighten the aircraft in line with the runway, but the aircraft did not respond to the correction. The tail continued to move quickly around (ground loop)¹ before the pilot could take any other action. The pilot was pushed up against the cockpit door. A very loud bang was heard as the left main landing gear failed, the left wing folded up and the fuselage tilted onto its side where the aircraft skidded a short distance to a stop. The aircraft stopped, almost pointing back in the opposite direction to the landing, partly on the grass beside the runway (Figure 2). The pilot turned off the engine magnetos, aircraft fuel, and electrical master switch. The two passengers exited the cockpit right door with the help of bystanders and then the pilot exited the same way. The pilot received minor injuries and the two passengers were uninjured. The aircraft was substantially damaged.

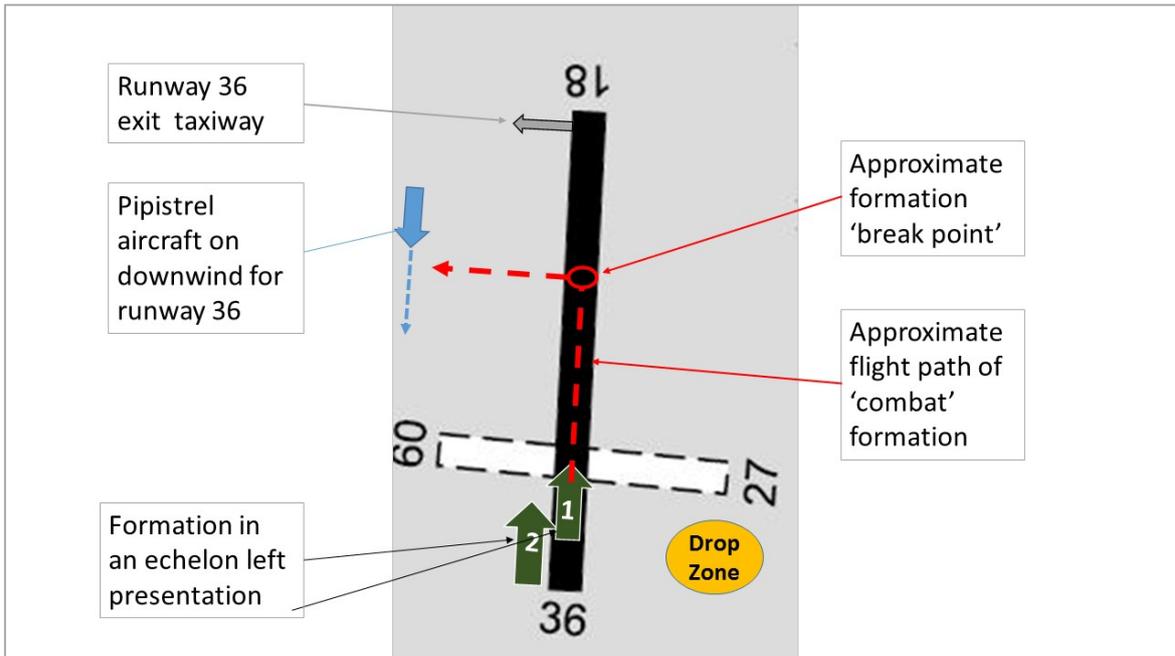
Figure 2: Barwon Heads airport showing relative positions of the formation, Pipistrel and the drop zone

To avoid any issues for the novice parachute jumpers, and to prevent Number 2 from flying too close to the drop zone in the preferred echelon right,³ 'dead side'⁴ of the circuit join, the pilot in ALO made the decision that the formation would remain in the echelon left configuration and join over the top of runway 36. At the break point, Number 2 would move ahead, and both aircraft would conduct an early turn onto crosswind. This would keep both Nanchang aircraft well clear of the remaining parachute jumpers approaching the drop zone (Figure 2).

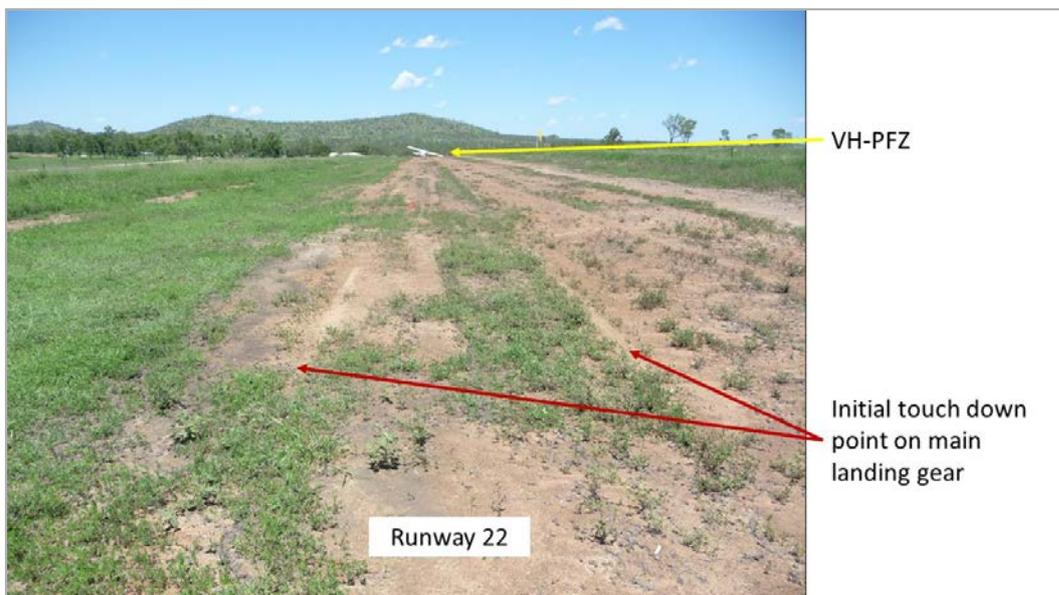
Figure 1: Initial touchdown point on runway 22, and VH-PFZ (far end)

The pilot described the approach and initial touchdown as a little faster and higher than normal, with the touchdown point about 300 m into the 1,100 m airstrip (Figure 1). The aircraft ballooned slightly. At about 10-15 ft above ground level, the pilot commenced a go-around and applied full throttle, with the propeller remaining at 2,000 RPM. With an airspeed of 64 kt, the pilot assessed there was sufficient airspeed to climb out, so retracted all of the flap and then the landing gear.

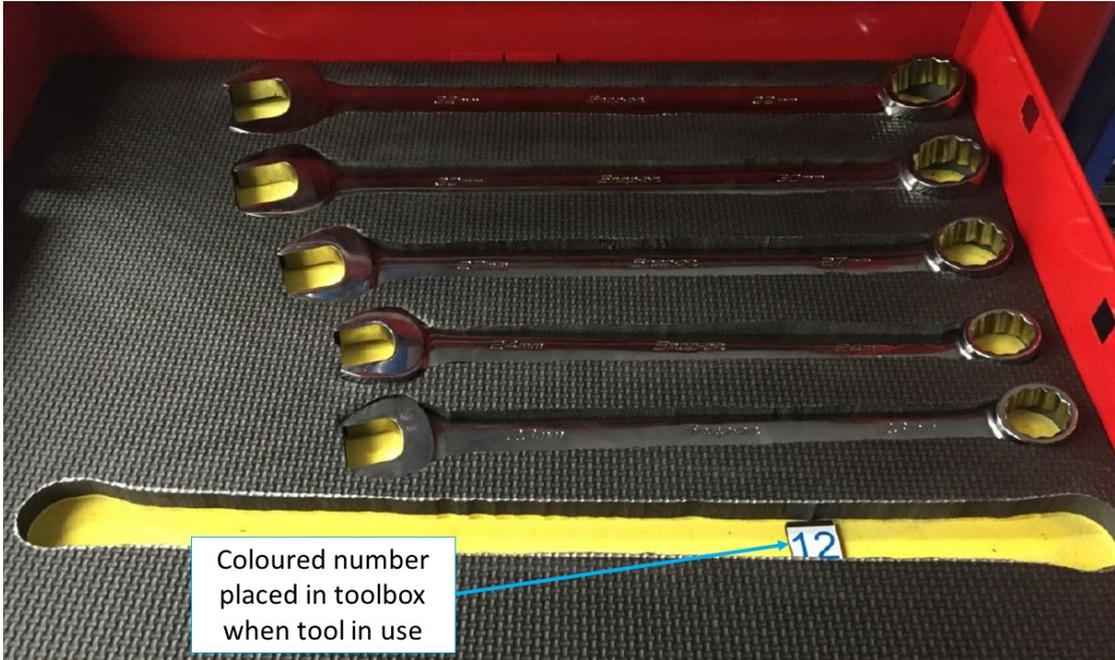
Figure 2: Tool control procedure showing coloured number replacing tool in use by the engineer assigned the blue coloured tags

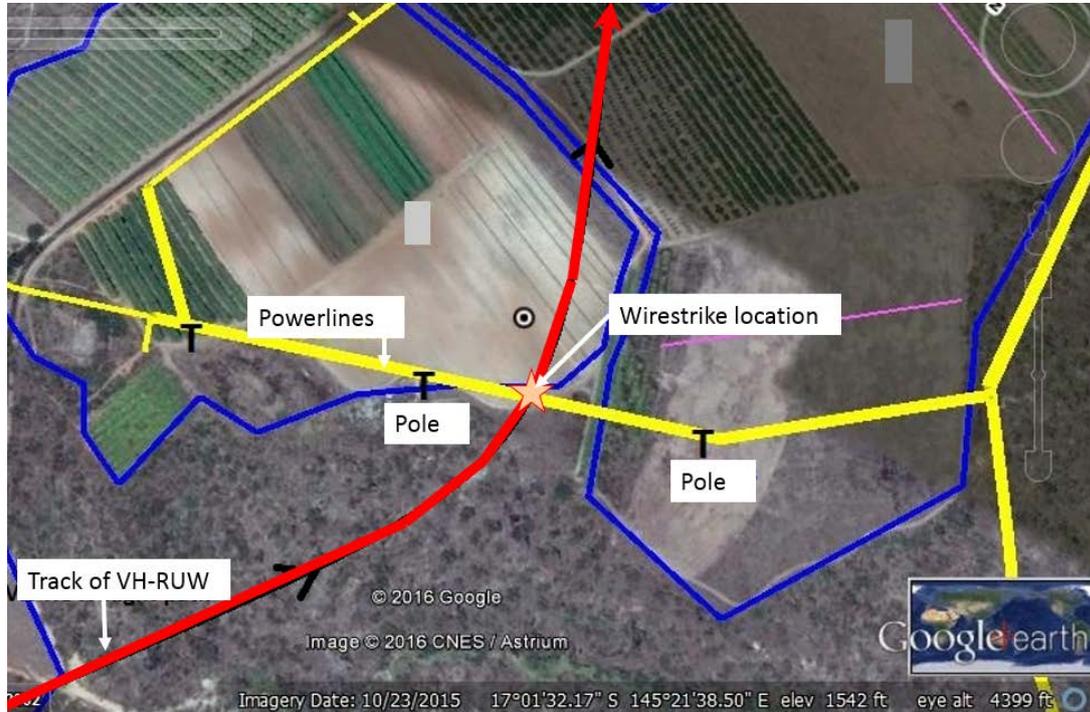
Figure 2: Balloon track and location of powerlines

The powerlines were difficult to see as the area was heavily vegetated. The sun was to the right of the balloon and did not affect the pilot's vision of the wires.
