Engine failure involving Jabiru J430, VH-SZQ

85 km WSW of Oakey Airport, Queensland, 19 November 2015

ATSB Transport Safety Report
Aviation Occurrence Investigation
AO-2015-138
Final –27 July 2016

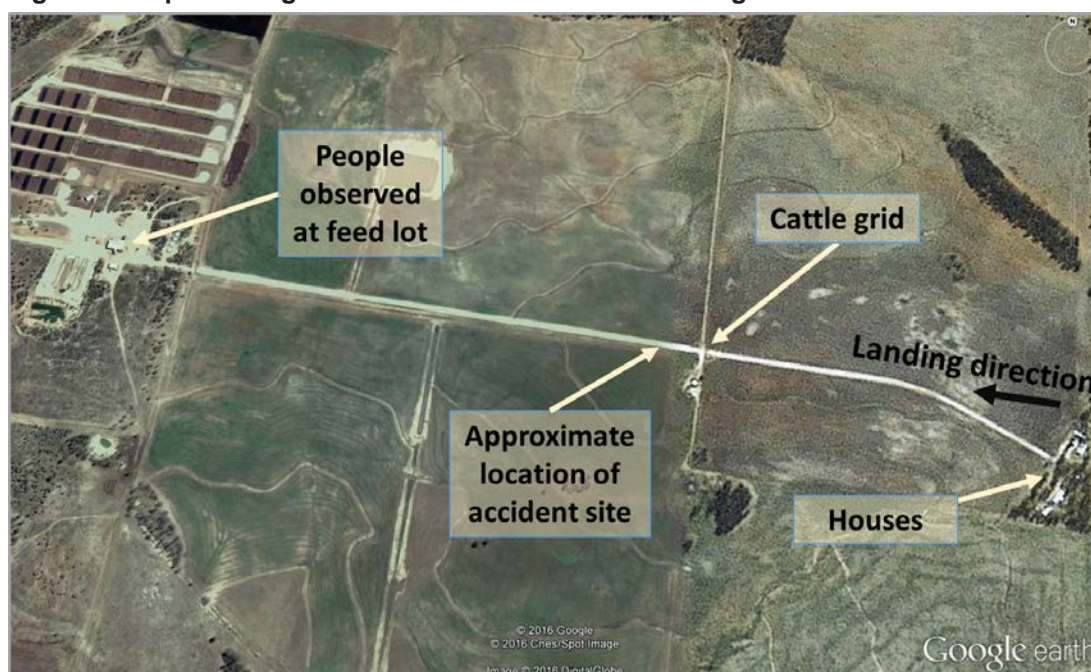
Figure 1: Map showing the relevant features of the landing area

The pilot established the aircraft in a glide and looked for a suitable forced landing area. An airstrip was identified on an electronic world aeronautical chart (WAC), about 4 NM to the left of track, which the pilot initially navigated towards. The pilot was unable to locate the strip and subsequently turned towards a property where they could see people, houses, sheds and a highly visible white road (Figure 1).
