Aviation Short Investigations Bulletin

Issue 49

ATSB Transport Safety Report
Aviation Short Investigations
AB-2016-068
Final – 27 July 2016

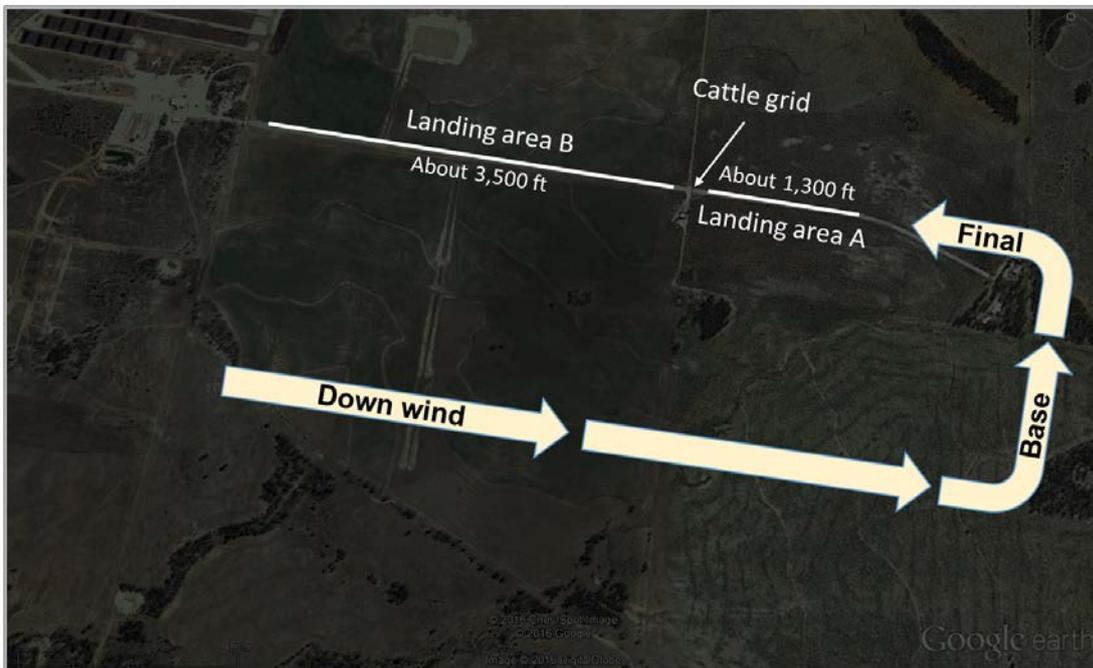
At about 4,000 ft, the pilot selected a landing area on the road between the houses and a cattle grid (landing area A in Figure 2). SZQ entered on the downwind leg for a left circuit with the final approach towards the west. The pilot identified power lines close to the road (landing area A) and as they were unsure if they crossed the road, selected the road beyond the cattle grid as the land

area (landing area B in Figure 2). The pilot completed the downwind and forced landing checks, and left the electrical master switch on to adjust the flap position when required.

The left main landing gear collided with the grid and failed, partially remaining attached to the aircraft. The pilot flared for a landing and the left landing gear dug into the ground and swung the aircraft to the left. The aircraft subsequently collided with a fence and came to a stop about 100 m beyond the cattle grid. The pilot exited the aircraft. The pilot was not injured. The aircraft was substantially damaged.

Figure 2: Diagram representing the circuit pattern and landing areas

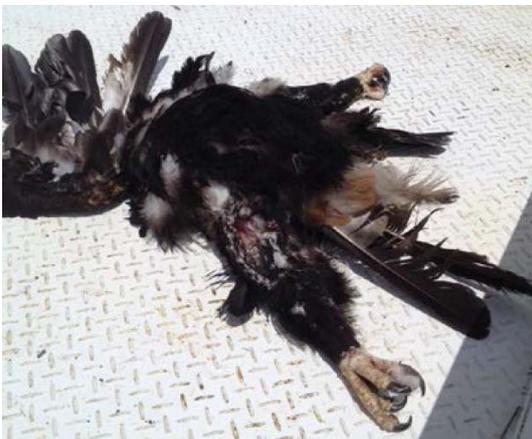
After landing, the Airport Safety Officer met the aircraft and provided the pilot with parking instructions. The pilot shut the aircraft down and medical services were called. Aside from the damage to the windscreen (Figure 1) and some relatively minor marks around the propeller, there appeared to be no other damage to the aircraft. The remains of the bird were retrieved from the cockpit (Figure 2).

Figure 2: Some of the bird remains retrieved from the cockpit
