# Collision between a ballast regulator and tamper

near Greta, NSW | 14 July 2015

**ATSB Transport Safety Report**  
Rail Occurrence Investigation  
RO-2015-012  
Final – 24 March 2016

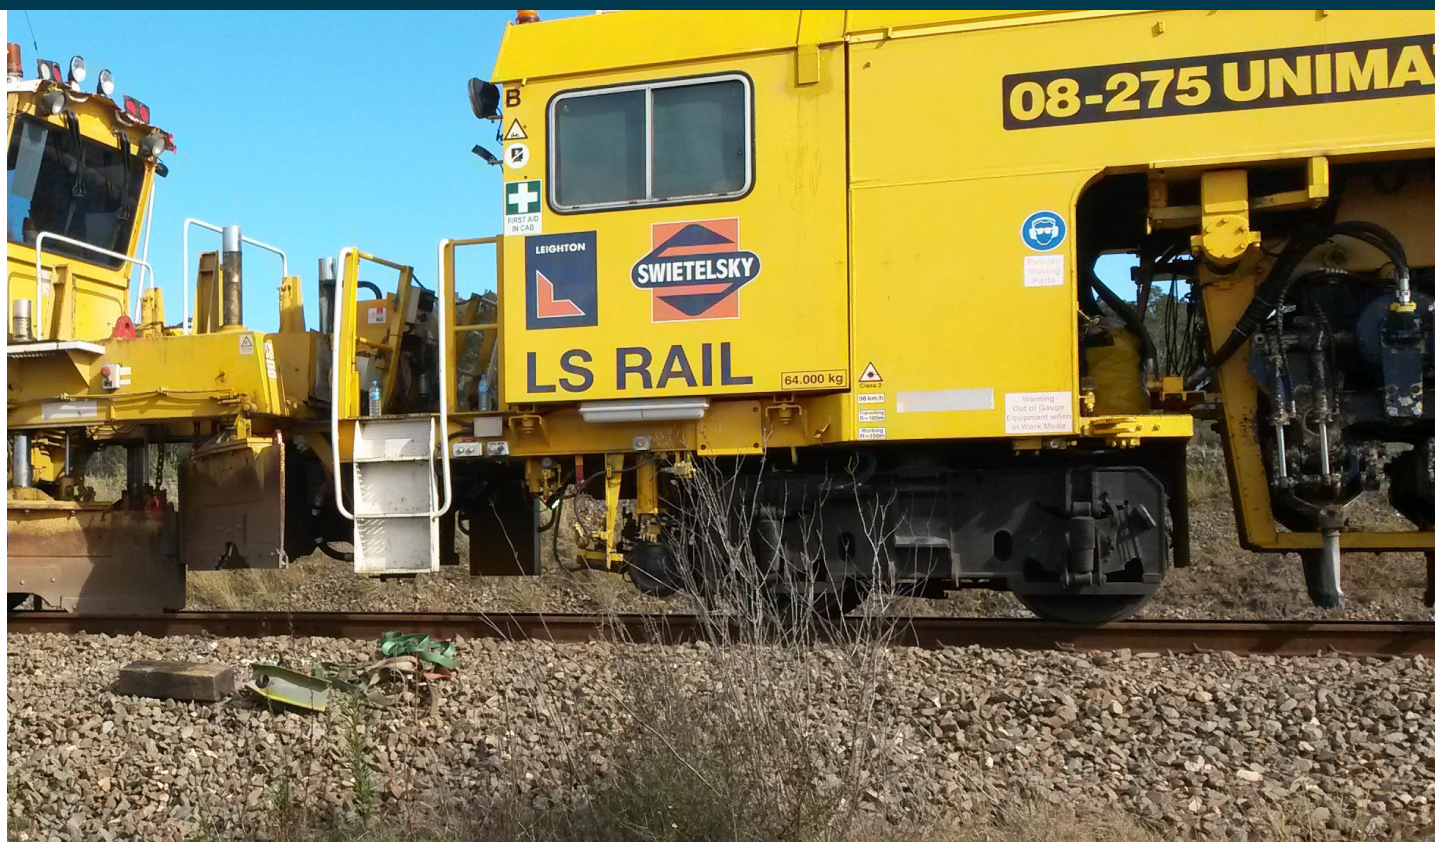
The collision saw the ballast regulator ride above the tamper coupler and remain supported on the tamper deck. The ballast regulator also derailed the lead axle. The tamper operator sustained a minor injury and there was moderate damage to both vehicles.

The ballast regulator remained overlapping and resting on the tamper's rear deck where ancillary equipment was damaged during the collision. The ballast regulator suffered a broken front towing 'A' frame and a deformed front chassis cross beam. Image Source: The Australian Rail Track Corporation.
