Aviation Short Investigations Bulletin

Issue 52

ATSB Transport Safety Report
Aviation Short Investigations
AB-2016-105
Final – 28 September 2016

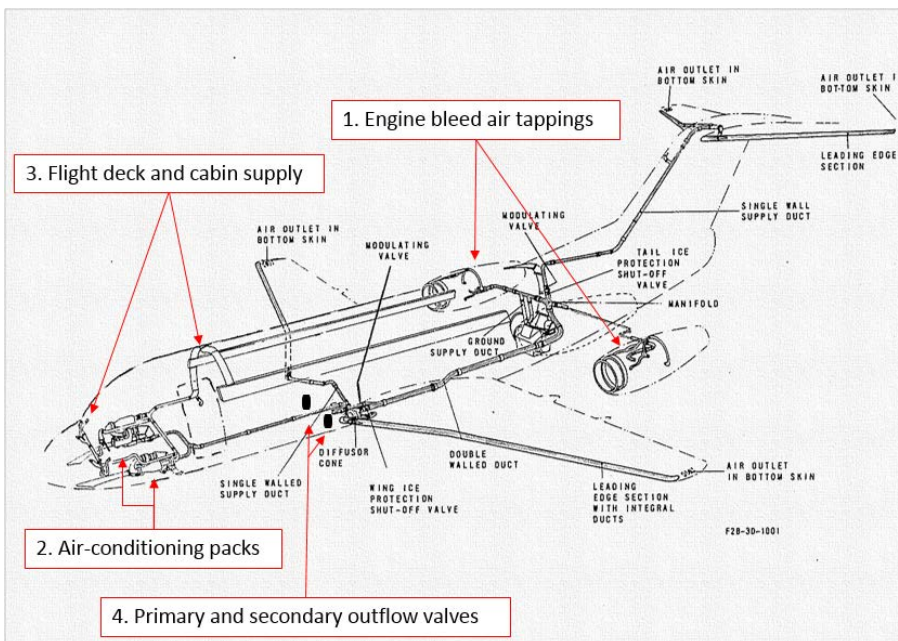
Figure 2: F28 bleed air supply

Bleed air is compressed air taken from the compressor stage of the engine. Bleed air is used for several functions including pressurisation, air-conditioning and anti-icing. For pressurisation, the bleed air is supplied to the two air-conditioning packs located underneath the floor of the flight deck, which are used to control the temperature of the air prior to distribution into the flight deck and cabin (Figure 2).

When one pack is selected off, the respective pack main valve shuts off bleed air supply and the other pack increases its output flow rate to 140 per cent of the normal flow rate. A single pack is capable of maintaining cabin altitude by itself at the maximum operating altitude of FL 350. Air-conditioning pack 1 is located underneath the floor of the flight deck on the left-hand side, which is just forward of the forward lavatory.

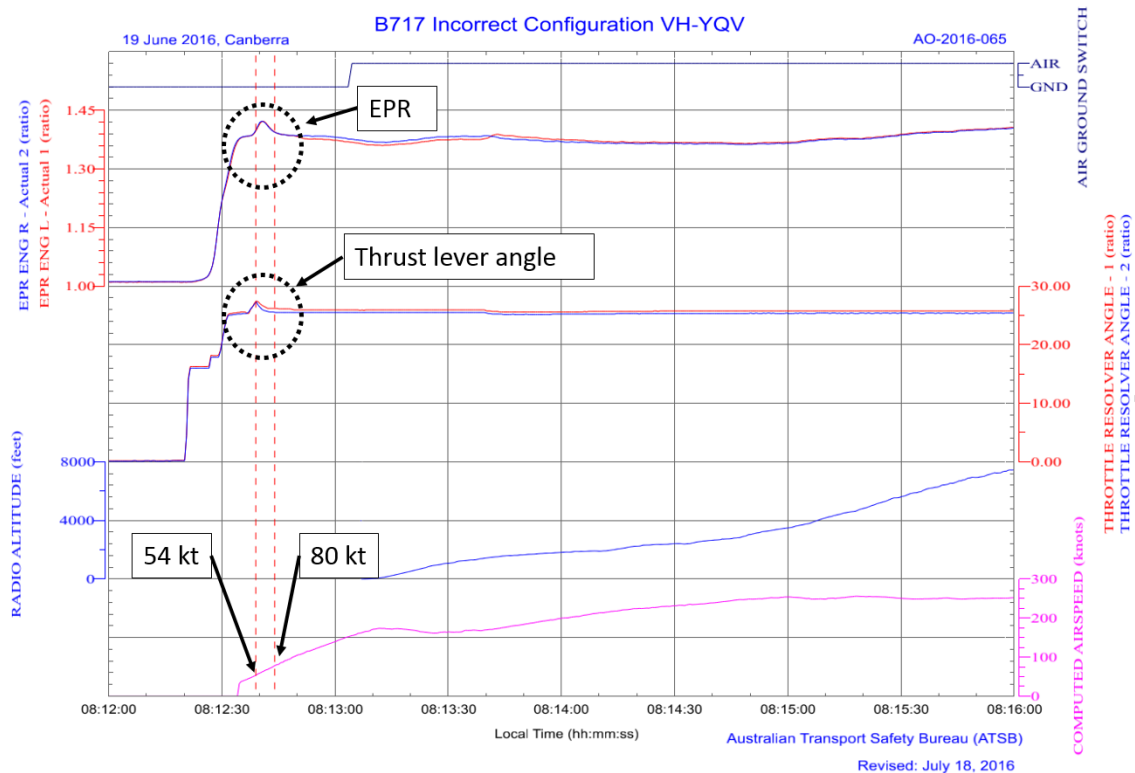
Figure 2: Graph of flight data from the incident flight

⁶ A change in bleed configuration, such as selecting air conditioning packs on or off, can change the EPR value. Therefore there is a small discrepancy allowed while parked and during taxi, but the two figures must match at take-off

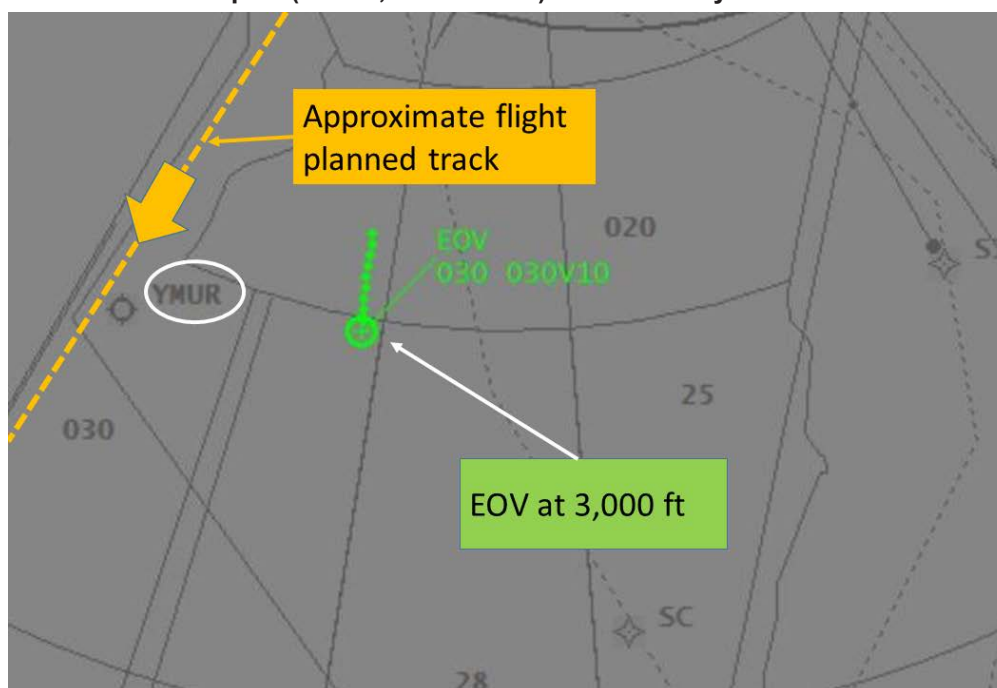
Figure 2: Flight planned track to Casino in yellow. EOV (green) tracking to the east of Murwillumbah Airport (YMUR, white circle) in a southerly direction

Part way through the right turn, the pilot unintentionally stopped the turn and started to track in a southerly direction, instead of south-westerly toward Casino. Noting that the aircraft was not tracking as expected, the Tower controller asked the pilot to confirm their current heading. The pilot asked the controller to 'standby'. With no further response from the pilot, the controller then instructed them to turn right onto a heading of 250°. However, the pilot continued to track about 40° left of track (Figure 2). To assist the pilot, the controller advised them of their current position, cleared the aircraft from that position direct to Casino, and as per normal procedure, and instructed the pilot to change frequency to contact Brisbane Approach.

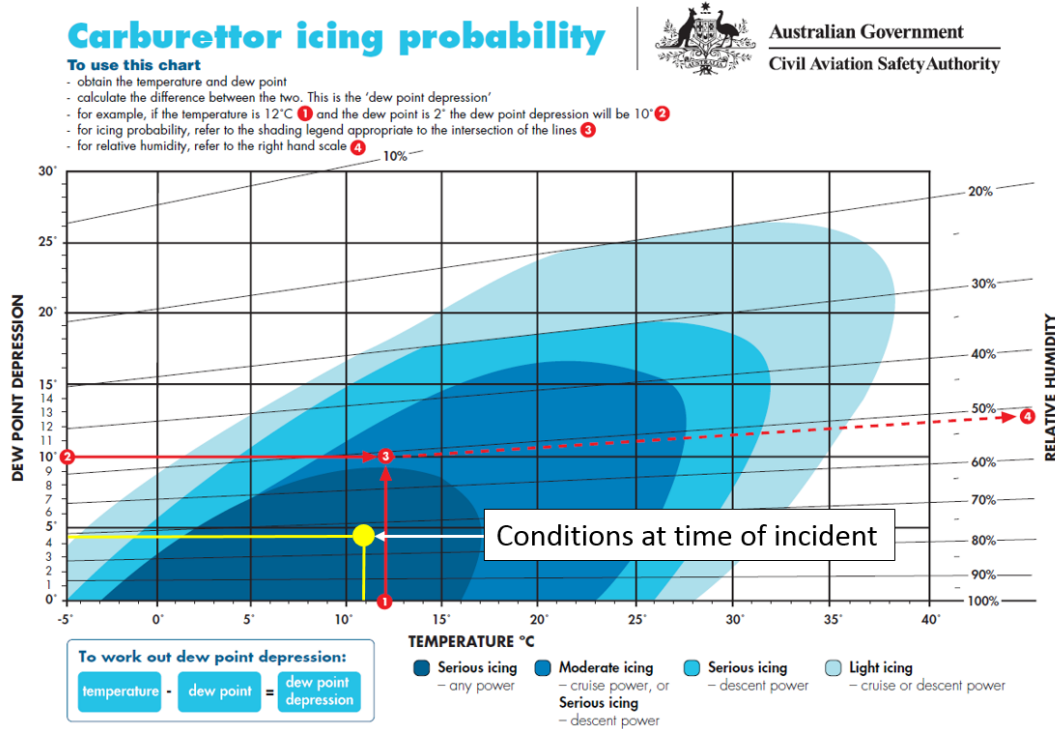
Figure 1: Carburettor icing probability chart showing prevalent conditions in yellow

The carburettor icing probability chart shows the conditions at Mangalore Airport placed IPO in the serious icing zone for carburettor icing at the time of the incident (Figure 1). Carburettor icing could be expected at any power setting.

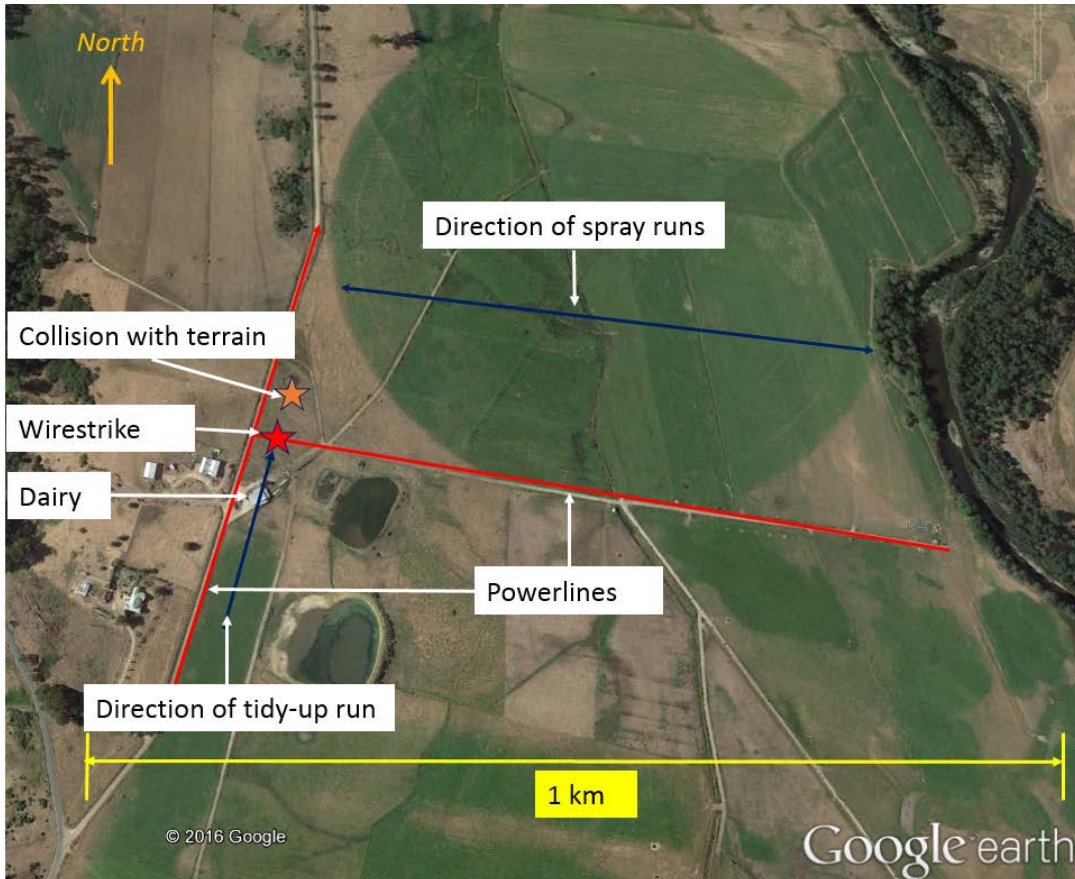
Figure 1: Area of operations showing powerlines

The pilot completed spraying one area, and prior to commencing spraying another, overflew it to assess the site. During that inspection, the pilot sighted two sets of powerlines, one running approximately north-south, and the other branching off to the east. Based on the location of the powerlines and the wind, which was a light northerly, the pilot elected to spray the paddock in an east-west direction (Figure 1). The helicopter was operating north of the powerline running east-west, and in each run, was overflying and remaining clear of the powerlines at the western end of the paddock.
