# Loss of power and collision with terrain involving Stoddard Hamilton Glasair SH-2FT, VH-HRG

near Wedderburn Airport | New South Wales on 19 July 2015

## ATSB Transport Safety Report

AO-2015-079

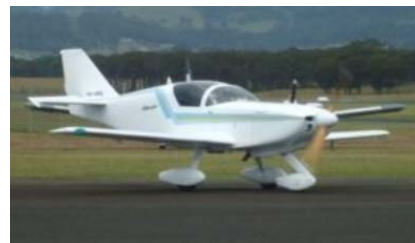
VH-HRG

The pilot sustained serious injuries, the passenger was fatally injured and the aircraft was destroyed.

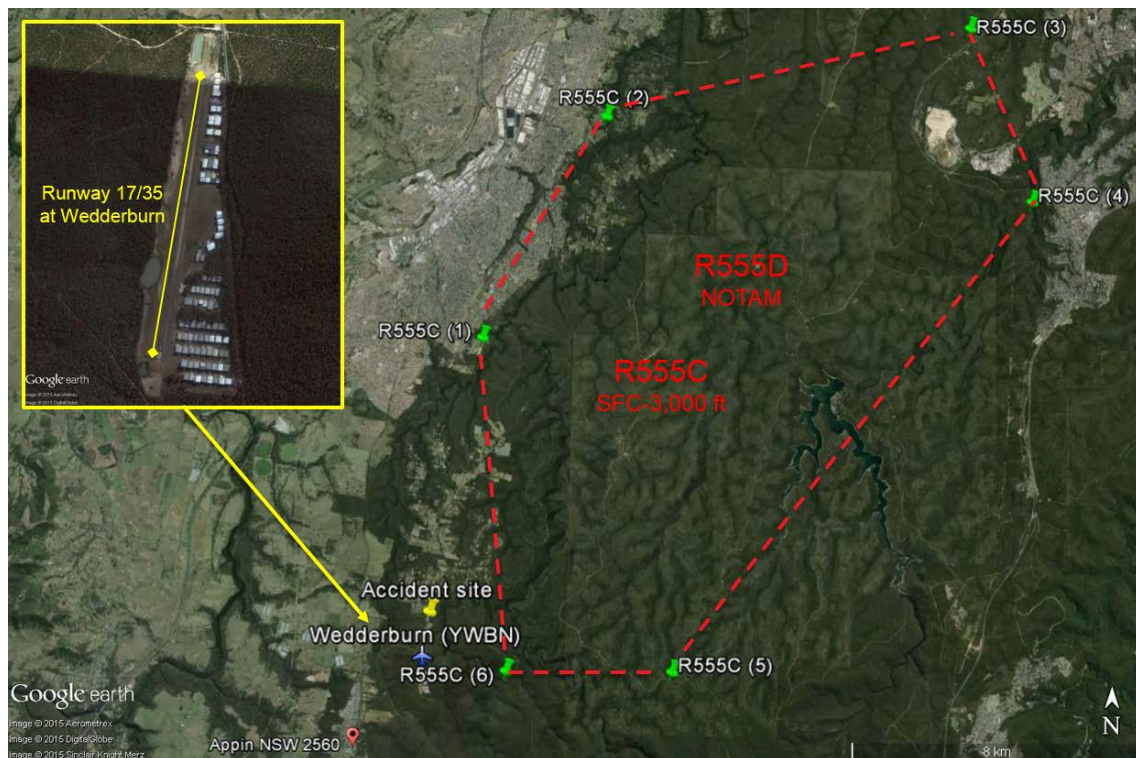
**Figure 3: Proximity of restricted area R555 (outlined by the red dashed line) to Wedderburn Airport (bottom-left of the restricted area) and Wedderburn runway 17/35 at inset**

Wedderburn Airport was an uncertified, unregistered landing area about 13 km south of Campbelltown. The airport had a sealed and adjacent grass runway and was aligned 17/35 (roughly north-south) (Figure 3 inset). The airport was privately-owned and -operated. The Airservices Australia En Route Supplement Australia (ERSA) extract for Wedderburn advised the following:

- pilots should avoid flying over Appin Township (Figure 3)
- circuit traffic should avoid flying over the populous area to the north of the airstrip (refer to the section titled *Wedderburn circuit pattern*)
- restricted area R555 is located 1.5 NM (3 km) to the east of the airport (Figure 3).

The terrain surrounding the airstrip was heavily timbered, which provided minimal landing opportunities for an off-field forced landing.
