Australian Government
Australian Transport Safety Bureau

Aviation Short Investigations Bulletin

Issue 57

ATSB Transport Safety Report
Aviation Short Investigations
AB-2017-007
Final – 9 February 2017

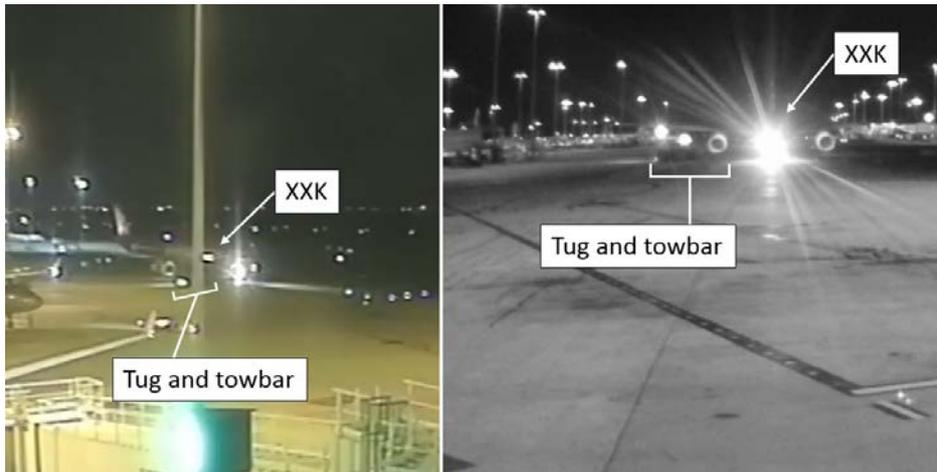
Figure 2: Positions at commencement of aircraft taxi

- Both flight crew interpreted the AME displaying the bypass pin as meaning the tug and AME were clear, and it was safe to commence taxi.
- The flight crew assumed that ATC providing the taxi clearance meant that ATC had confirmed the tug was clear of the aircraft.
- The first officer observed the tug and AME to the right of the aircraft and assessed that they were clear of the right engine.

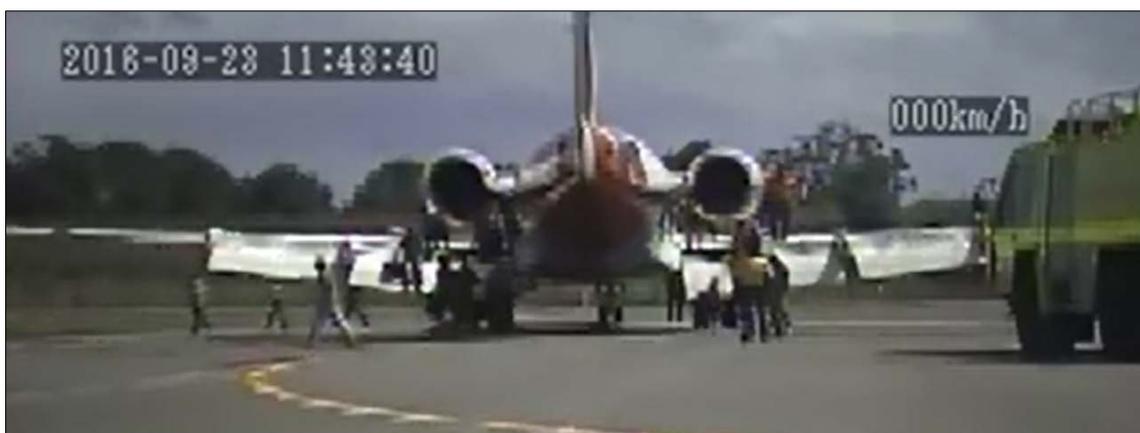
Figure 1: Emergency evacuation of VH-NHY

The flight crew started the emergency evacuation checklist and the captain called for the evacuation over the public address system. The cabin crew opened the two front doors and the four over-wing emergency exits were removed by the passengers (Figure 2). The forward left door (L1) slide did not automatically inflate when the slide deployed, so the CCM manually inflated the slide. When the CCM checked on the forward right door (R1) slide they observed that it was not deployed and the cabin crewmember was blocking the exit. The passengers evacuated through the forward left door and the over-wing exits.

The flight crew completed the emergency evacuation checklist and the captain directed the first officer to take the fire extinguisher from the flight deck and join the passengers. The captain then left the flight deck about one minute after the evacuation started with the passenger manifest. They noted there were only a couple of passengers left in the cabin, and the CCM was directing one of them to leave their baggage behind and evacuate. The captain waited for all personnel to leave the aircraft, completed an inspection of the cabin and then exited the aircraft to join the passengers, provide them with support and liaise with the authorities. During the emergency evacuation, three passengers received minor injuries.

During the emergency evacuation, the R1 door slide did not deploy. The maintenance inspection found the R1 door was disarmed and no fault was found with the door operating mechanism. Therefore, it is likely that during the emergency evacuation procedure the cabin crewmember at the R1 door reverted to previous experience and disarmed the door prior to opening it, which prevented the slide from automatically deploying.

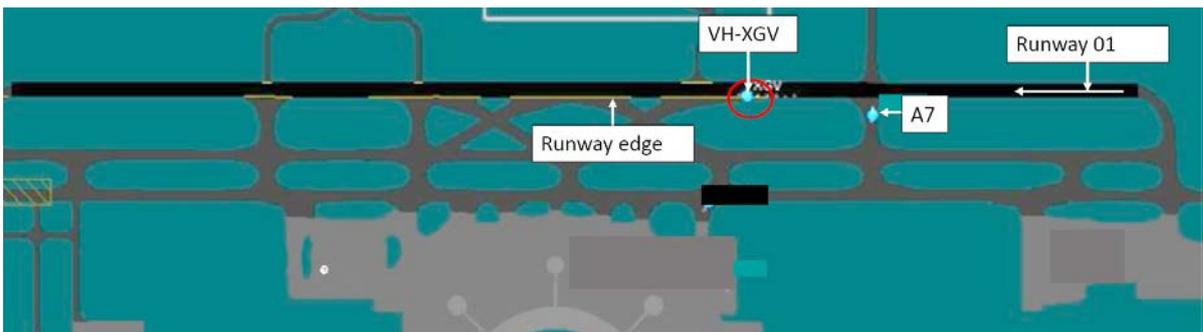
Figure 3: VH-XGV commencing take-off on runway 01

At about 2011, the aircraft commenced the take-off run. During the take-off, the pilot realised that the aircraft was not on the centreline, and steered the aircraft right towards the centreline prior to the aircraft becoming airborne. A subsequent runway inspection found damage to a runway edge light and the aircraft sustained minor damage to the nose landing gear.

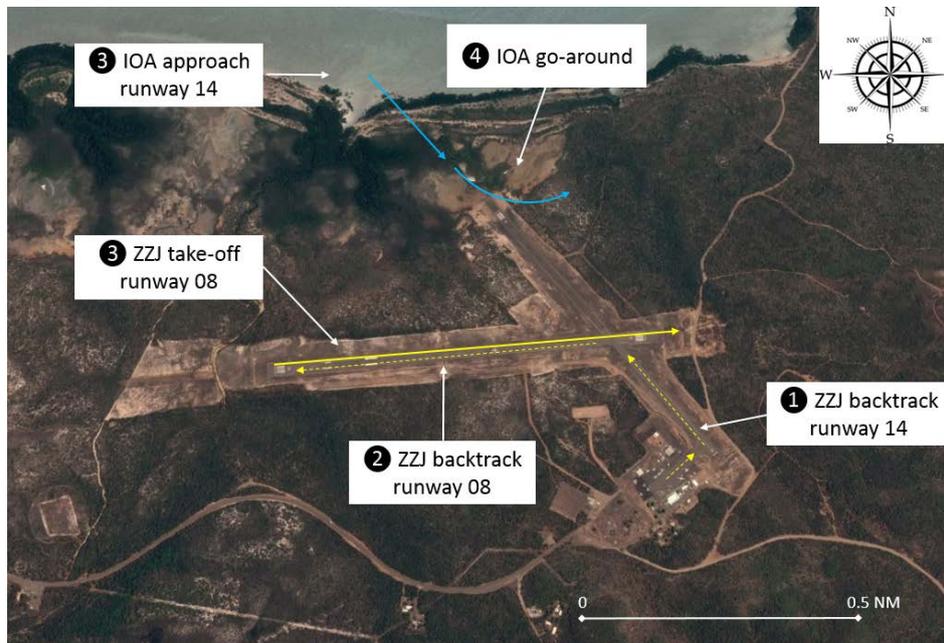
Figure 2: Sequence of movements

By the time the pilot flying IOA heard ZZJ broadcast 'rolling for departure from runway 08', IOA was at about 400 ft on final approach for runway 14. The pilot of IOA reported that at about 300 ft, they broadcast 'hold short' to ZZJ. However, the captain of ZZJ reported they heard the pilot of IOA say 'land and hold short of runway 08'.² Consequently, ZZJ continued their take-off. As IOA approached 100–150 ft on final approach, ZZJ had not crossed the runway intersection and the pilot flying IOA conducted a left climbing turn away from the runways to join the downwind circuit leg for runway 08. The captain of ZZJ looked out their left window when they were in the initial climb overhead the threshold of runway 26 and saw IOA turning through east at about the same level (position 4 on Figure 2). IOA then joined the circuit for runway 08 and landed after WOT without further incident.
