# In-flight pitch disconnect involving ATR 72 aircraft VH-FVR

47 km WSW of Sydney Airport, New South Wales on 20 February 2014

AO-2014-032

Second Interim Report – 5 May 2017

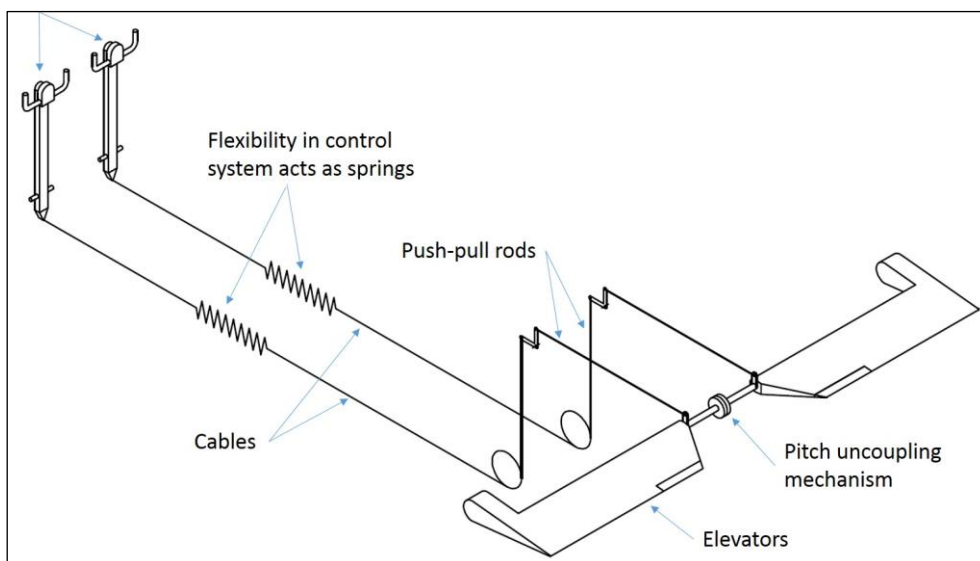
The flexibility in the pitch control system acts like a spring which stores potential energy within the system when a tension load is applied. Although the pitch control system consists of a relatively complex arrangement of push-pull rods, bellcranks, pulleys and cables connecting the control columns to the elevators, the system can be represented as the simplified system shown in Figure 4. Although not detailed in the figure, the design of the system is such that a tension is generated within the control cables regardless of whether the controls are pushed or pulled. The manufacturer advised that the flexibility is primarily within the control cables, so for the purposes of the simplification the flexibility of the entire system is represented as a spring within the control cables.

**Figure 4: Simplified model of the pitch control system with the flexibility in each channel being represented as a spring in the control cables**

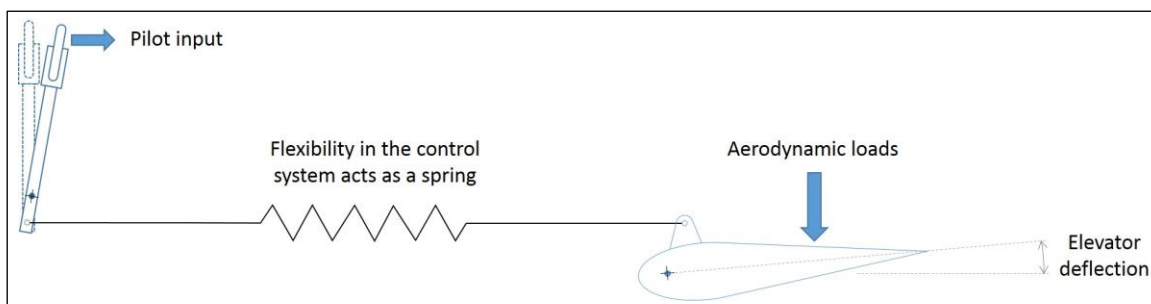
In considering the behaviour of this system, this representation can be further simplified to one channel of the pitch control system (Figure 5). In this simplified representation, when the control column is pulled back an upward deflection of the elevator will result. This elevator deflection generates an aerodynamic load that acts in the direction opposite the deflection. The opposing forces between the control column and the aerodynamic load on the elevator will result in a tension in the system. Because the system acts like a spring, it will stretch under this tension.

**Figure 5: Simplified model of one pitch control system channel showing the generalised balance of loads in the system**

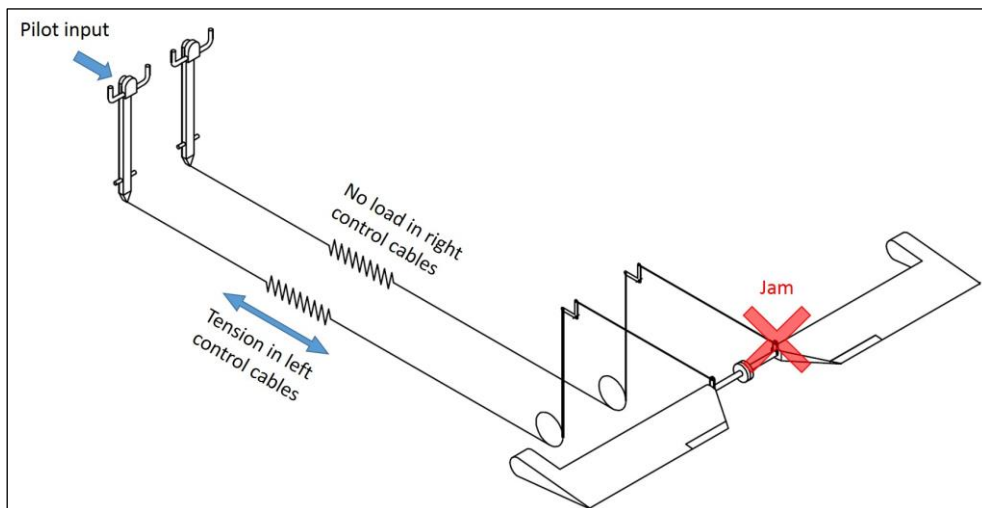
If the jam is located at, or close to, the elevators, forces applied to the control columns (control input) will result in a tension in the system, but there will be effectively no movement of the elevators while the pitch uncoupling mechanism (PUM) is connected (Figure 6). When the PUM

activates, the jammed elevator will remain in the same position, but the elevator of the unjammed side is free to move.

**Figure 6: Simplified model of the pitch control system with a jam at, or close to, the right elevator.**

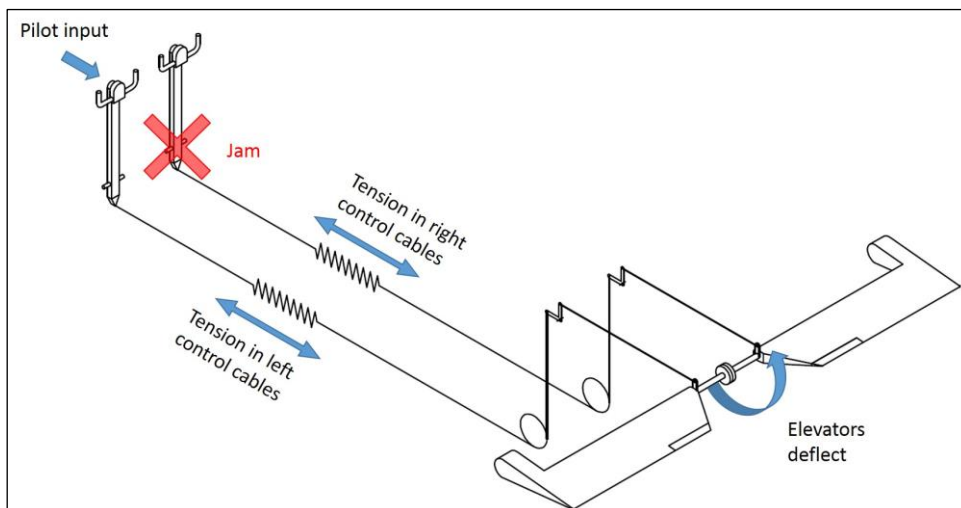
If the jam is at, or close to, a control column (Figure 7), input to the free control column can result in some elevator deflection because of the flexibility in the system. This deflection will result in an aerodynamic load in a direction opposite to the deflection, but it will also generate a tension in the control system between the elevators and the jammed control column. After the activation of the PUM, the non-jammed control channel is free to move. However, unlike the case where the jam is at the elevator, the elevator of the jammed channel still has some movement as a result of the system flexibility.

**Figure 7: Simplified model of the pitch control system with a jam at control column**

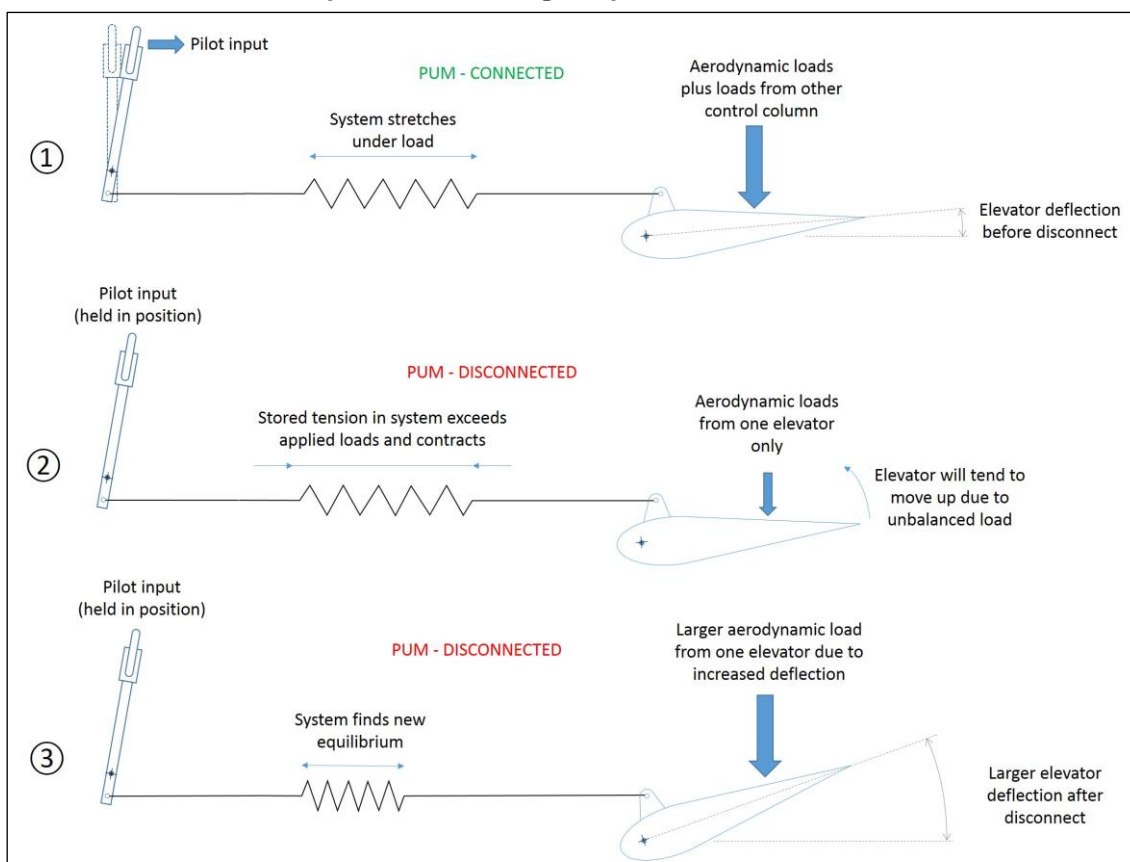
Figure 8 represents how one pitch control channel changes in response to a pitch disconnect. The case examined represents the case of a jam at one control column, or opposing dual control inputs. The behaviour presented assumes that the control column has been moved to the position at which the PUM is activated, but does not move following the pitch disconnect. Only one pitch channel is shown; however, due to the balance in the system, the other channel will behave in a similar manner, but in the opposite direction.

The instant before a pitch disconnect occurs ①, the PUM has not been activated and the left and right elevators are connected. The control load input through one system is balanced by the aerodynamic load from both the left and right elevators and the tension generated in the other pitch channel (Figure 7). Because of the inherent flexibility, the system between the control column and elevator has been stretched.

The contraction of the system will increase the deflection of the elevator until the aerodynamic load on the elevator balances the load on the control column ③. The new deflection will be larger than the position just before the pitch disconnect.

**Figure 8: Behaviour of the pitch control system during a pitch disconnect shown just before the pitch disconnect ①, the instant of the pitch disconnect ②, and at a time after the pitch disconnect when the loads have balanced ③. Note, this assumes that the control column is held in position following the pitch disconnect.**

The ATSB recommends that ATR complete the assessment of transient elevator deflections associated with a pitch disconnect as soon as possible to determine whether the aircraft can safely withstand the loads resulting from a pitch disconnect within the entire operational envelope. In the event that the analysis identifies that the aircraft does not have sufficient strength, it is further recommended that ATR take immediate action to ensure the ongoing safe operation of ATR42/72 aircraft.

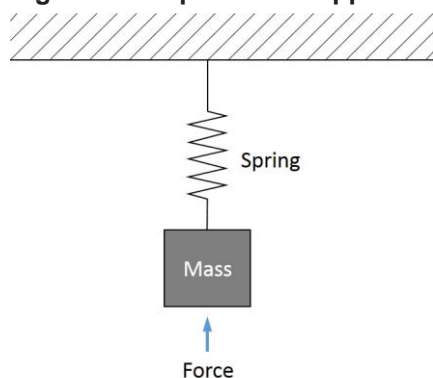
A simple mechanical system consisting of the mass supported by a spring is shown below (Figure 9). If no force applied, the position that the mass is at will be considered the normal resting position. However, if a force is applied to the mass, the position of the mass will change, albeit not instantaneously. There will also be a period of time that the mass will be in motion. The motion of the mass during this time is referred to as the transient response of the system.

**Figure 9: Simple mass supported from a spring that is acted upon by a force**

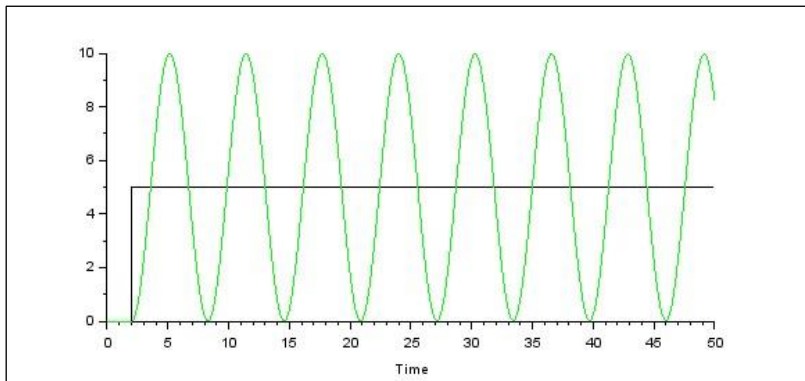
If there is no damping, the mass will endlessly oscillate without ever settling to a steady-state, as shown in Figure 10. The magnitude and frequency of the oscillation are functions of the mass and spring stiffness.

**Figure 10: Response of a simple mass-spring system (green trace) to a step input (black trace) with no damping. Note that the system will continue to oscillate without settling to a steady-state.**

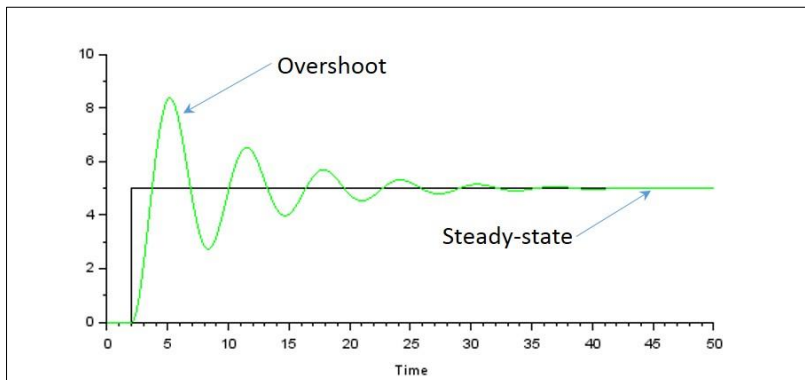
When some damping is added to the system, the oscillation reduces over time and the mass will eventually settle to a new steady-state position as shown in Figure 11. This characteristic response is referred to as an under-damped system. A key feature of this response is that the system will initially overshoot the steady-state value.

**Figure 11: Characteristic response of an underdamped simple mass-spring system (green trace) to a step input (black trace). Note that the system will oscillate, but the magnitude of the oscillation will decrease over time until the system reaches a steady state value.**

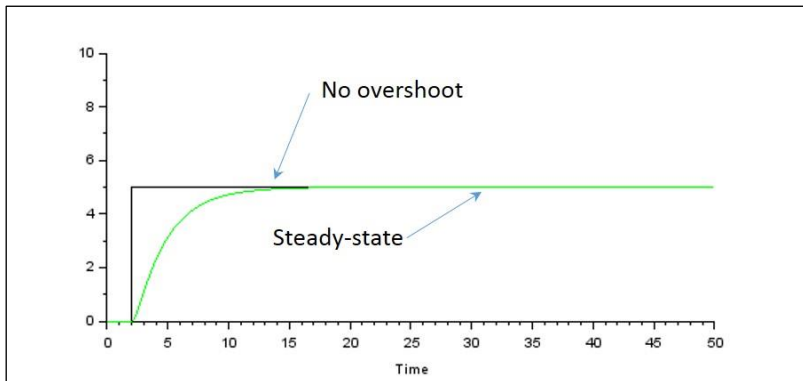
Increasing the damping will reduce the amount of overshoot and oscillation before reaching the steady-state; however, the initial response will be slower. If the damping is sufficiently large, there will be a point where there is no oscillation within the system. The minimum amount of damping that results in no overshoot is called the critical damping. Further damping will display a similar response, but will slow the response and increase the time that it takes to reach the steady-state position. The characteristic response of a critically, or overdamped system is shown in Figure 12.

**Figure 12: Characteristic response of an overdamped simple mass-spring system (green trace) to a step input (black trace). Note that there is no oscillation and the system does not overshoot the steady-state value.**
