Breakaway of *Spirit of Tasmania II*

Station Pier, Port Melbourne, Victoria | 13 January 2016

ATSB Transport Safety Report
Marine Occurrence Investigation
324-MO-2016-001
Final – 11 May 2017

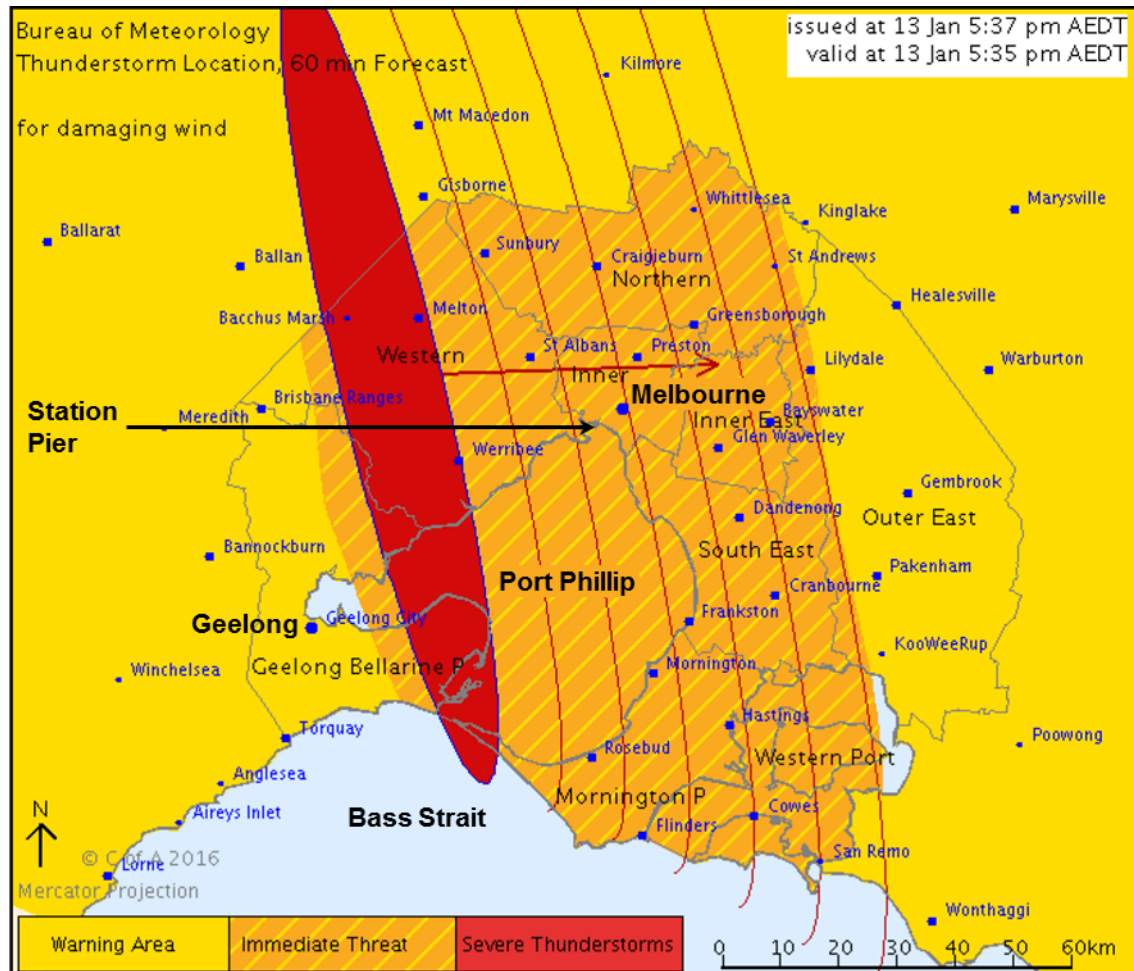
Figure 2: Map issued with the severe thunderstorm warning at 1737 on 13 January

It was not until shortly after 1745 that the master returned to his cabin and again checked the BoM website (no internet access was available on the bridge). He saw that a 'severe thunderstorm warning'⁴ had been issued at 1737. The website indicated a series of thunderstorms approaching Station Pier from about 13 miles⁵ to the west (Figure 2).

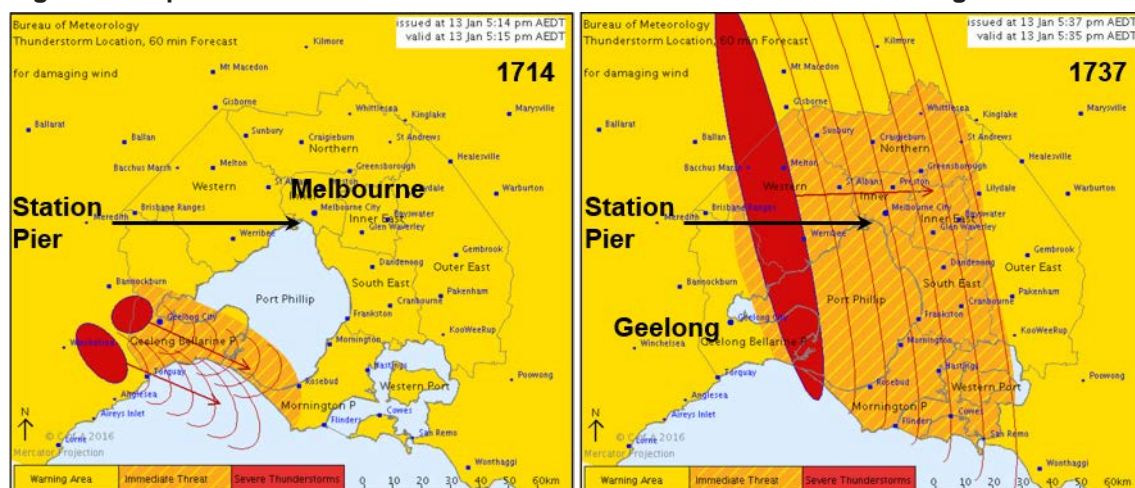
Figure 9: Maps issued with the 1714 and 1737 severe thunderstorm warnings

The local waters forecast at 1640 retained information about the cold front and squalls associated with thunderstorms. At 1714, a severe thunderstorm warning was issued for the Melbourne area, which indicated that two thunderstorm cells with damaging winds located southwest of Melbourne were moving southeast (Figure 9). The next warning was due to be issued an hour later, at 1815.

However, at 1737, a further severe thunderstorm warning was issued after thunderstorms were detected west of Melbourne. This band of thunderstorms with winds up to 54 knots (100 km/h) was moving east toward Melbourne and forecast to affect the city by 1805. The thunderstorm passed across Station Pier at 1753, bringing with it a sudden increase in wind speed. By 1830, the storm had passed and, a couple of hours later, the thunderstorm warnings were cancelled.
