Derailment of train 3MP5

Rawlinna, Western Australia | 21 April 2016

ATSB Transport Safety Report

Rail Occurrence Investigation RO-2016-005 Final – 18 July 2017

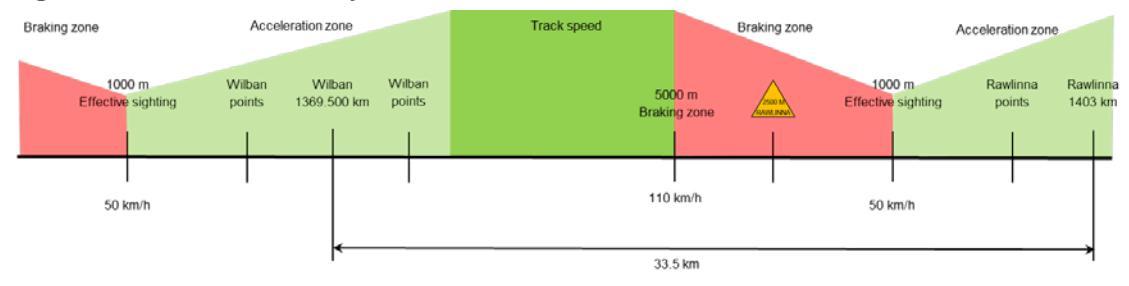
Figure 9: Section time analysis

The section between Wilban and Rawlinna was then divided into operational zones (Figure 9) to determine the appropriateness of the section running time. Given the difference between braking distance and effective sighting distance of the enhancer, the braking zone is compressed into a full service application at the location board. In reality, this is not consistent with best practice driving principles. Best practice driving involves predictive driving, anticipating braking requirements well in advance.

The section running time of 23 minutes for train 3MP5 was analysed as shown in Figure 9.

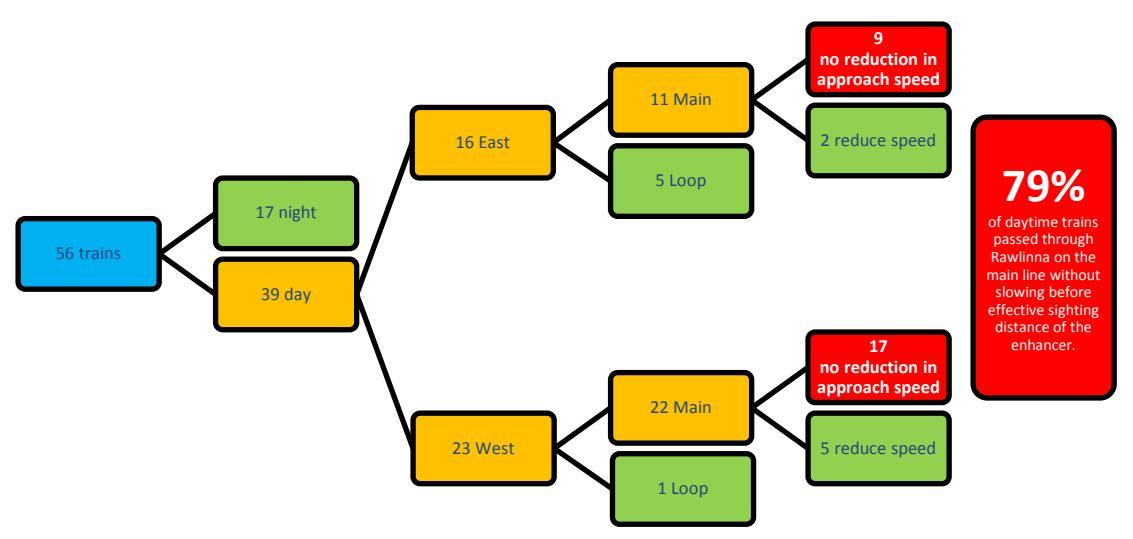
Figure 10: Approach speed analysis results

Train speeds were examined over the section beginning 6 km prior to the enhancer/points. Movements outside of daylight hours were excluded due to enhancer conspicuity and increased sighting distance. The results are shown in Figure 10.

The results indicate that 79 percent of daytime trains (passing through Rawlinna) do not slow down before the effective sighting of the enhancer, both east and west. This meant that trains

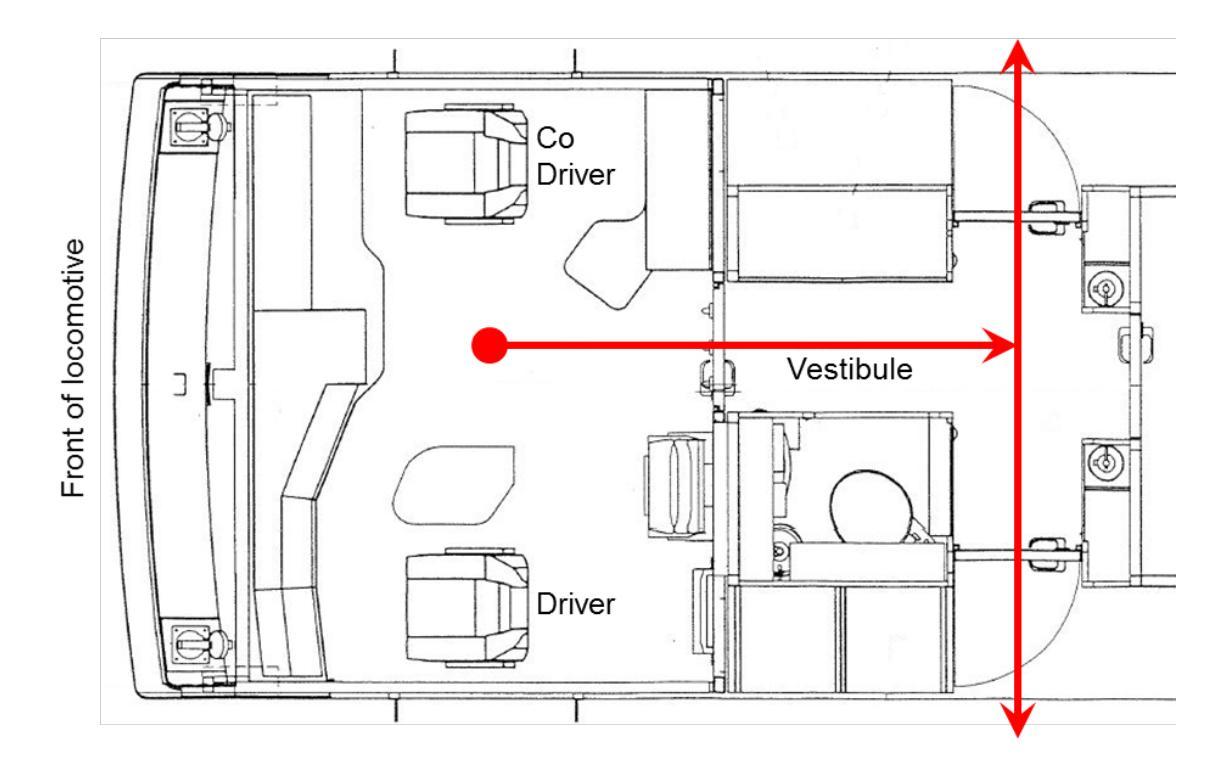
The NR class locomotive has an enclosed cab. Access and egress to the cab was via a single door to a central vestibule, and two doors to the outside of the locomotive (Figure 11). This access was also the primary emergency escape path. Although the construction of the NR class locomotive (NR34) occurred prior to the publication of the RISSB Standard AS 7522, Pacific National had included the identification of an alternate escape path through the locomotive cab side windows. The alternate escape path was available after sliding open the side windows.

Diagram of NR class locomotive primary emergency egress path (in red) through centre vestibule and rear side doors. Source: Pacific National Annotated by ATSB.

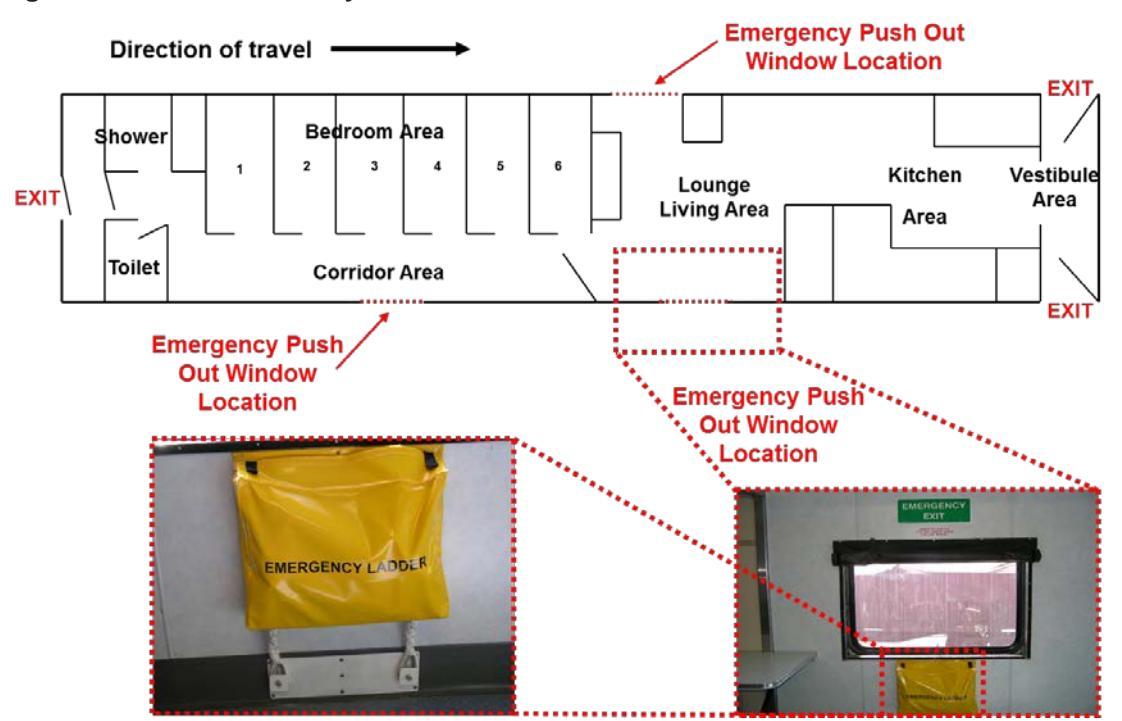
Figure 13: FAM crew van layout and exits

The ATSB also found that the crew van did not meet the requirements of AS 7522-2012 - Railway Rolling Stock Access and Egress, since the occupant could not access any escape paths without external assistance and additional equipment.

The crew van is a steel-framed car, has a stainless steel body and rides on all-steel two-axle bogies. Metal-framed rectangular windows are evenly spaced down the sides of the carriage. Vehicle access is via two external side doors into a central vestibule, and a vehicle end door (Figure 13). The external doors were also the primary emergency escape paths. A supplemental escape path through side windows was available after removing the window, and lowering an emergency ladder out of the window.
