MH370 – Search and debris examination update

ATSB Transport Safety Report Aviation External Investigation AE-2014-054 2 November 2016 Released in accordance with section 25 of the Transport Safety Investigation Act 2003

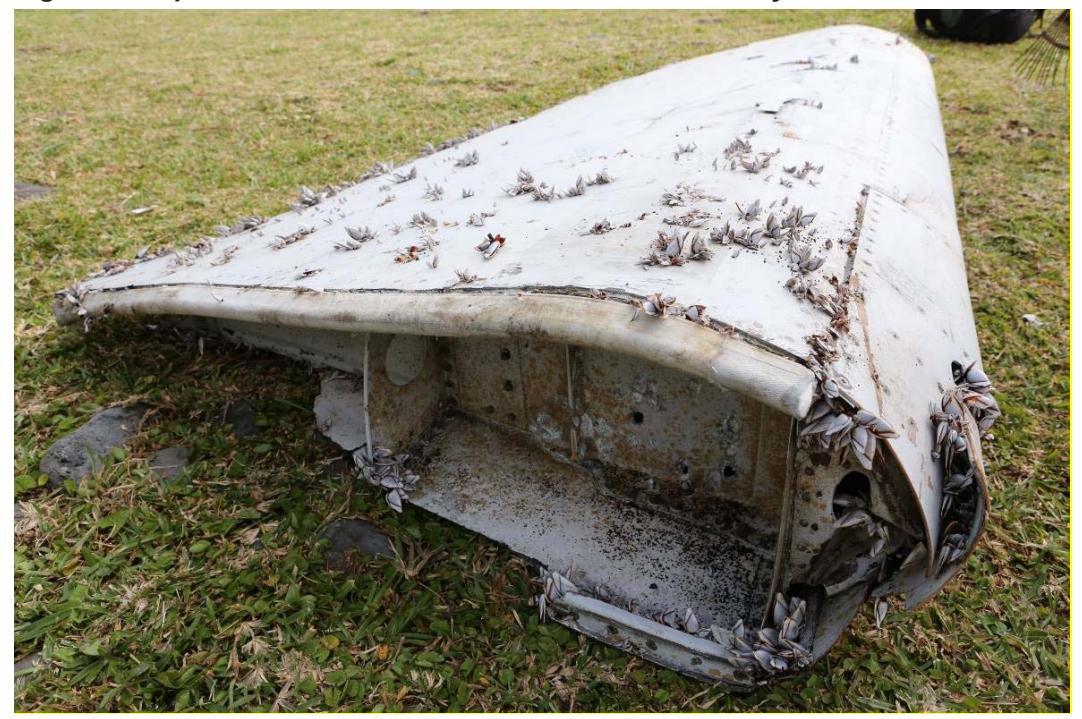
Figure 7: Flaperon recovered from Reunion Island on 29 July 2015

As part of the ongoing field testing, the drift behaviour of replica flaperons and other recovered aircraft parts is being assessed. Replica flaperons were constructed with dimensions and buoyancy approximately equal to that of the recovered flaperon (Figure 7), which was float-tested during the detailed examinations in France. The replica flaperons were deployed into a bay for short term tests during various weather conditions. Longer term tests were then performed in the open ocean. For comparison, undrogued drifters were deployed alongside the flaperons. Drogued drifters were also used, because they move predominantly with the currents, as opposed to wind and waves. Data for currents was then able to be subtracted from the flaperons' drift data so that wind and wave behaviour could be assessed in isolation.

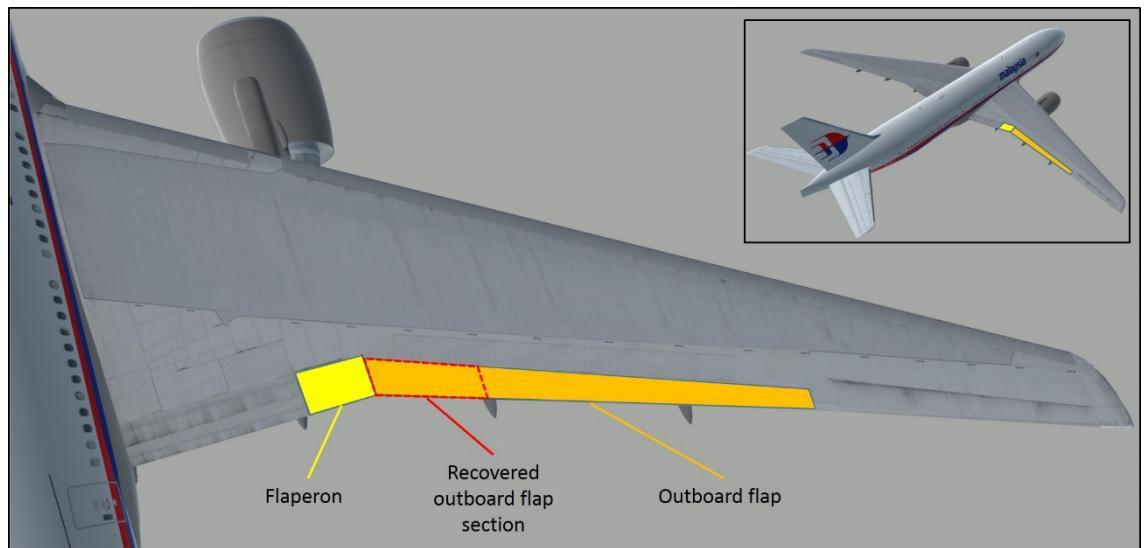
Figure 12: Location of recovered outboard flap section

The recovered right, outboard wing flap section (Figures 12, 13 and 14) was examined for any evidence of interaction with mechanisms, supports and surrounding components that may indicate the state of flap operation at the time of fracture and separation from the wing. The purpose of the examination was to inform the end-of-flight scenarios being considered by the search team. The most significant items of evidence in relation to this are documented below.
