Engine failure involving a Eurocopter AS350-BA VH-SFX

Whyanbeel Valley, Queensland | 2 November 2015

ATSB Transport Safety Report
Aviation Occurrence Investigation
AO-2015-124
Final – 17 October 2017

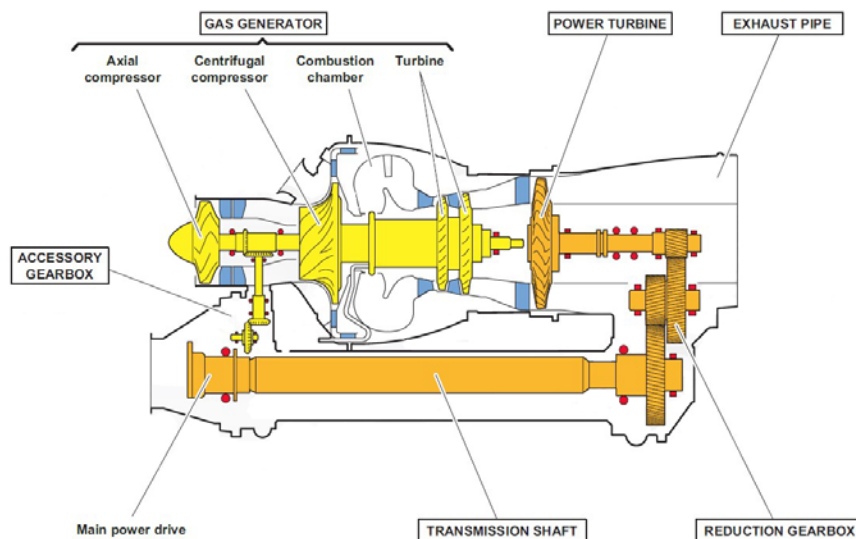
Figure 4: General arrangement of a Turbomeca Arriel 1B turboshaft engine showing the locations of the major sub-components

The helicopter was powered by a Turbomeca³ Arriel (model 1B) engine, located above and to the rear of the passenger compartment. The Arriel 1B engines feature a modular design with the major modules consisting of an axial and centrifugal compressor, an annular combustion chamber, a two-stage axial turbine, a single-stage axial power turbine and a reduction gearbox (Figure 4). This occurrence related to a failure within the power turbine.

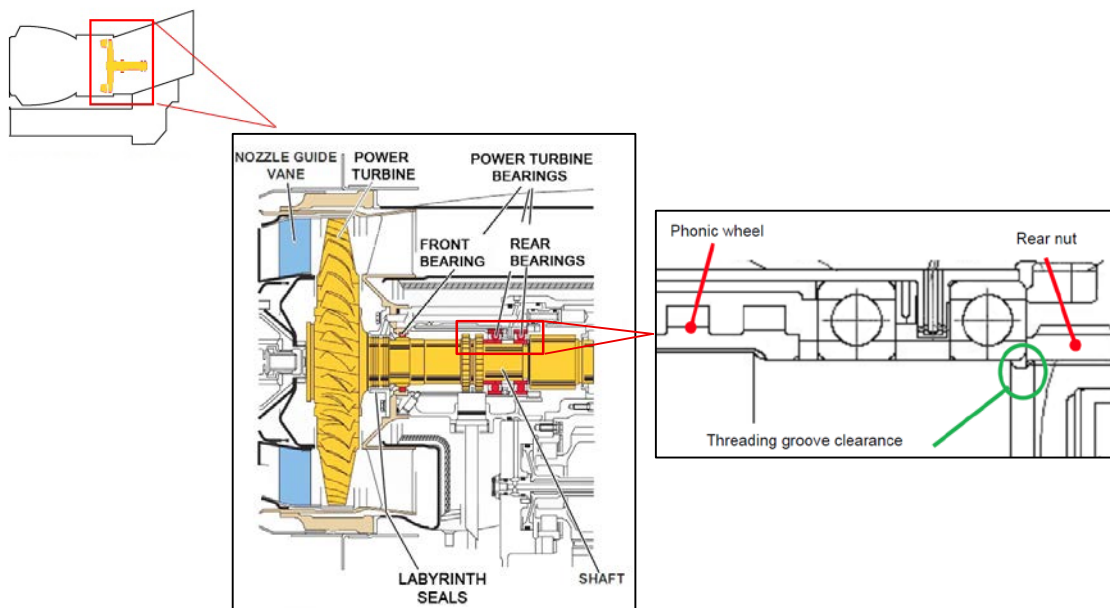
Figure 5: General arrangement of the power turbine showing the relative location of the major parts including; the guide vanes, labyrinth seal, power turbine shaft, rear nut, and the front and rear bearings.

Gases from the two-stage axial turbine are directed downstream to the power turbine. The power turbine disc and shaft is a cantilevered design supported by front and rear bearings (Figure 5). Surrounding the power turbine is a containment shield to prevent high-energy engine debris from exiting the engine in the event of a blade fracture or disc separation from the shaft. The fractured turbines blades did not penetrate the containment shield in this occurrence.
