Tailstrike and runway overrun Airbus A340-541, A6-ERG

Melbourne Airport, Victoria | 20 March 2009

ATSB Transport Safety Report
Aviation Occurrence Investigation
AO-2009-012
Final

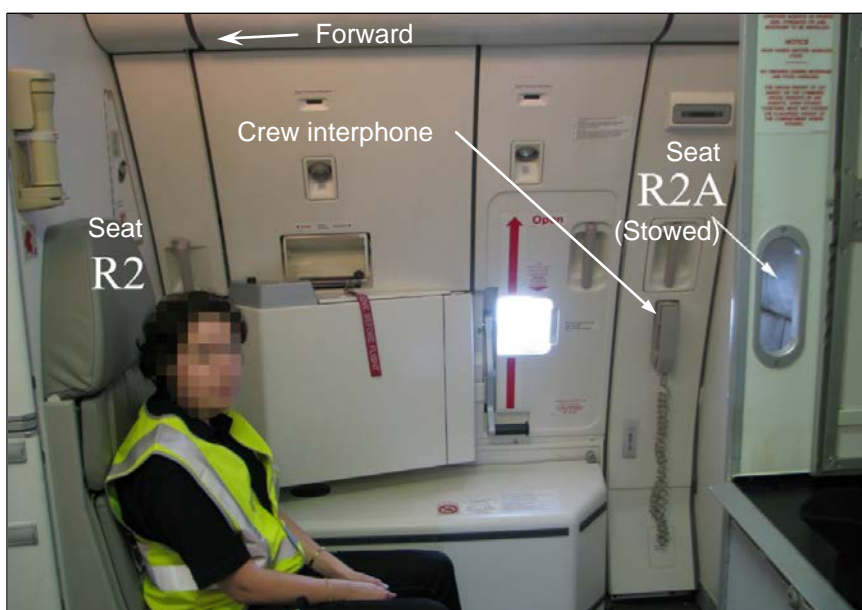
Figure 22: Door R2 interphone

The captain requested that the cabin crew remain seated for the duration of the flight and that all communication between the cabin crew was via the interphone system. The only report of any difficulty with the interphone system was from the cabin crew member who was seated at door R2 who reported that she was unable to reach the interphone from her door operator position at R2 (see Figure 22).

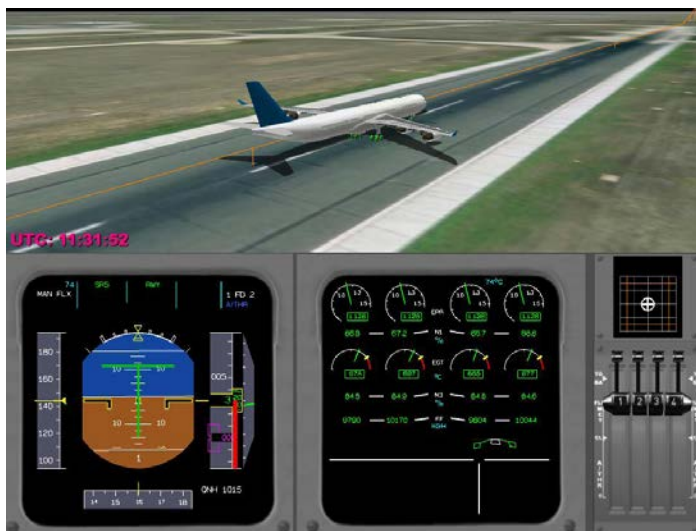
2231:52 Automated announcement of V_1 (the decision speed)
CAS: 144 kts Distance to runway end: 1,118 m

2231:53 The captain called 'rotate'
CAS: 146 kts Distance to runway end: 1,043 m

2231:54 The first officer applied back pressure on his sidestick controller to raise the nose of the aircraft.
The aircraft did not immediately respond with a nose-up pitch and, when it did, the response was slow.
CAS: 147 kts Distance to runway end: 964 m

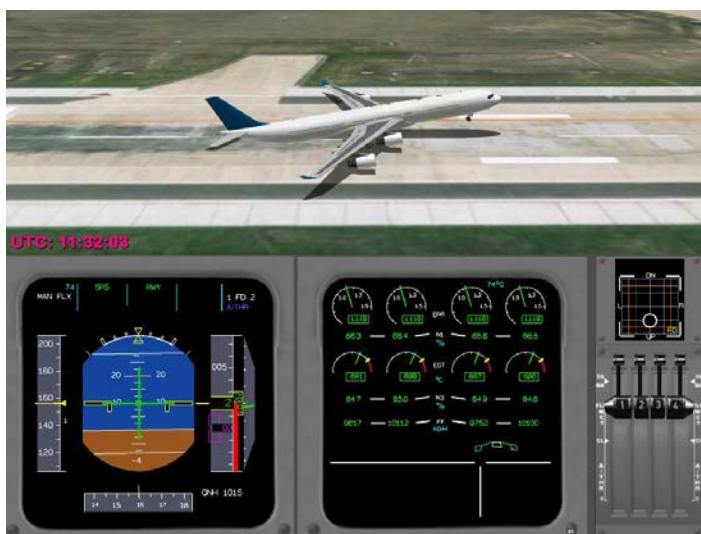
2232:03 The tail made first contact with the runway surface.
CAS: 156 kts Distance to runway end: 265 m

2232:03 The captain called 'TOGA'.
CAS: 156 kts Distance to runway end: 229 m
The captain reported that the decision to apply TO/GA thrust was based on the realisation that 'something was not right' with the aircraft's performance and his recollection of the reports on a previous take-off event involving another of the operator's A340-313 aircraft.⁸⁹

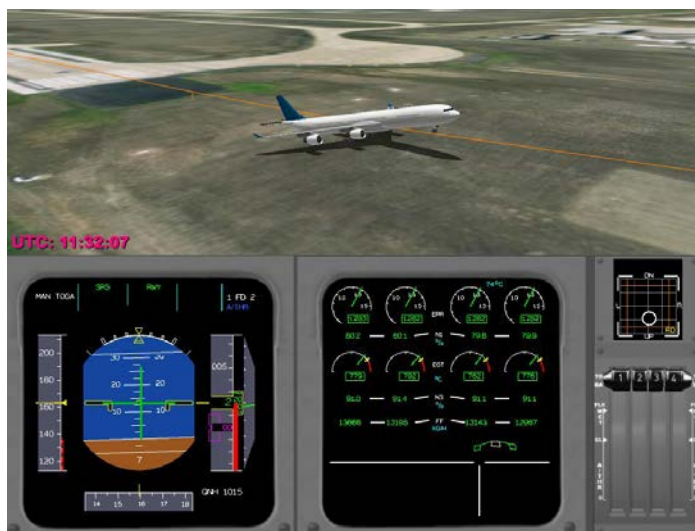
2232:07 The tail lifted off from the ground.
CAS: 161 kts Radio altitude: -1 ft⁹⁰

2232:08 The rear of the aircraft's fuselage struck the localiser near-field monitor antenna and a runway 34 lead-in strobe light.
CAS: 164 kts Radio altitude: 1 ft

2232:09 The rear inboard tyre of the left main landing gear struck the localiser antenna as the aircraft achieved a positive rate of climb.
CAS: 166 kts Radio altitude: 19 ft
The damage to the localiser antennas disabled its function and resulted in the instrument landing system becoming unserviceable.

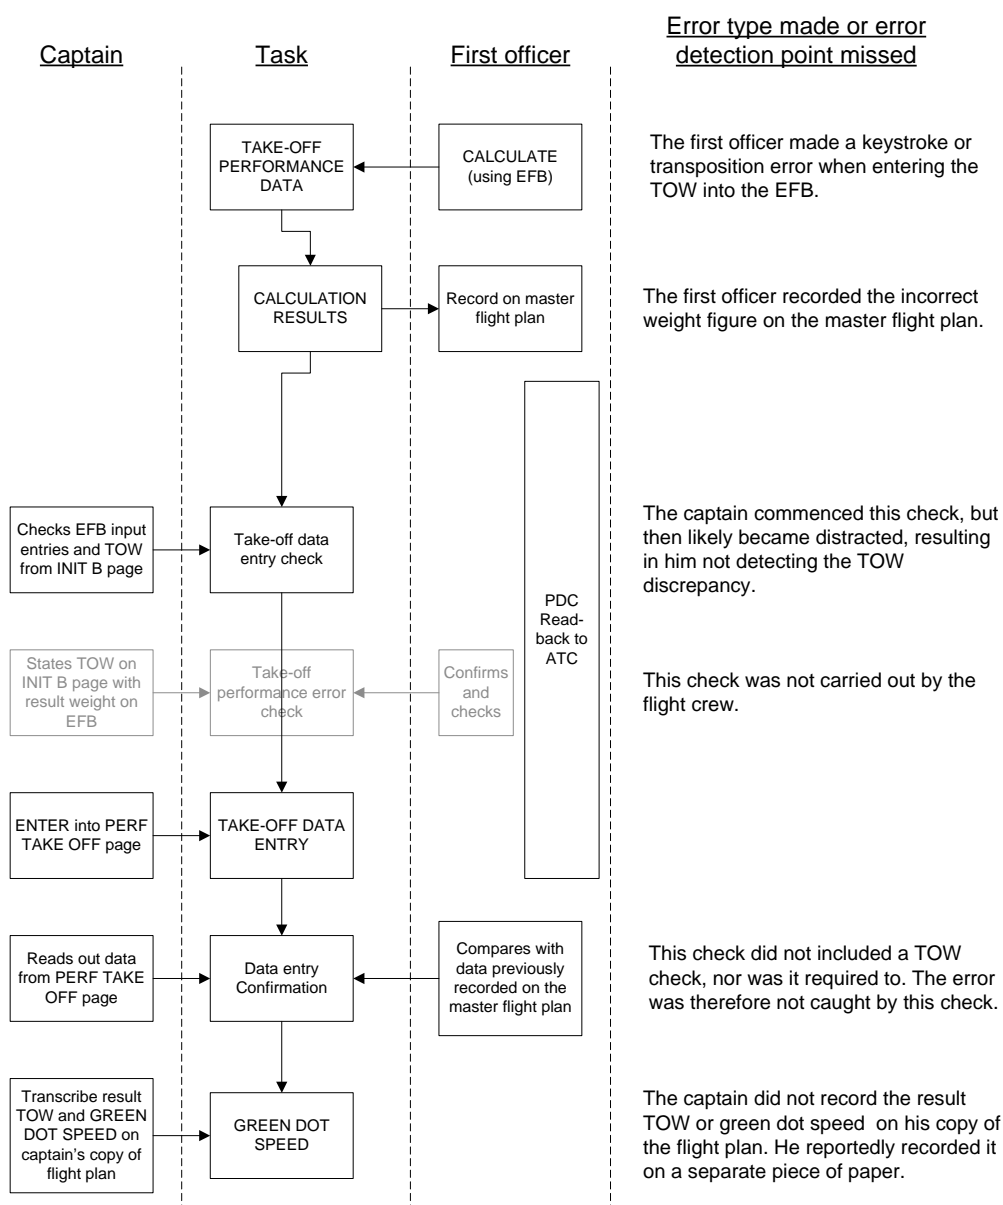
Figure 33: Take-off performance error check

The take-off performance error check included a check of the data input into the EFB that was performed silently by the captain, and a verbal check by the captain and first officer of the EFB 'result' take-off weight against the FMGS INIT B page take-off weight (Figure 33).

Although not required by the operator's procedures, had the augmenting captain the opportunity to perform his own check of the take-off performance calculations, he may have detected the take-off weight entry error.

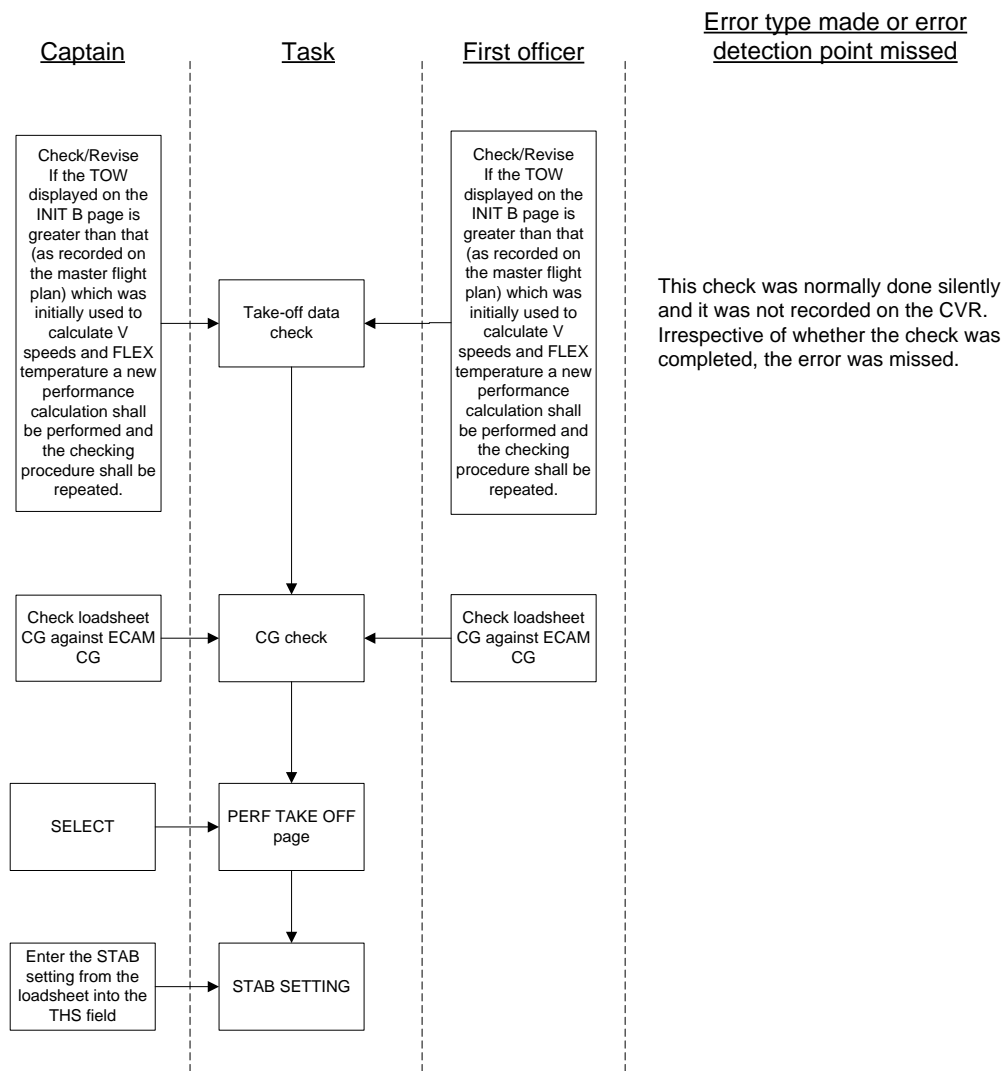
Figure 34: Take-off data check

The take-off data check was to be carried out following receipt of the final load sheet, and included a requirement for both crew members to silently verify that the take-off weight displayed on the INIT B page was greater than the FLEX-limiting take-off weight previously recorded by the first officer on the master copy of the flight plan (Figure 34).

The lack of a requirement to verbally verify the two take-off weights prevented the investigation from confirming whether this check was carried out by the crew. However, if it was carried out, it was ineffective and neither the captain nor the first officer detected the erroneous take-off weight.

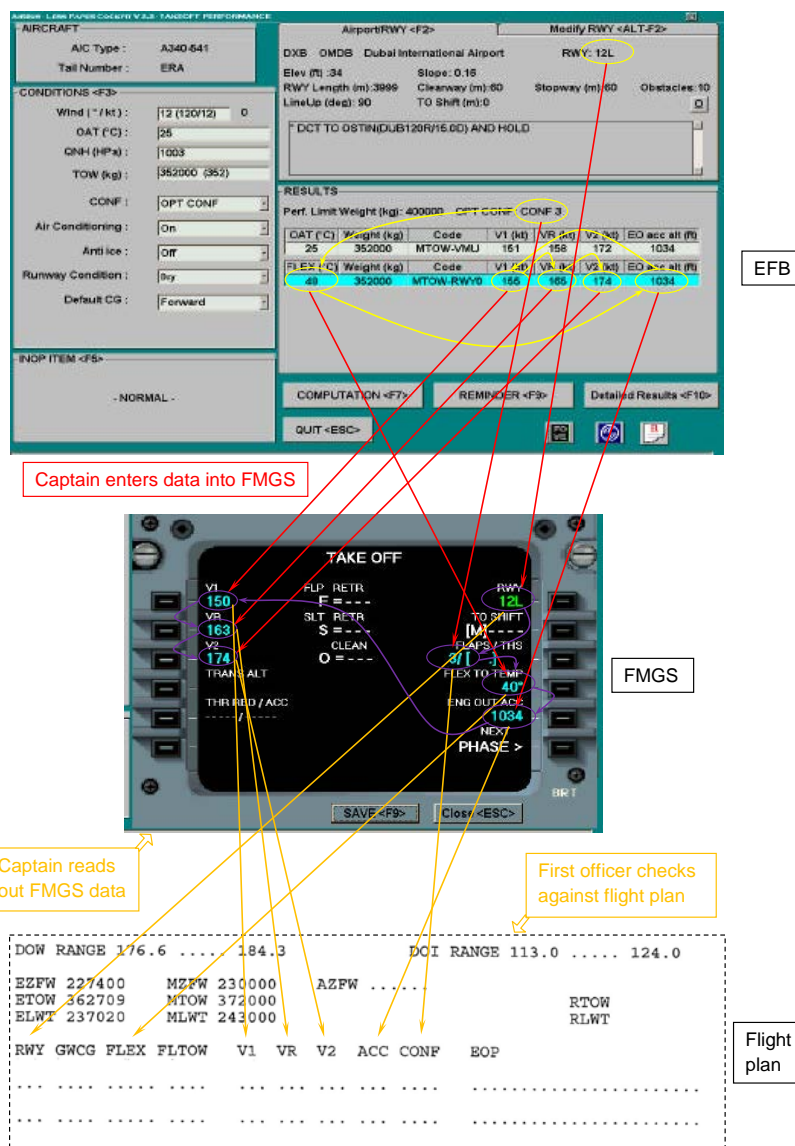
Figure 36: Link analysis on EFB

This included a review of the flow of information into the EFB, from the EFB to the flight plan, from the EFB to the FMGS, and from the FMGS to the final check against the flight plan. Figure 36 shows the link analysis for the flow of information from the EFB to the FMGS and then to the flight plan for the final check.

In addition to the flow of information, a number of other issues were highlighted. The first related to the inconsistency in the weights entered into the EFB and recorded on the flight plan, which varied between tonnes and kilograms. The possibility of transposition errors would be reduced if the units were consistent.

The second issue was related to the initial entry of data into the EFB. The EFB required the user to enter the take-off weight and not the individual ZFW and fuel load figures. The previous incidents highlighted the number of times that the zero fuel weight was entered into the EFB instead of the take-off weight. If the user was required to enter the ZFW, the fuel weight and the take-off weight, the EFB could perform an independent check of the figures to reduce the likelihood of a data entry error.

The final issue related to last-minute changes. To minimise the possibility of conducting last-minute recalculations of take-off performance parameters, it was common practice for users to enter a take-off weight that included an additional weight to account for the maximum permissible last minute change. This created a potential problem because, by adding this margin the flight crew could, inadvertently, enter an incorrect take-off weight into the EFB, or be less likely to identify an error in a weight value entered into the EFB because the original value had been deliberately altered during entry.

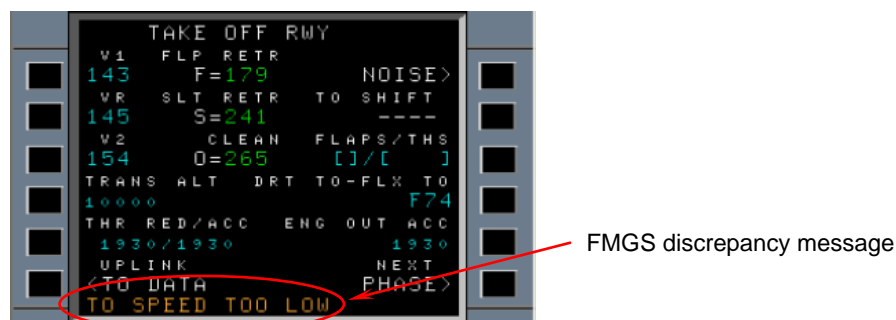
On 28 May 2010, Airbus provided the ATSB with the results of a simulation of the TOS function for the A340 using the accident flight take-off performance parameters. The result is shown below.

On 28 October 2011, Airbus advised that they plan an additional development that will include functionality to check that the aircraft has sufficient runway length to support a safe takeoff.

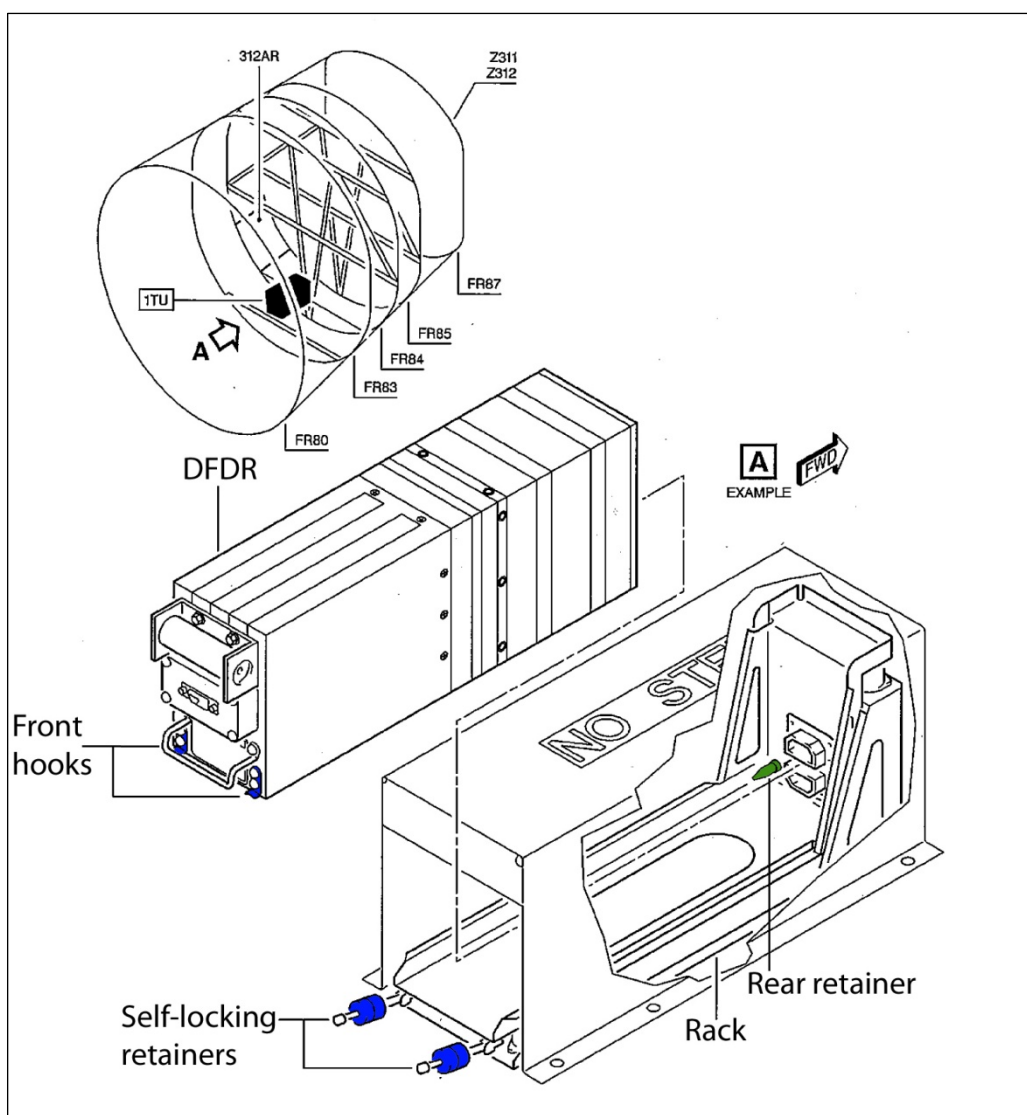
Figure A2: Schematic diagram showing the orientation of rack/FDR in aircraft

The FDR was normally secured in the rack with two attachment hooks on the front of the unit. The fasteners used for securing the FDR are known as positive self locking retainers, and work on a spring loaded mechanism (Figure A2). The knurled outer sections of the fastener are placed over the hooks on the front of the FDR, and then tightened via the internal nut to lock it in position. The spring forces the lower section to lock onto the top segment (closest to the rack) which cannot rotate around the rod. The fastener is loosened by pulling on one side of the outer casing, to release the locked mating faces, allowing for the threaded nut to be undone.

The left fastener was damaged, with the bottom section (including the spring and the circlip used to hold the spring in place) no longer attached to the assembly. The bottom section of the fastener, and the circlip were found in the rear fuselage, however the spring was not recovered. Yellow paint was observed on the outside surface of the nut, along with some minor scoring damage. The circlip and associated components were examined visually, but no evidence of damage to identify the failure mechanism was observed.

did not sit flush with the upper plate due to the permanent deformation of the rack. As a result, the right fastener could not be secured over the hook on the front of the FDR in the as-received position. The threaded nut of the left fastener appeared to be further from the hook; however it should be noted that a full examination of the effectiveness could not be performed, as the spring loaded mechanism was not recovered.

The damage observed on the FDR rack was considered to be the result of the tailstrike event. The vertical forces from the impact, acting on the weight of the FDR unit, would have imparted sufficient load to the rack through the fasteners, to permanently deform the aluminium sheet of the upper tray. The upper tray exhibited permanent plastic deformation/buckling along the vertical axis, towards the fastener end, in the order of 14 millimetres.

With the upper tray deformed, the nuts would have been able to disconnect from the FDR hooks, leaving the unit unsecured. The deformation was observed to be equal on the left and right sides of the upper tray, which indicated that both fasteners were secured at the time of the occurrence.

While a part of the left fastener had been separated from the rack (the spring assembly), the reason for the failure could not be determined.

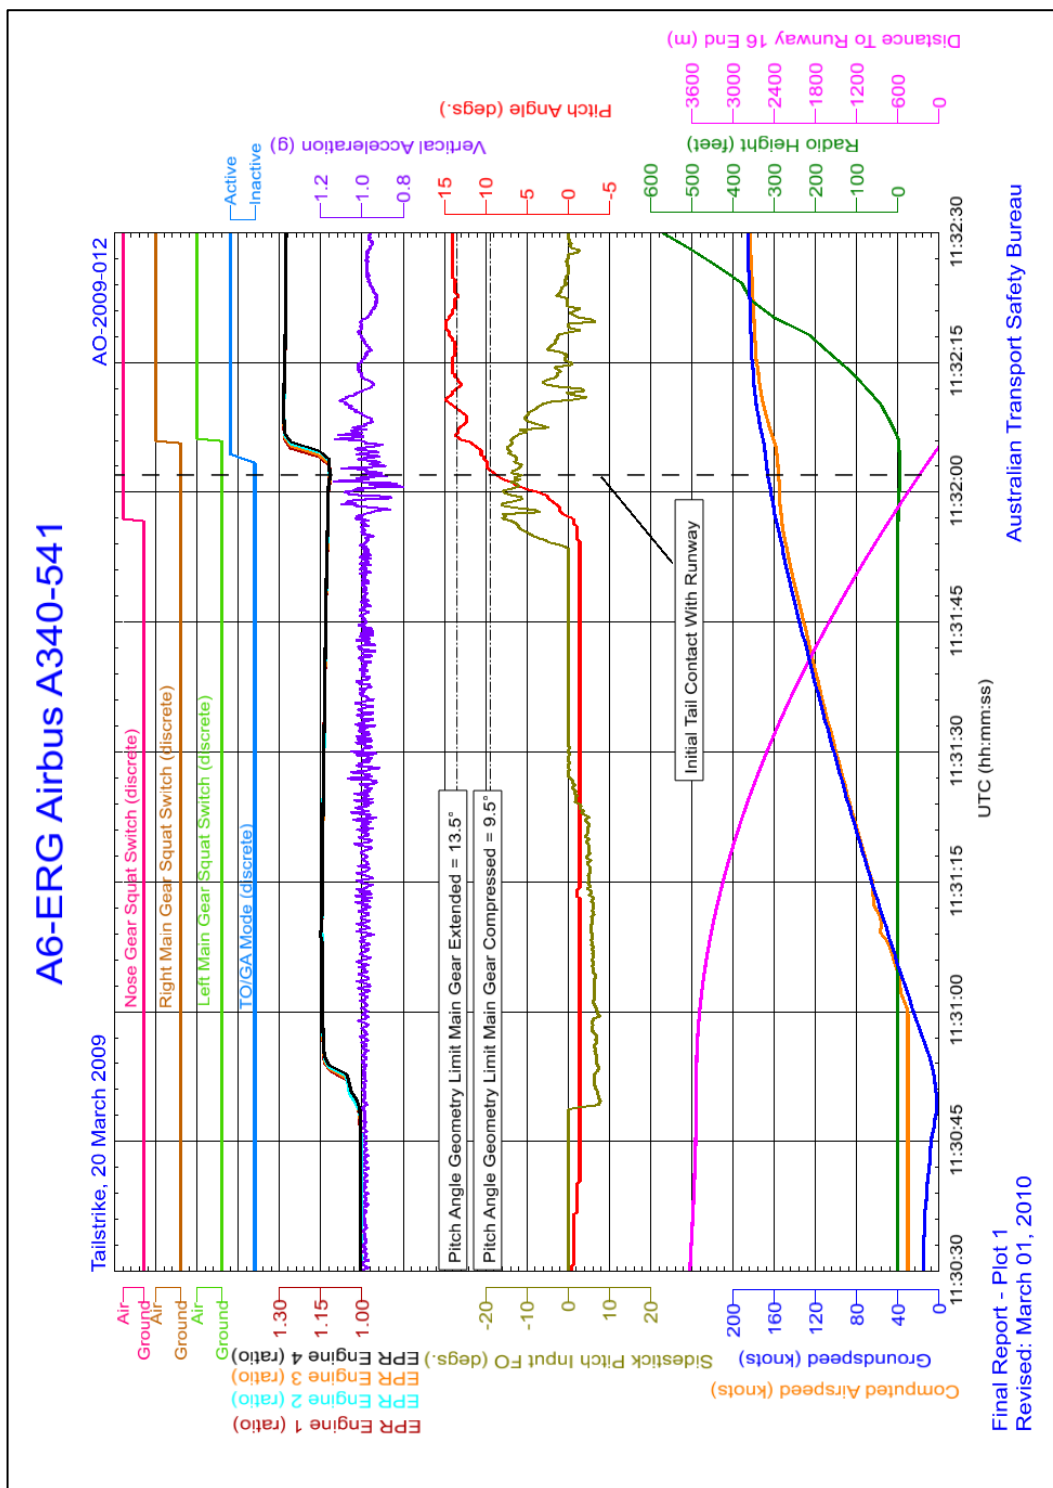
Figure C11: Selected DAR parameters for the take-off roll

Two plots of the relevant flight data from the digital aircraft condition monitoring system recorder (DAR) were prepared and are at Figure C11 and C12.
