Collision with terrain involving Cessna Aircraft Company 172S, VH-ZEW

Millbrook, Victoria | 8 September 2015

ATSB Transport Safety Report
Aviation Occurrence Investigation
AO-2015-105
Final – 17 April 2018

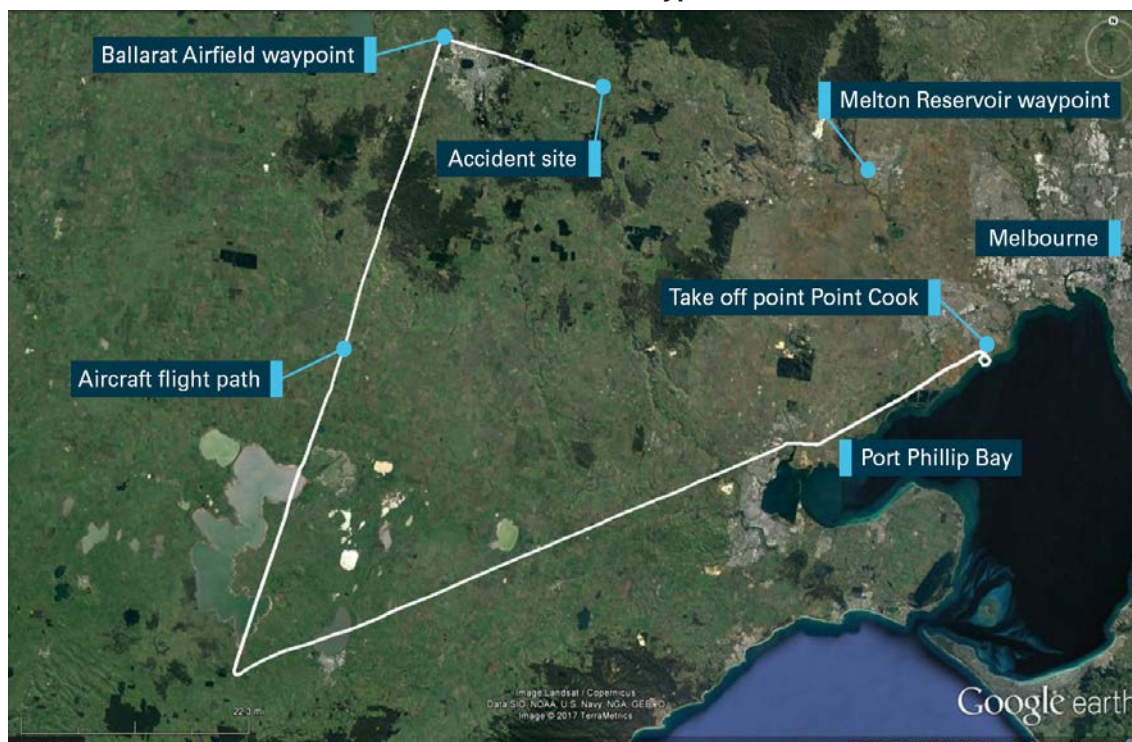
Figure 1: Map showing the aircraft's flight path, take-off point and accident site. ZEW was between the Ballarat airfield to Melton Reservoir waypoints at the time of the accident.

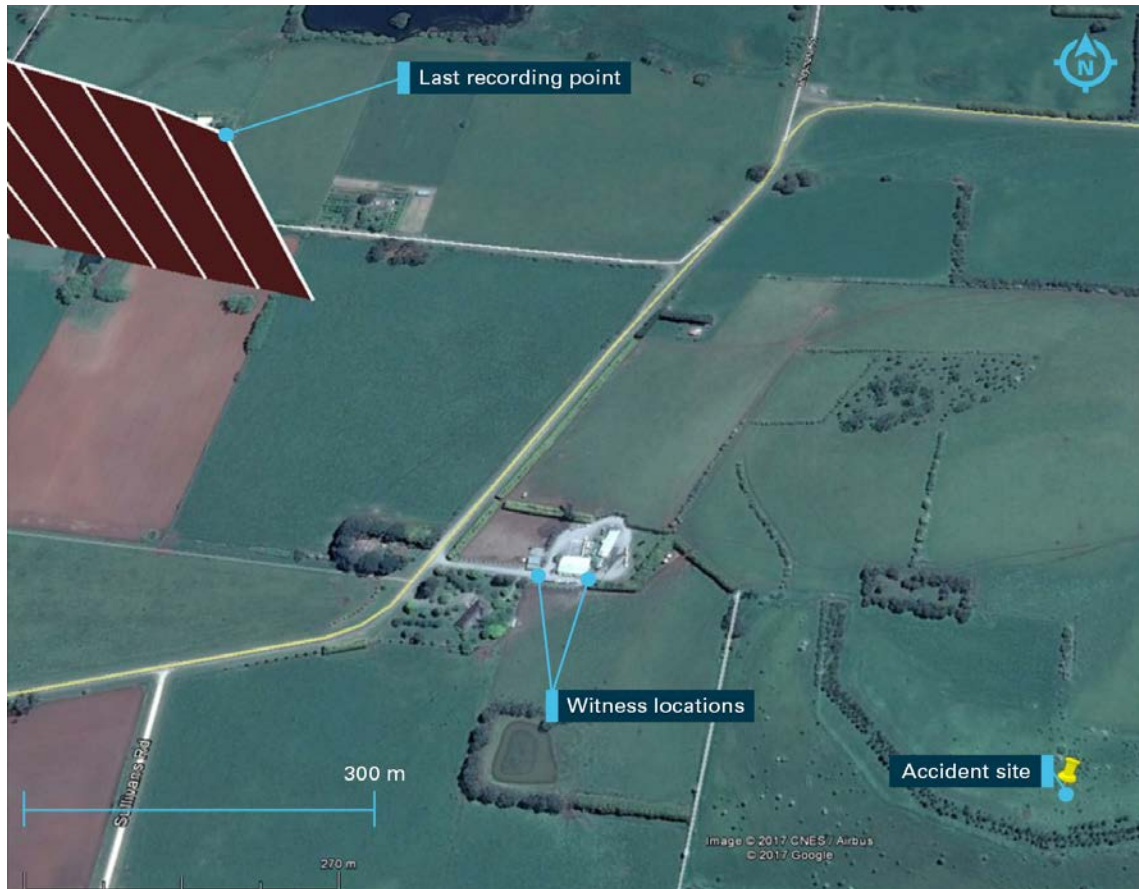
Figure 2: Last recorded aircraft position, witness locations, and accident site. The high terrain is an extinct volcano called Black Mount.
