Collision with terrain involving Airbus Helicopters EC135 T1, VH-GKK

10 km NNW Cooranbong, New South Wales | 7 November 2015

ATSB Transport Safety Report

AO-2015-131

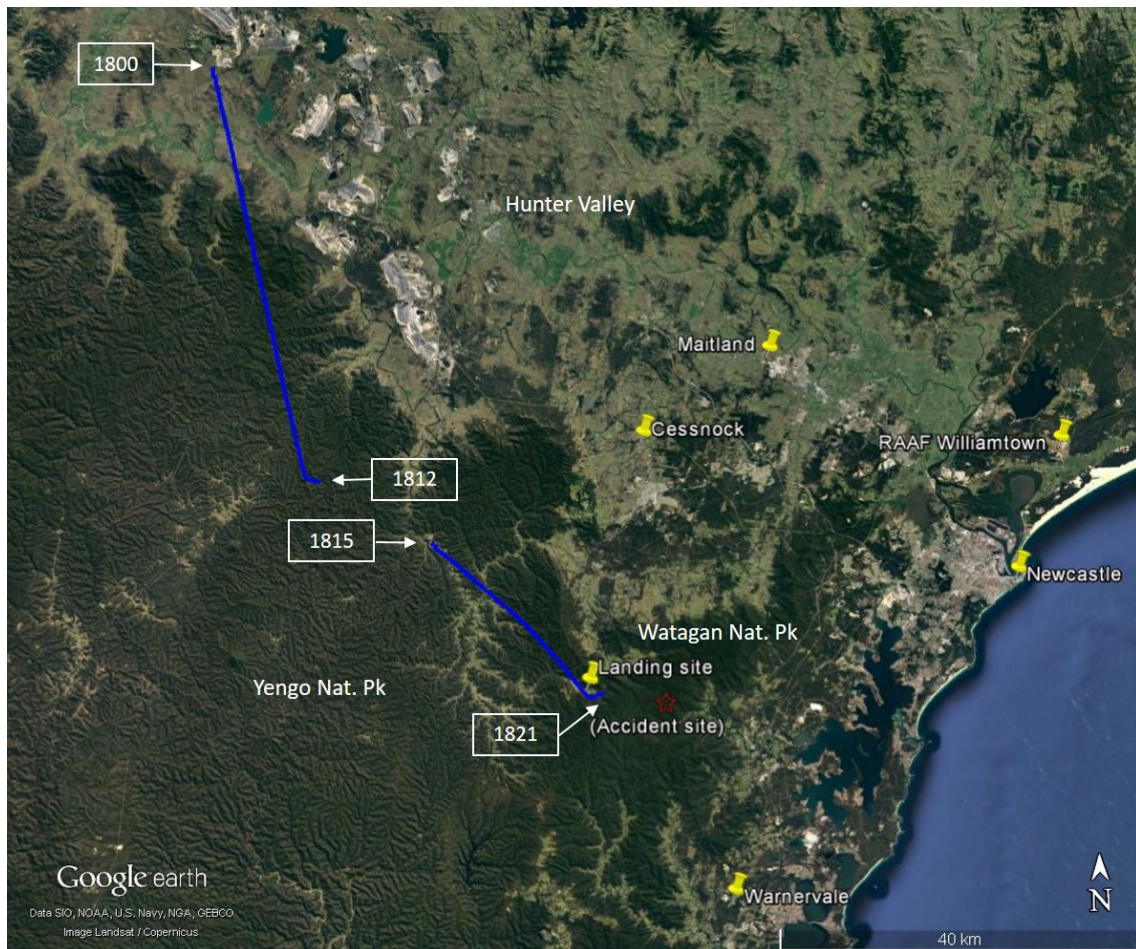
Figure 3: Radar data (in solid blue line) of the helicopter track on 7 November 2015 before the interim landing with times and accident site

Based on photos recovered from the filmmaker's camera, the pilot departed at 1735 and tracked to Werris Creek coal mine then southward in the general direction of Terrey Hills. At 1800, air traffic control radar detected the helicopter in the vicinity of the Liddell mine in the Hunter Valley, which was about the halfway point. On initial detection, the helicopter was at 2,800 ft above mean sea level,⁵ before climbing to 3,500 ft as it approached higher terrain. It had an average groundspeed of 116 kt and the pilot was maintaining a consistent track in the general direction of Terrey Hills (The radar data recorded between 1800 and 1821 is depicted in Figure 3).

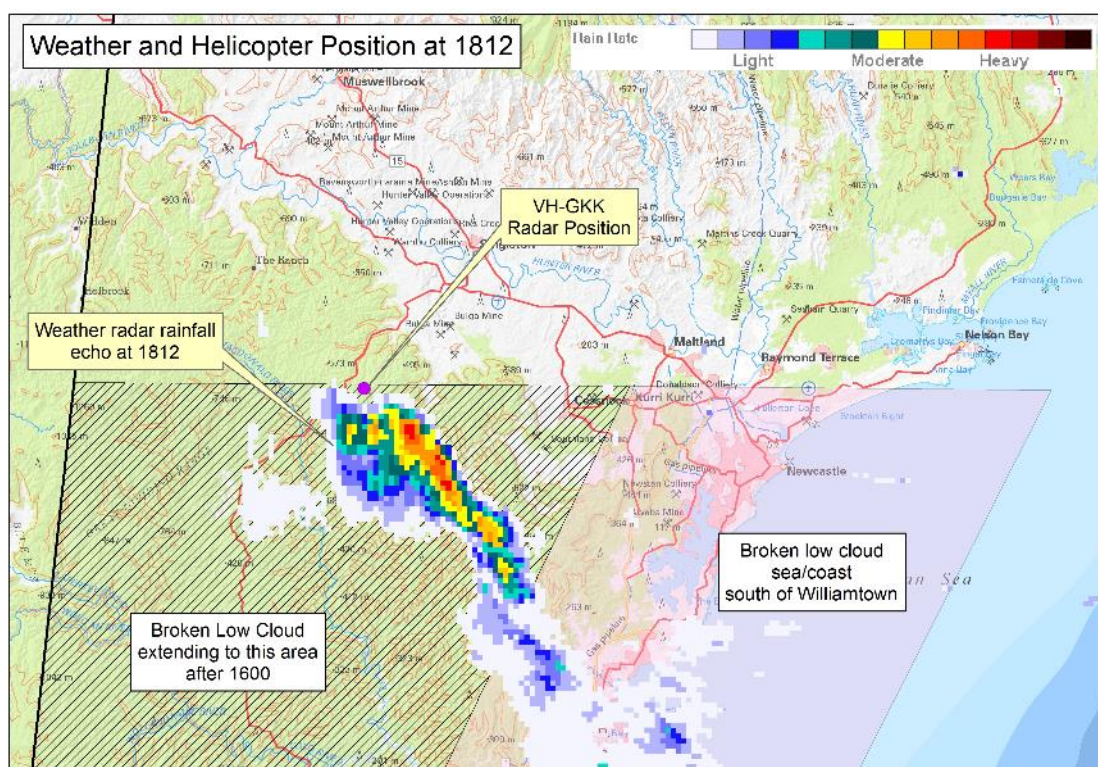
Figure 7: Composite weather image and position of VH-GKK at 1812

By 1812, the rain/storm band had moved north-east to be evident 100 km west and south-west of Williamtown Airport. At the same time, the helicopter was identified at a position that is just north of the weather band (Figure 7).

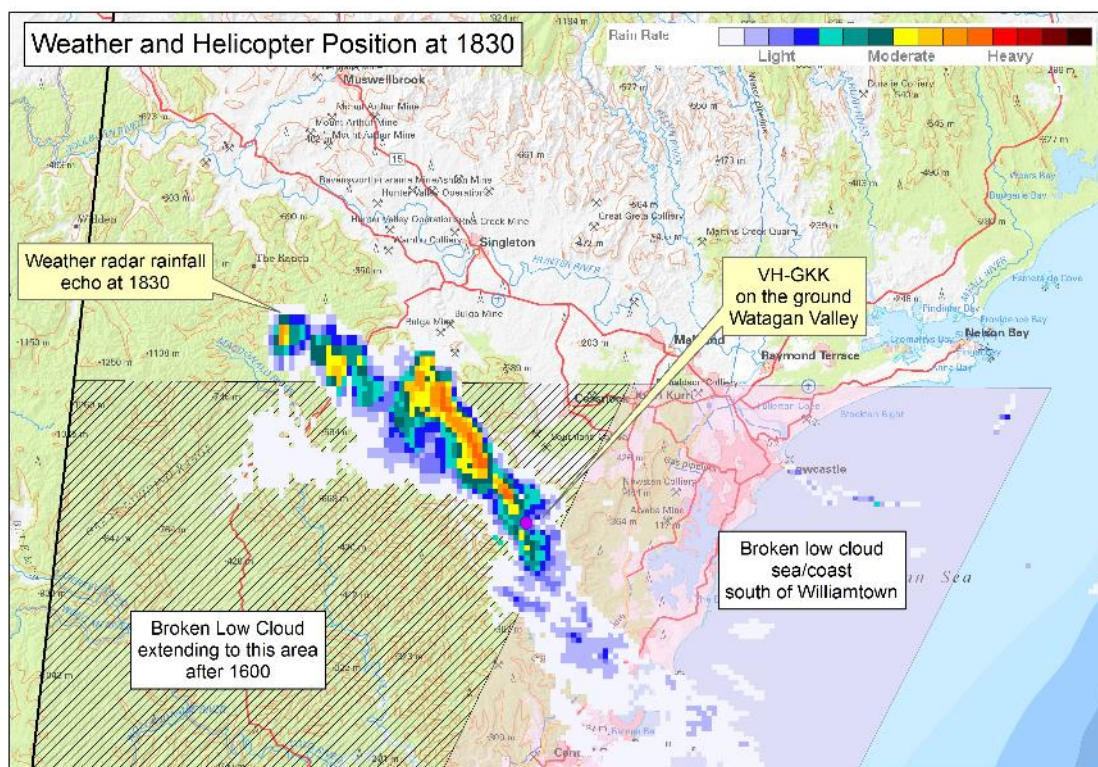
Figure 8: Composite weather image and position of VH-GKK at 1830

By 1822, the leading edge of the rain/storm band had encircled the identified position of the helicopter. At 1830, the rain/storm band was over the Watagan Creek valley location where the pilot landed the helicopter (Figure 8).
