Grain train 5422N parting and derailment

Parkville, New South Wales | 6 April 2016

ATSB Transport Safety Report
Rail Occurrence Investigation
RO-2016-004
Final – 4 June 2018

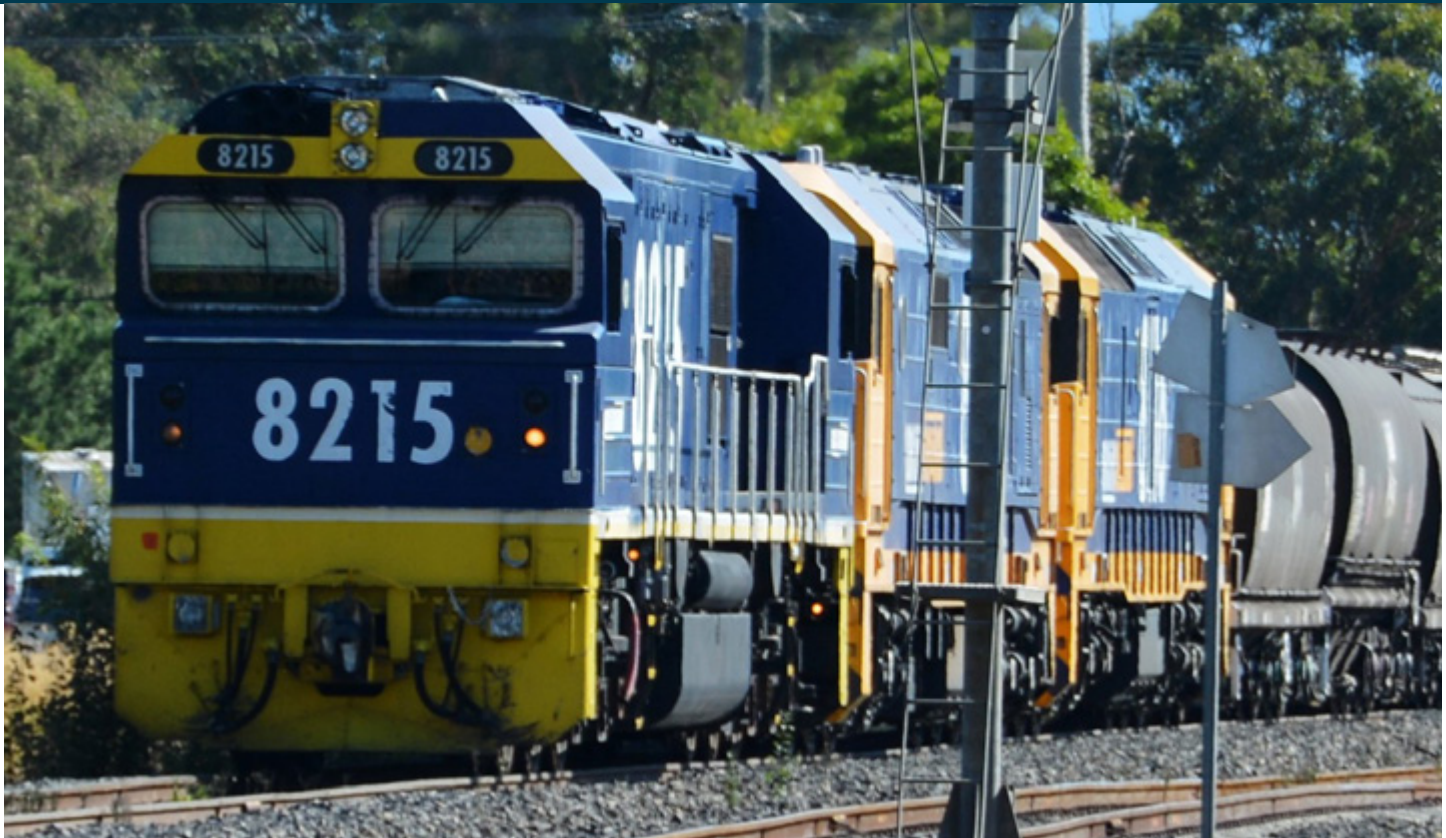
Figure 1: 5422N at Parkville

ATSB observed the train had parted five wagons behind the locomotive (see Figure 1). The draw gear assembly was missing from the rear of the fifth wagon, NGKF 35898X (see Figure 5). The coupler shank was found under the rear axle of the rear bogie of the sixteenth wagon, NGKF 35864R (see Figure 6).

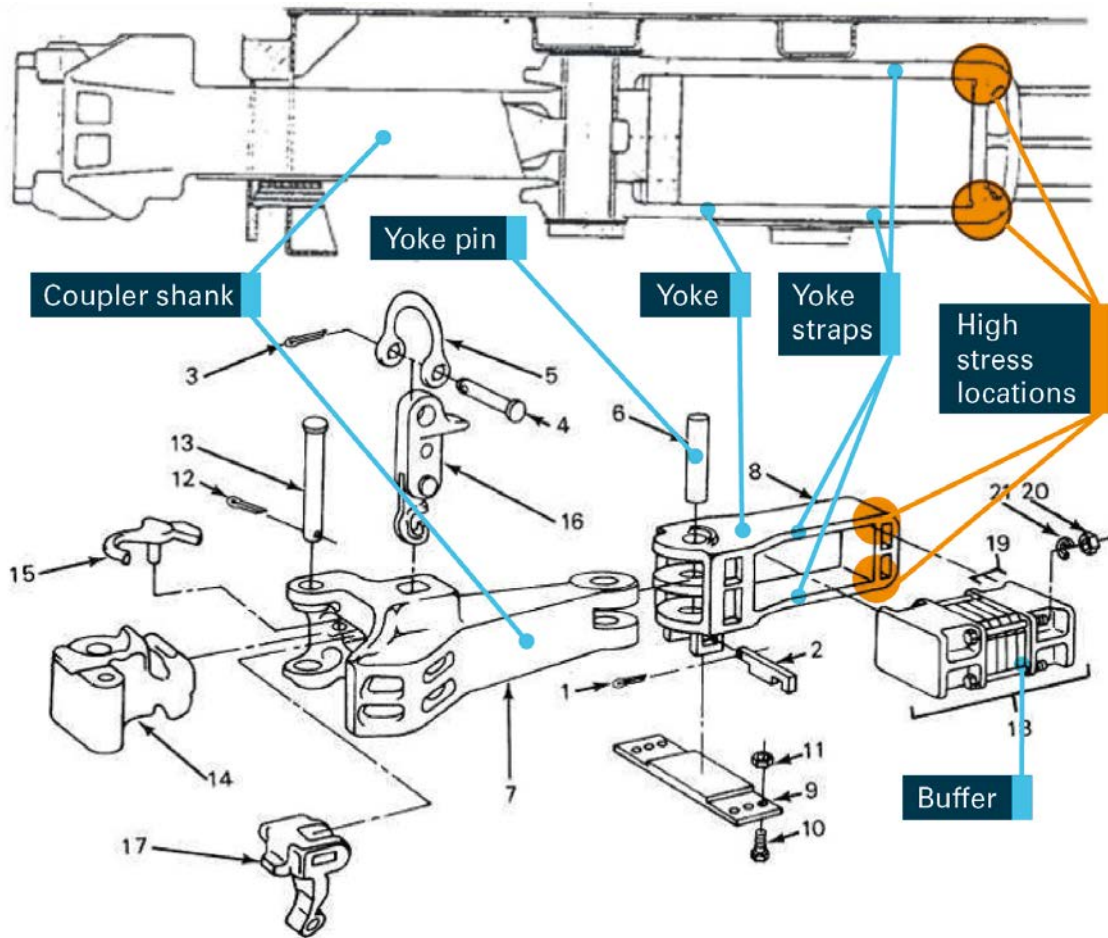
Figure 4: Draw gear assembly - fixed view (above) and exploded view (below)

The yoke is an integral component of a wagon's draw gear assembly. While a number of different designs are in service, they are all designed to retard the train's longitudinal draft and buffering⁴ forces. The major components of a draw gear assembly are typically: coupler shank, buffer package, yoke and yoke pin (see Figure 4).

The yoke in this incident was a pre-1980 design made from a lower tensile steel and without rounded smooth radius fillets in the high stress locations.

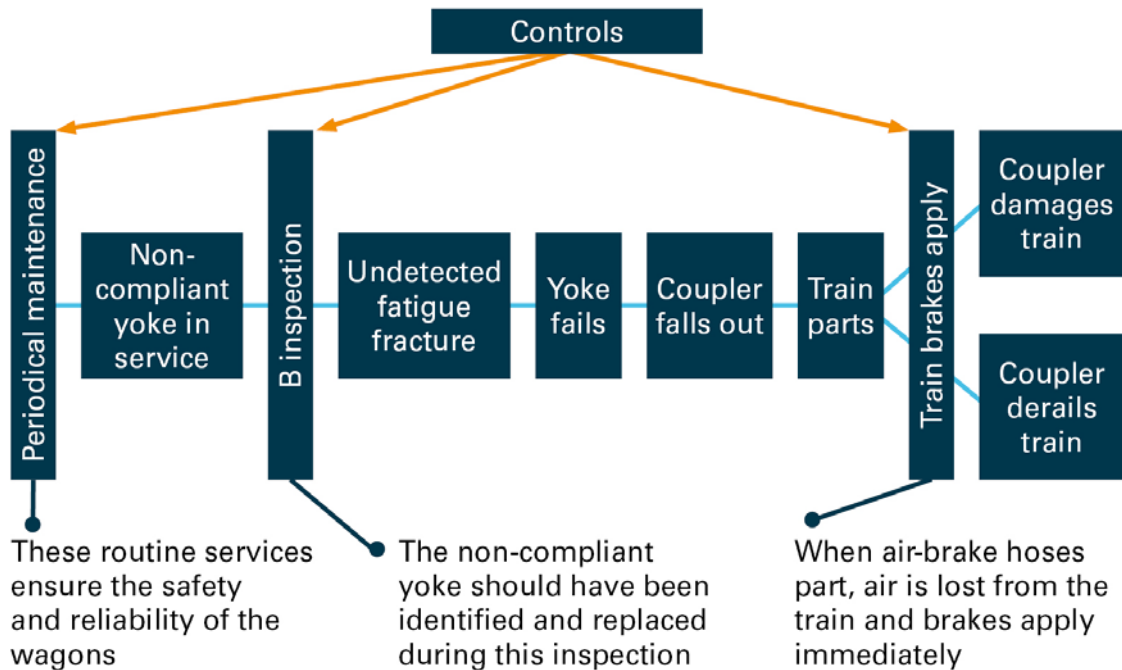
Figure 10: Event sequence

The yoke fitted on the rear of the fifth wagon, NGKF 35898X, was of an early design and was known to be susceptible to fatigue failure. The undetected older style yoke eventually failed in-service and led to the train parting and the subsequent derailment (see Figure 10).

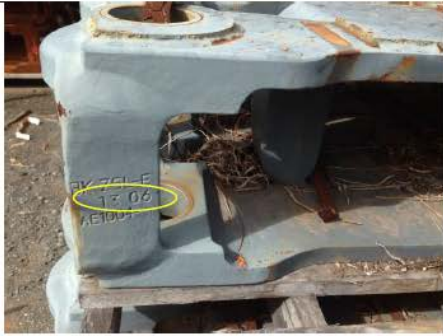
Figure 1 Yoke manufacture date

- All wagons are to be inspected in accordance to WMM 07-02 clause 1.9.4
- The manufacture date of the yoke is found on the yoke strap. Examples as per figures 1 and 2. The date of manufacture is often not visible when yoke is installed in pocket.
- The draft capacity is available in the WDO "Wagon Data for Train Operations" on SafetyNet.
- The relief fillet can be seen without removing the draw gear or bogie.

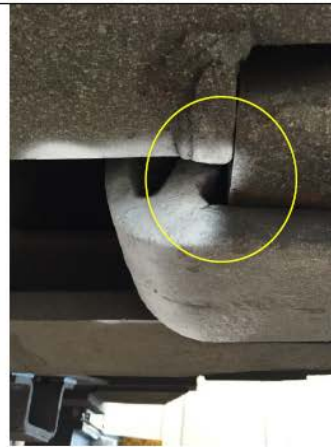
Figure 4 Yoke with relief fillet

This notice is to re-iterate the requirements for early model yoke straps.
Note Figures 3 and 4 included to show detail from WMM 07-02 figure 12.
