AVIATION  
SAFETY  
DIGEST

100

DEPARTMENT OF TRANSPORT - AUSTRALIA

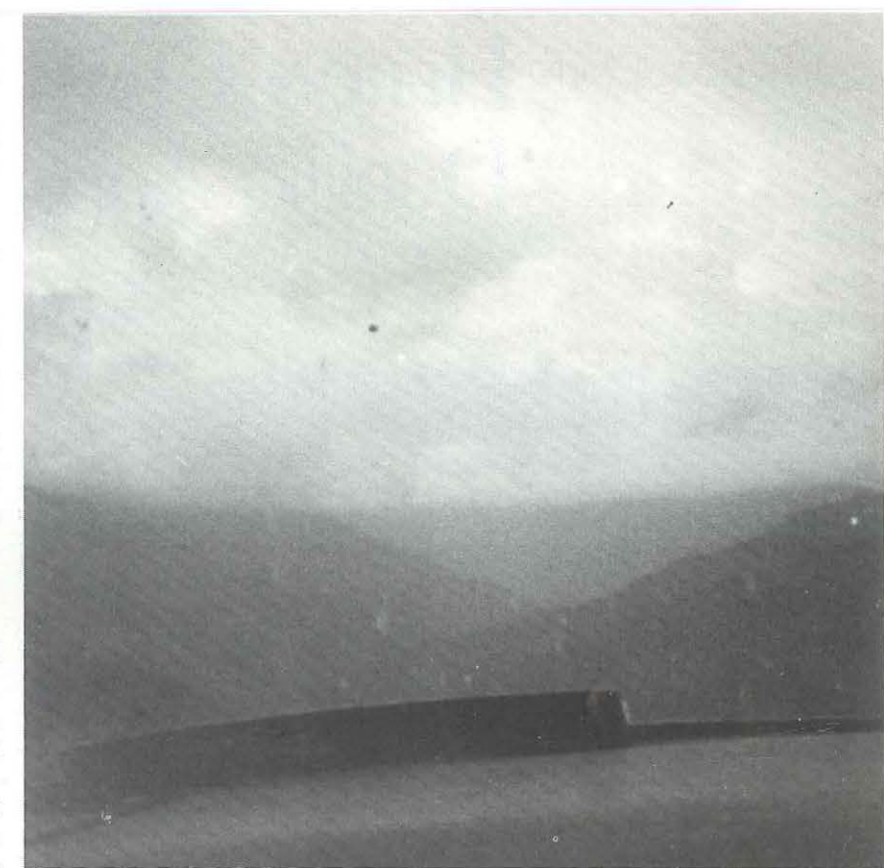
Actual photograph taken by the passenger in the right-hand seat of the Aztec as it was flying up the blind valley. Although already hemmed in by the low cloud and by the valley walls to either side, it is not evident at this stage that there is no means of escape for the aircraft.

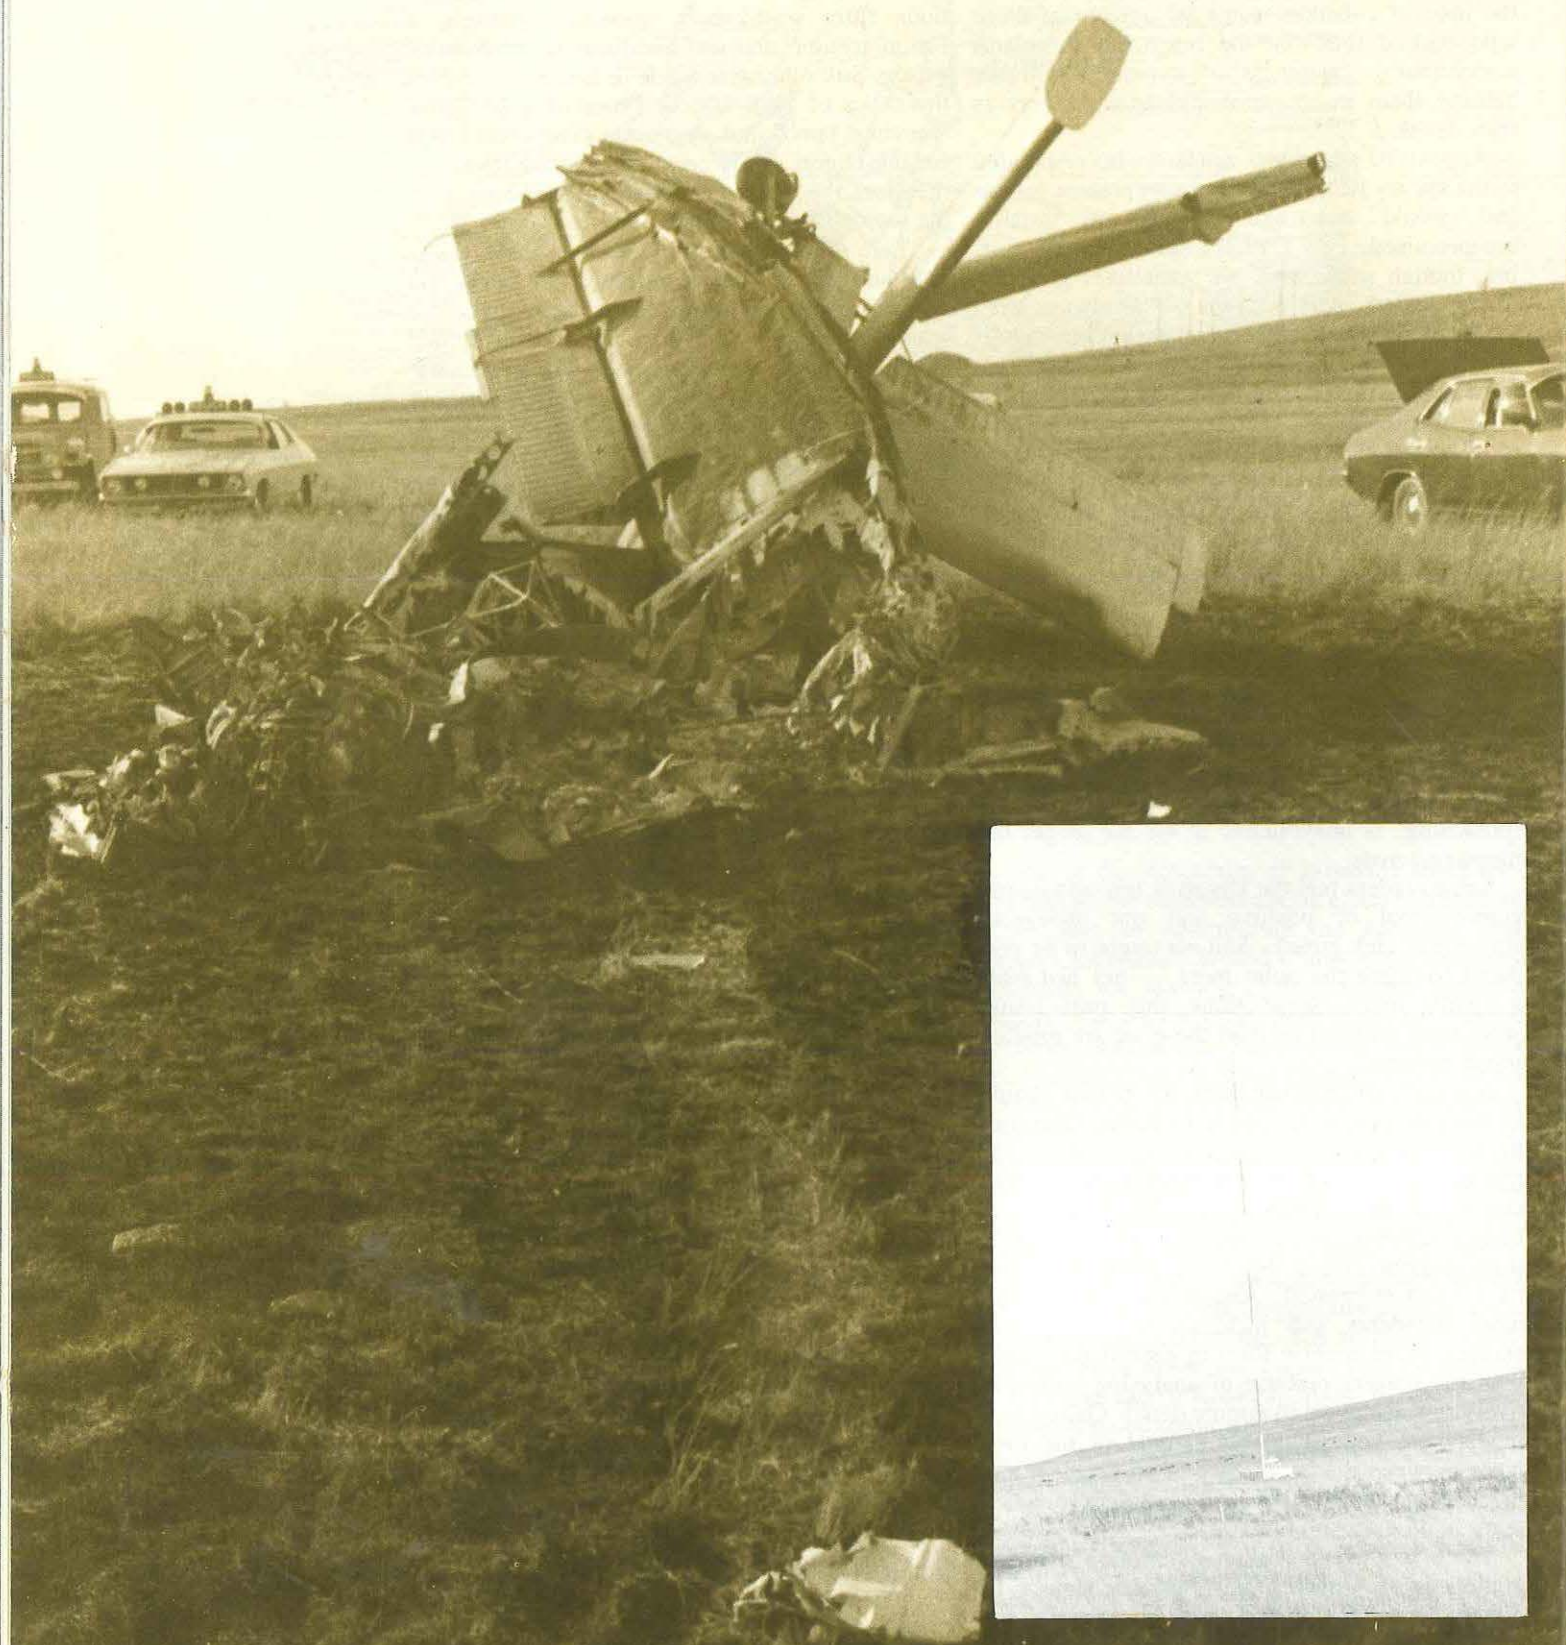
Burnt-out wreckage of the Pilatus Porter. The damaged transmitter mast can be seen in the background.
