AVIATION SAFETY DIGEST

No. 12 DECEMBER, 1957

CONTENTS

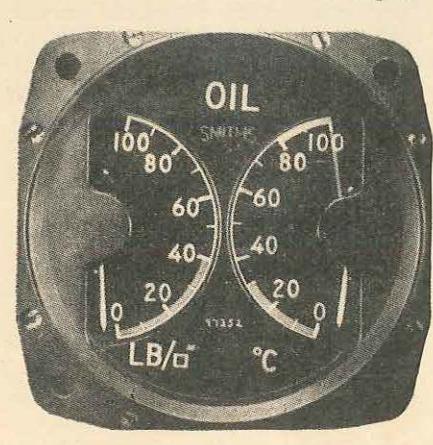
The evidence indicated that the pilot shut down the port engine instead of the starboard engine which had developed serious mechanical trouble. The pilot was experienced and had completed over 500 hours flying as pilot-in-command of this type. A factor which might give rise to this mistake is the use of combined oil pressure/temperature gauges. These instruments are duplicated, one for each engine, and normally mounted side by side. Each instrument is marked "OIL" at the top centre and, although annotated "LB/□" and "°C", respectively, at the bottom, the marking of adjacent pressure and temperature scales are not dissimilar (see photograph). A fall in oil pressure in the starboard engine would be recorded by the left-hand pointer of the starboard gauge. It is possible that a pilot, seeing the left-hand pointer of the starboard gauge falling could, in the stress of the moment, associate "left" with "port" and in consequence shut down the sound port engine instead of the failing starboard engine.

In this accident the pilot appears to have realised his mistake and restarted the port engine. Unfortunately, by this time the aircraft was down to a very low altitude. Even then, had the starboard engine

been shut down and its propeller feathered, the accident might have been avoided. Why this was not done could not be determined.
