AVIATION SAFETY DIGEST

No. 13
MARCH, 1958

(Prepared by Division of Accident Investigation and Analysis. Published by authority of the Director-General)

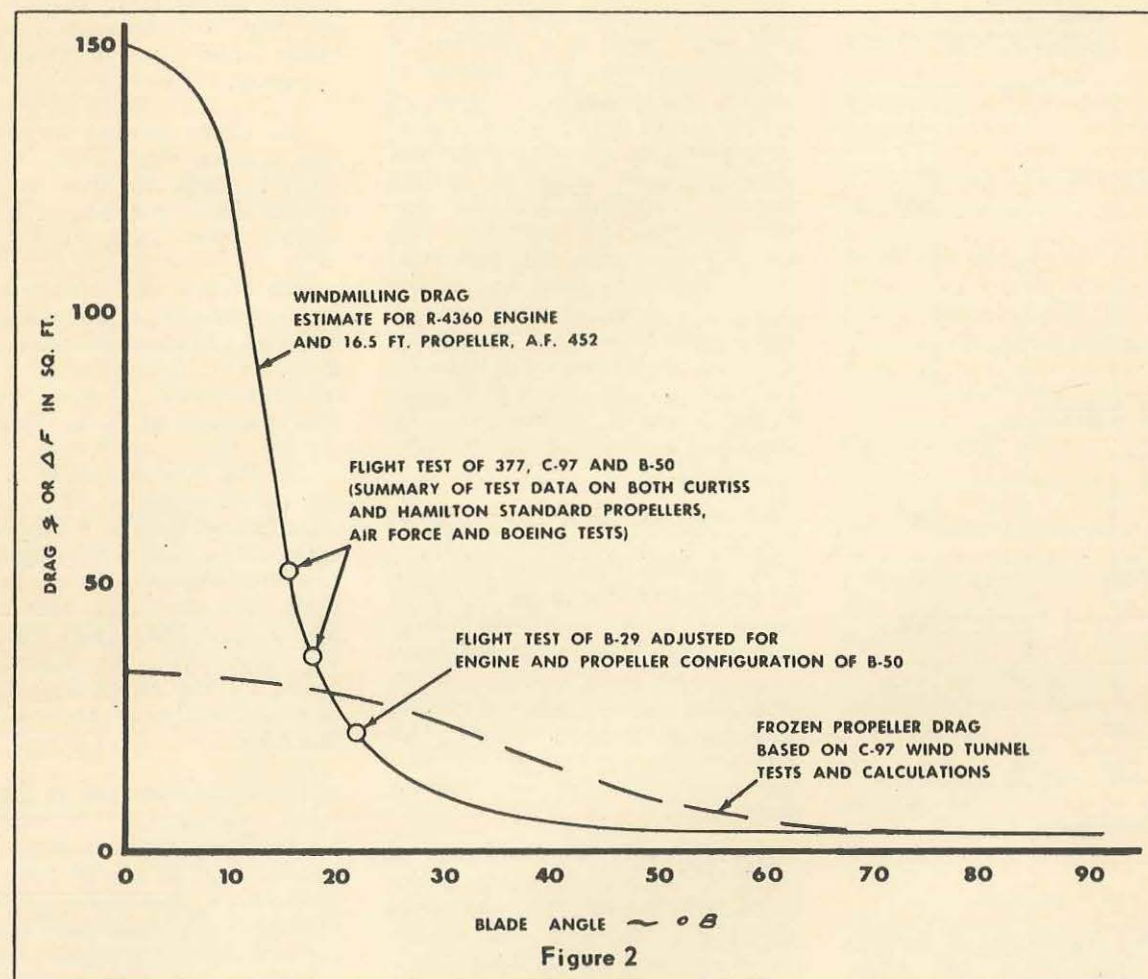
Figure 2

The chart showing the relationship between blade angle and drag (Fig. 2) indicates that drag of a windmilling propeller increases rapidly below about 15 degrees.

approved for the WB-50 and is to be instituted shortly after the first of the year as the aircraft go into IRAN. This program calls for the mechanical stop to be set at 16.5 degrees blade angle which will entail moving the low limit switch angle to 20.3 degrees. In substantiating information supporting this proposal the aircraft manufacturer pointed out that from 1949 through 1953 UR's showed that in 54 overspeed cases in 97's no aircraft were lost. The propellers have mechanical low pitch stops. In nine cases

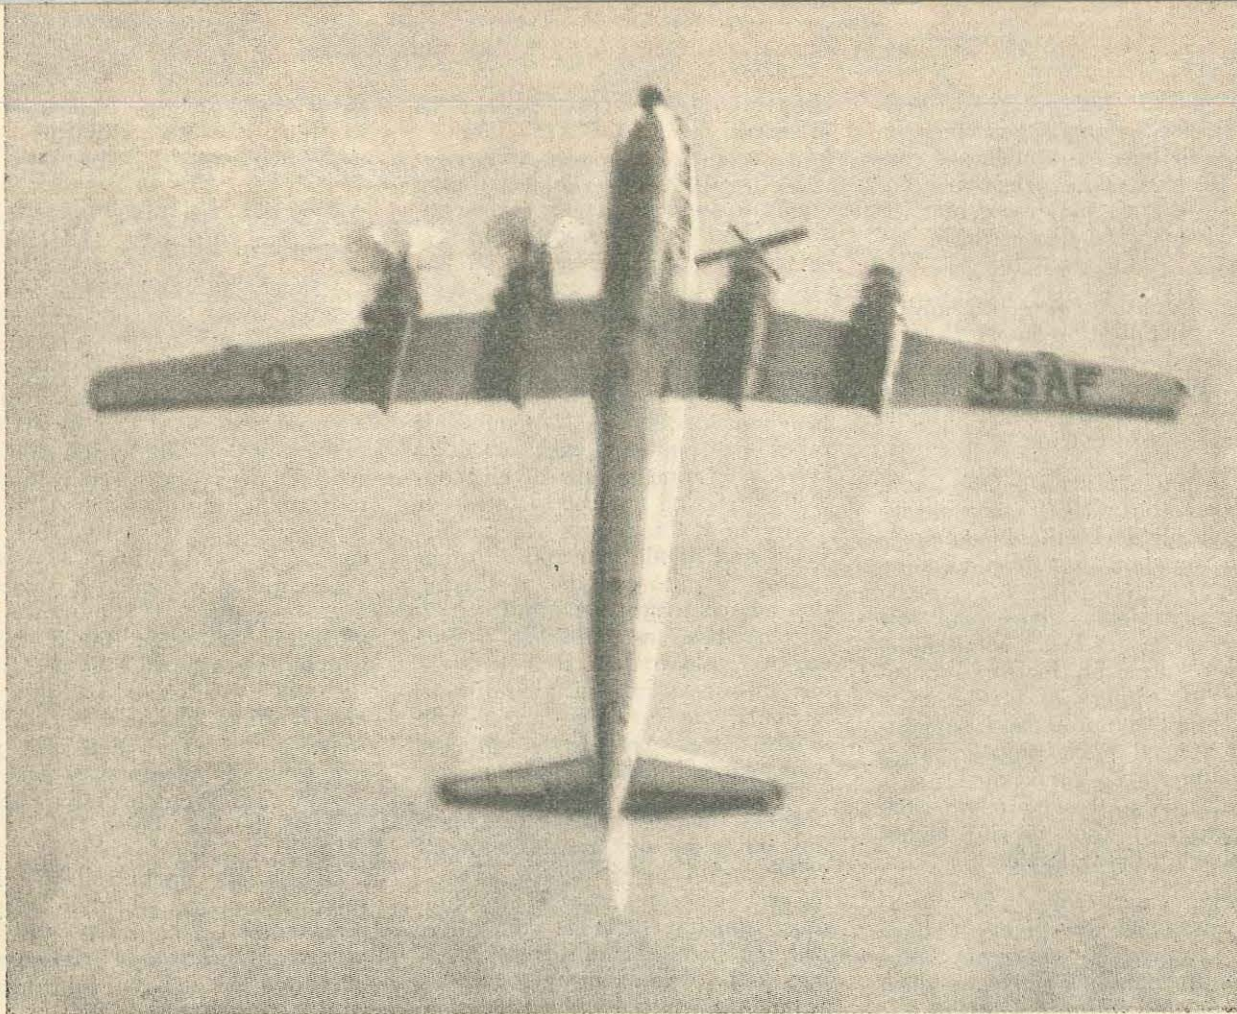
These precautions paid off. It wasn't long until No. 1 propeller separated from the engine. When it did it struck the No. 2 propeller, cutting off three feet of one blade, and also doing damage to the No. 2 nacelle and comparatively insignificant damage to the fuselage and empennage. It missed the main fuselage.
