# SAFETY DIGEST

# DEPARTMENT OF CIVIL AVIATION

No. 14, JUNE, 1958

No. 14 — June, 1958

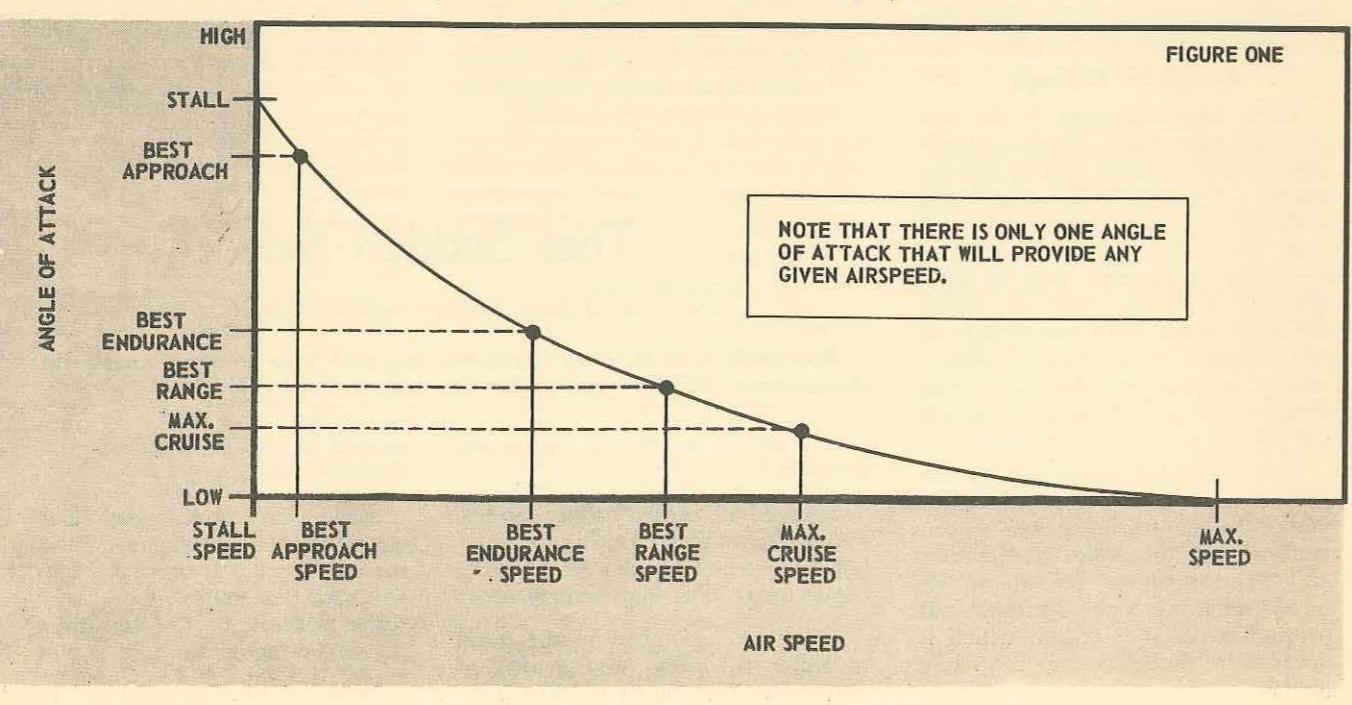
## Figure 1. Typical Angle of Attack vs. Air Speed Curve for flight under unaccelerated (IG) conditions.

First, an aerodynamic fact: In unaccelerated (1G) flight, at any one angle of attack, there is only one equivalent airspeed at which an aircraft can fly. (Fig. 1). This is true whether the aircraft is climbing, descending or in straight-and-level flight. It is also true whether you are at full power, low power or power off. Also, the airspeed varies inversly with the angle of attack. The higher the angle of attack, the lower the airspeed and vice versa. From this we can see that angle of attack is the primary factor in the control of airspeed.

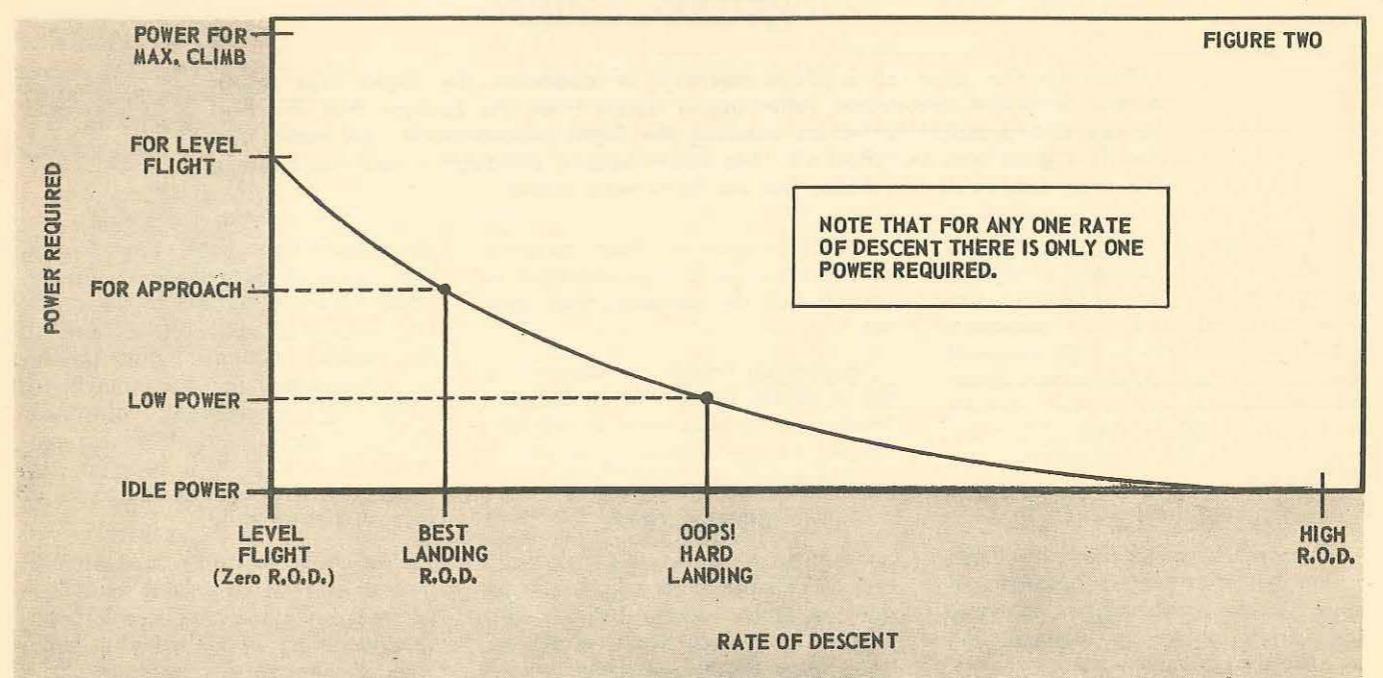
Figure 2. Typical Power Required vs. Rate of Descent Curve for constant Angle of Attack and Air Speed.

will produce a particular rate of descent. (Fig. 2.) Also, the rate of descent will vary inversely as the thrust.

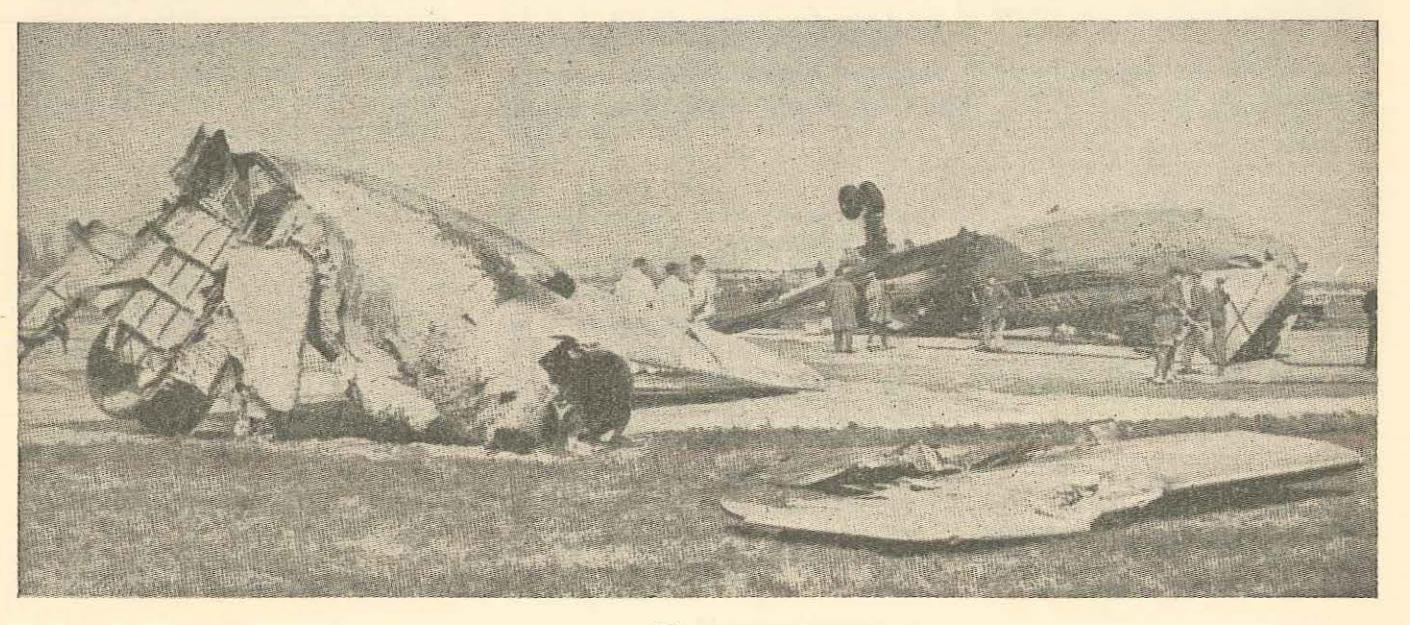
But the captain did not do this. Instead, he elected to dive steeply with full flaps and no power. The precise angle of descent is not known but the preponderance of testimony is that it was exceedingly steep. This testimony is largely by well-qualified witnesses. Such an approach would require, in order safely to check an abnormally high rate of descent, a much earlier starting of the flare out with the use of such power as might be needed to maintain a safe margin of speed.

is in conflict with general and long established airline training and practice. Because no other factors were involved in this accident and no alleviating circumstances stand forth, the Board can only conclude that the pilot erred in executing this type of approach and touchdown. Specifically, the approach was too steep, the flare out was ineffective because of the low airspeed, and consequently the landing was destructively hard.

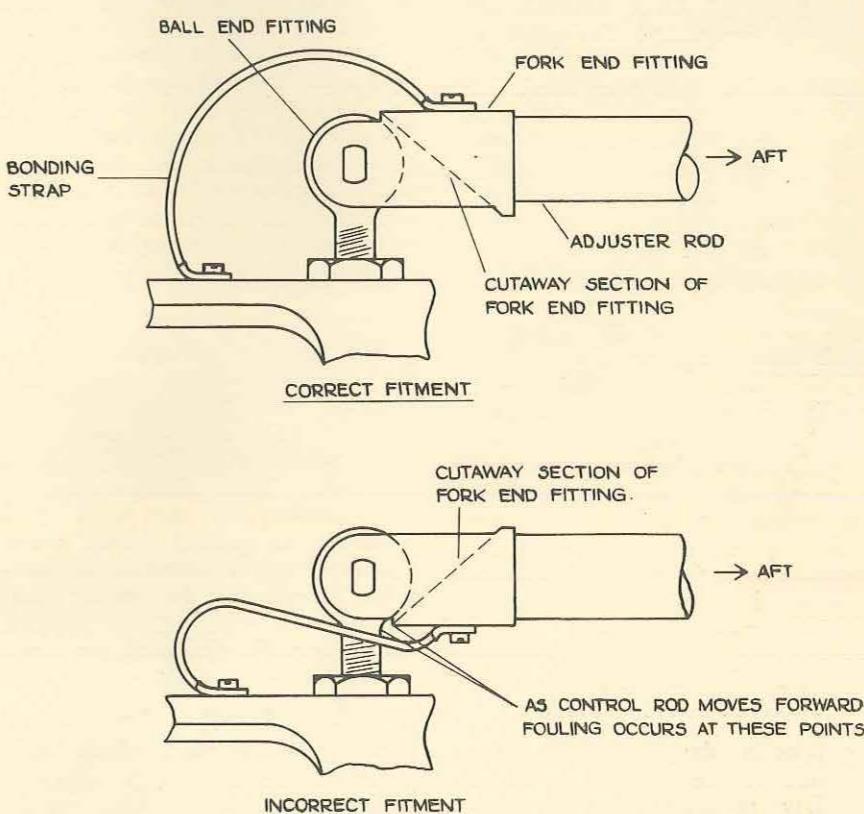
The last known inspection of this aircraft when the fork end could have been installed incorrectly was on the 23rd August, 1957, when a check of the elevator rigging had been carried out-nearly five months before the error was discovered. Arising from this incident, a fleet check was made and a similar error was discovered on one other aircraft; this aircraft had undergone an elevator rigging check on the 6th

December, 1957. No defects were found in the rudder control system which is of similar design.

Do you know of any other part that can be installed incorrectly? If so, what effect would it have on the safety of the aircraft? If it could be dangerous inform your supervisor. If you are not certain, be doubly sure to tell him, then any doubt can be eliminated.
