# AVIATION SAFETY DIGEST

Aviation Safety  
Digest

No. 15                      September, 1958

Prepared in  
the Division of  
Air Safety Investigation

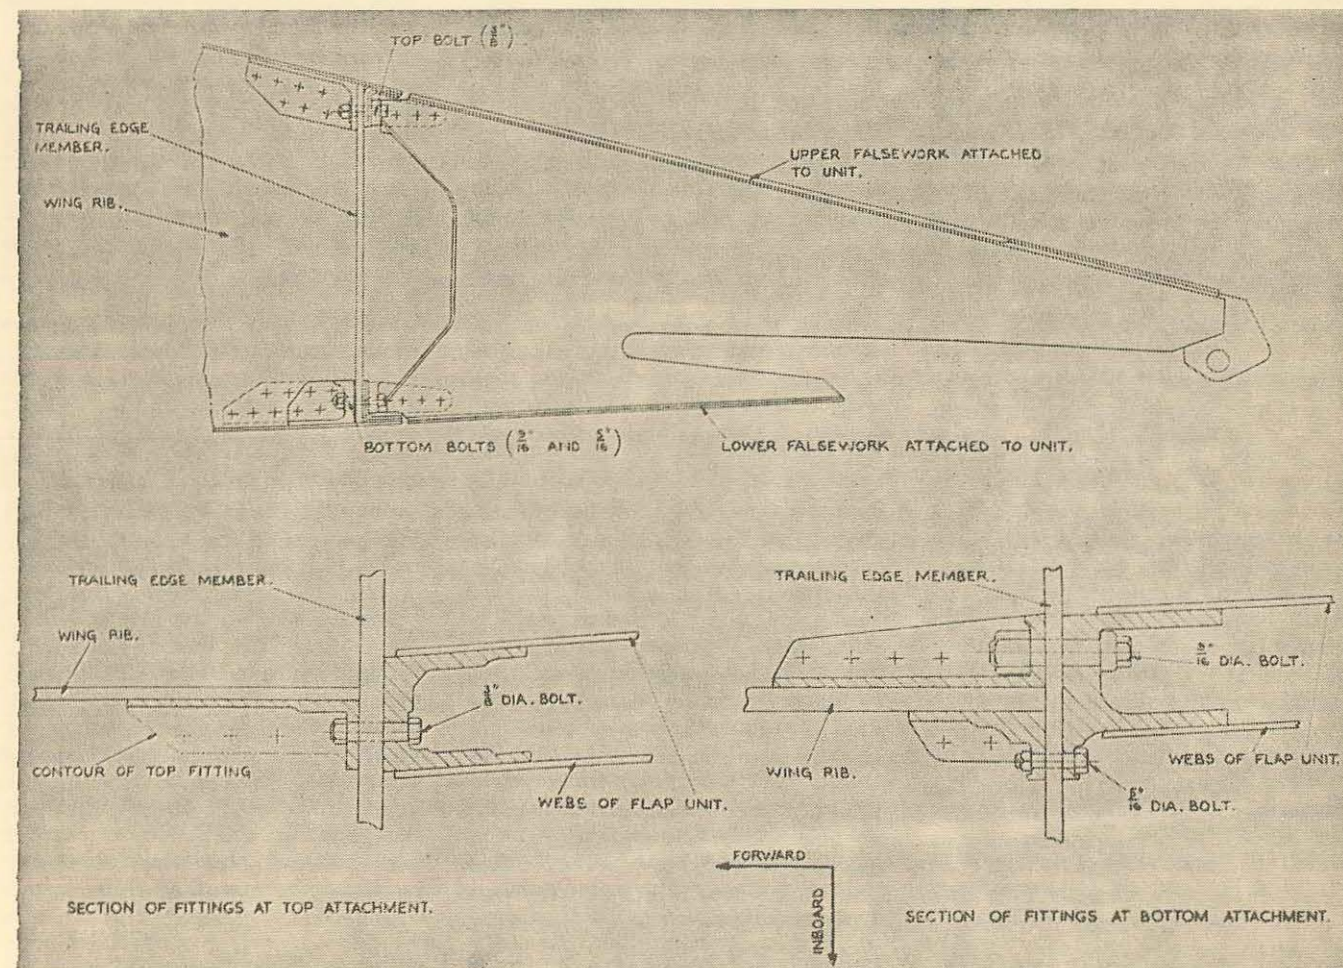
Fig. 1

Each flap unit is attached to the trailing edge member of the wing in this way (see figs 1 and 2). To the top and bottom of the trailing edge member are bolted fittings; (these are called "forward fittings"). To the top and bottom of the front edge of the flap unit are bolted fittings; (these are called "aft fittings"). The fittings are of aluminium alloy. A bolt passes from aft forward through the top aft fitting, the trailing edge member, and the top forward fitting, and is secured by a nut. On flap units 1, 3 and 4 a bolt passes from aft forward through the bottom aft fitting, the trailing edge member, and the bottom forward fitting, and is secured by a nut. On No. 2 flap unit the bottom aft fitting has a small lug and there is one bolt passing through the main part of the aft fitting, the trailing edge member and a forward fitting, and a smaller bolt passing through the lug, the trailing edge member and a subsidiary forward fitting. (The reason for the subsidiary bolt is that the position of No. 2 flap unit in relation to the wing rib was such that the main bolt could not be placed centrally in the fitting). In every case the bolt is secured by a nut at its forward end. The bolts in different positions are of different sizes. They are of high

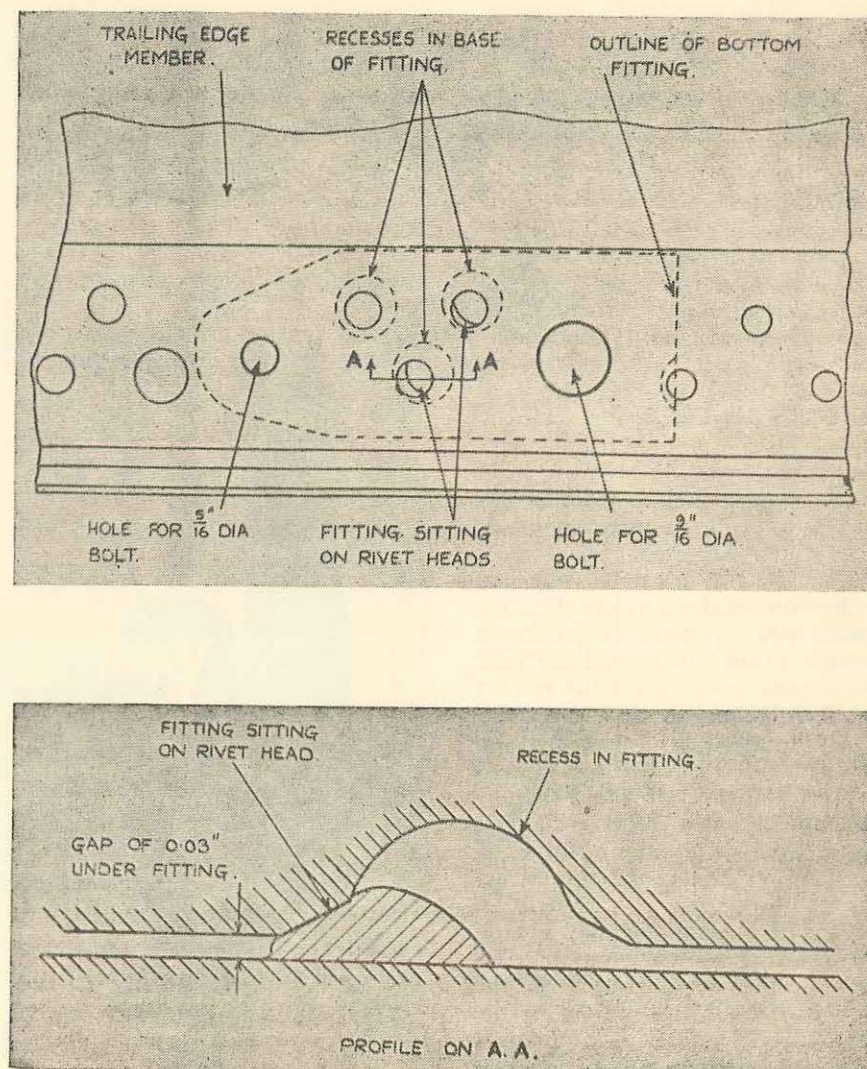
Fig. 4

right position and instead of completely enclosing their rivet heads the edge of these two rested on the edge of the rivet head. This meant that the forward face of the fitting was not in close contact with the trailing edge member. (Certain calculations suggest that the maximum distance between them was about 0.03 inch but this figure is not definitely established (see fig 4 lower drawing)). Two possible consequences would be (1) that when the

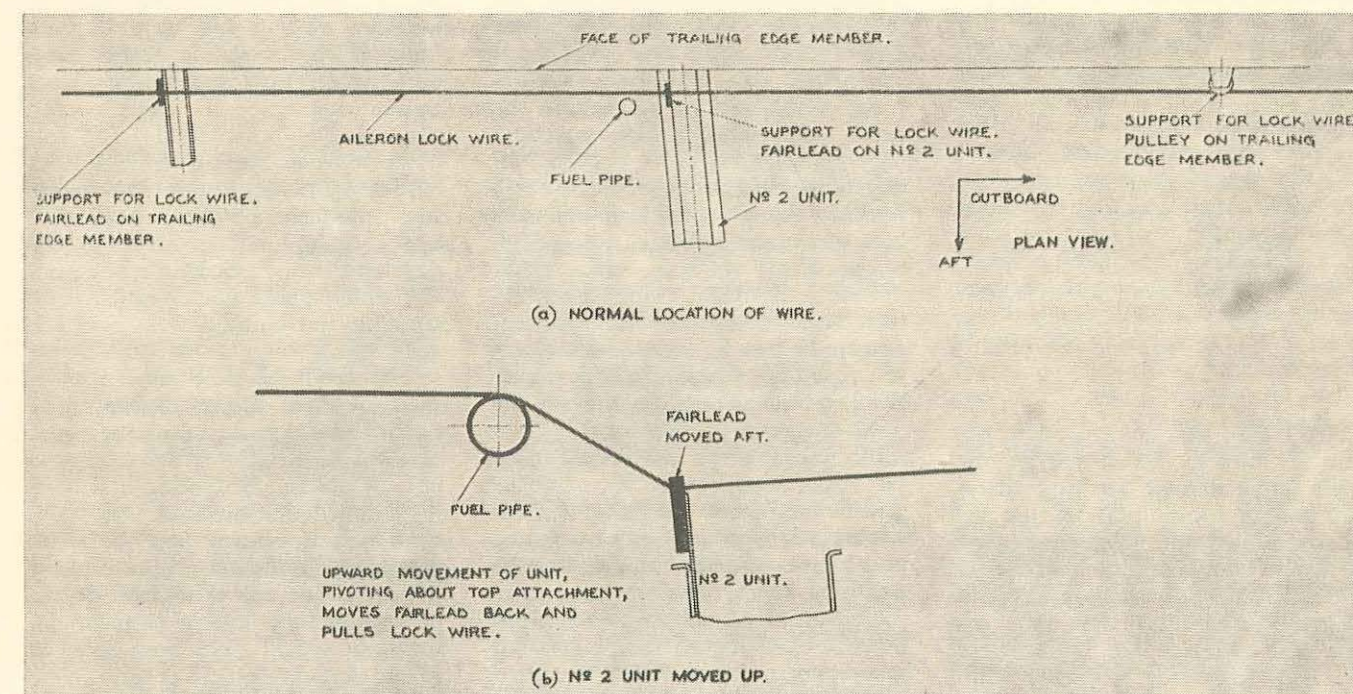
Fig. 5

The wire controlling the locking devices of the starboard aileron passed through a fair-lead on No. 2 flap unit. Just inboard of the unit it passed in front of a fuel pipe (see fig. 5). Geometrically it is clear that a movement of the unit such as has been described above would tend to pull on the wire (the extent of this pull being much magnified by the proximity of the fuel pipe) and so to lock the aileron. This would cause the port aileron also to be immovable. Tests which were made indicate that while the degree of movement obviously depends on the exact position of the wire (which cannot be ascertained), it would have been possible for the ailerons to be locked in this way, assuming a position for the wire within 1/4 inch of the fuel pipe which, though unusual (as shown by examination of a number of other Viscounts), does occur in a small proportion of cases. There are several indications in the wreckage that the ailerons were in fact locked.
