# AVIATION SAFETY DIGEST

DEPARTMENT OF CIVIL AVIATION

No. 17, MARCH 1959

Bogus Aircraft Parts

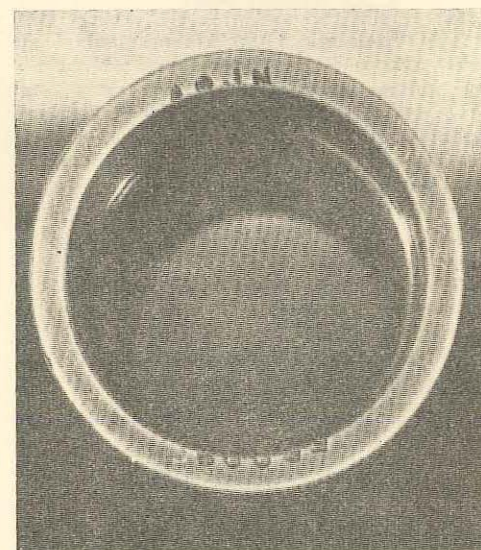
FIG. 1

6. Another piston pin which started out as a genuine surplus part ended up in a far different category. This piston pin was manufactured for fitment to an R-1830 engine but was modified for an R-985 engine. The hardness and material requirements for an R-985 engine were not met by reworking the R-1830 piston pin, too much material was removed and the inside surface was subjected to abnormal tempering. Figure 1 shows how machining of the inside diameter cut into the part number and heat code marks, leaving
