AVIATION SAFETY

DIGEST

No 23, SEPT., 1960

DEPARTMENT OF CIVIL AVIATION

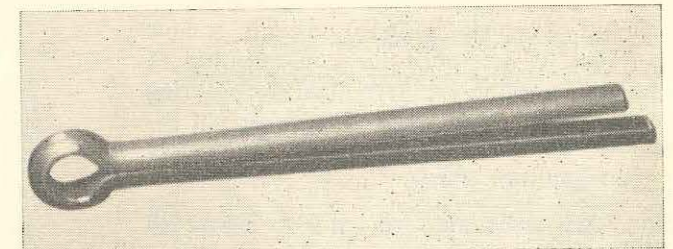
VITAL LINK

Seeking to establish the cause of looseness in his engine throttle controls prior to flight, the owner/pilot of a private ultra-light aircraft disconnected various joints in the throttle linkage. This involved the removal of a number of clevis pins. Eventually, he ascertained the cause of the apparent looseness, so proceeded to reassemble the control linkage. As each clevis pin was installed, he loosely inserted a retaining split pin, but did not bend out the ends to secure these pins. At this stage he was called away from the job.

Some time later he completed the work required and prepared his aircraft for flight. He then took-off to practise circuits and landings. Turning onto base leg on his first circuit the pilot reduced engine r.p.m. from the cruising setting for an engine assisted approach. On final approach, at a height of about 150 feet, he applied throttle to correct for undershooting but the engine failed to respond.
