AVIATION SAFETY

DIGEST

No 24, DEC., 1960

DEPARTMENT OF CIVIL AVIATION

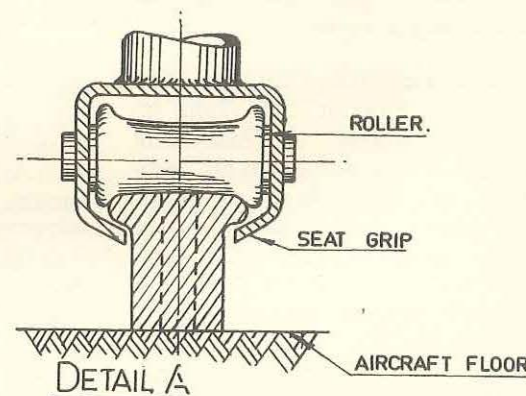
FIG. 3

However, with continued use the holes are liable to become worn and elongated as shown in Fig. 3. This worn condition will not detract from the effectiveness of the lock itself. However, it is possible for the pin, if not properly engaged prior

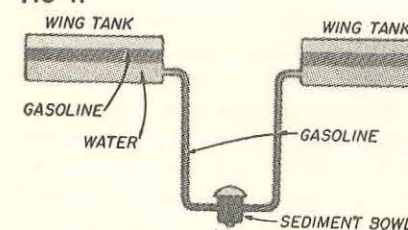
FIG. 1.

clear plastic wing tanks, metal tubing, and a sediment bowl. First, he filled the tanks with gasoline. The fuel system operated smoothly. Then he poured a large quantity of water into the tanks and waited for it to appear in the sediment bowl. He waited 30 minutes — no water. He added more water to the tanks. Again waited, this time for an even longer period. Still no water. He found that he could drain three soft drink bottles full of clear gasoline out of this system before the water showed up. When it did appear, it acted as it was supposed to, the water draining, clean gasoline following. The puzzled executive again built a fuel system, this time with clear plastic fuel lines. Now he would be able to actually see what was happening. In went clean gasoline. The lines filled smoothly. Then he added a generous quantity of water. The water settled to the bottom of the clear plastic "wing tanks", in the approved fashion — but — and the veteran pilot could scarcely credit his eyes — the water did not penetrate the fuel-filled fuel lines. It remained as shown in Figure 1.

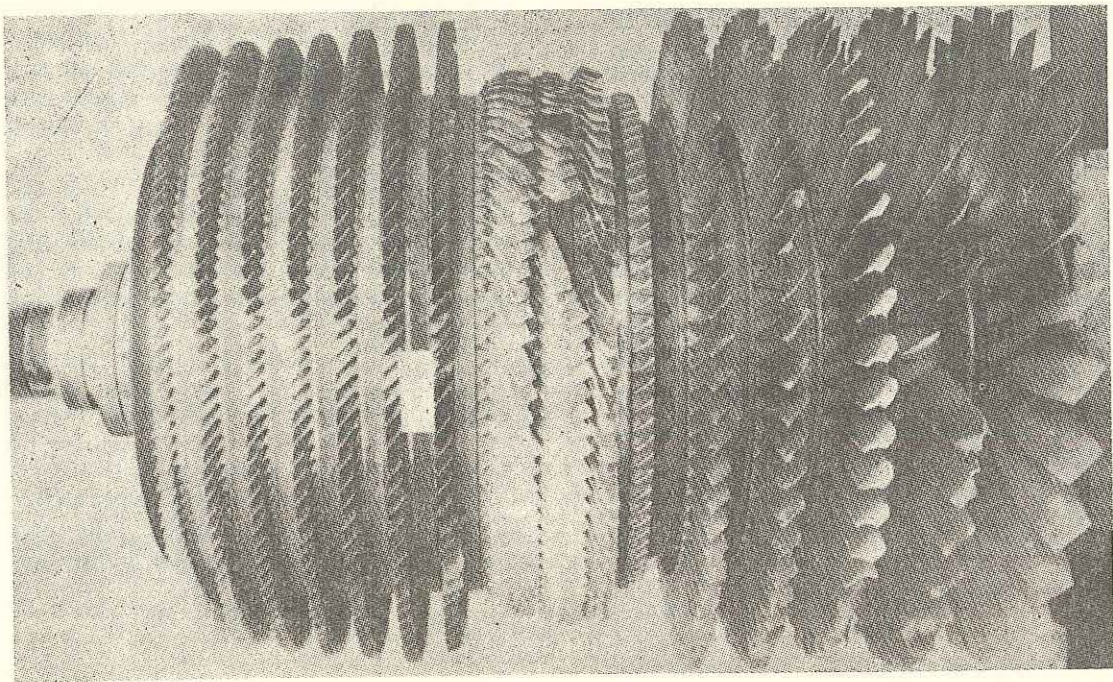
When the engine was started the box pressed against the entry guide vanes and by partially blocking off the intake air caused the compressor to stall. The resultant high frequency vibration led to fracture in fatigue of a first stage rotor blade.

The photograph shows the extent of the resultant compressor damage. Approximate cost — £20,000.
