AVIATION SAFETY

DIGEST

No 25, MARCH, 1961

DEPARTMENT OF CIVIL AVIATION

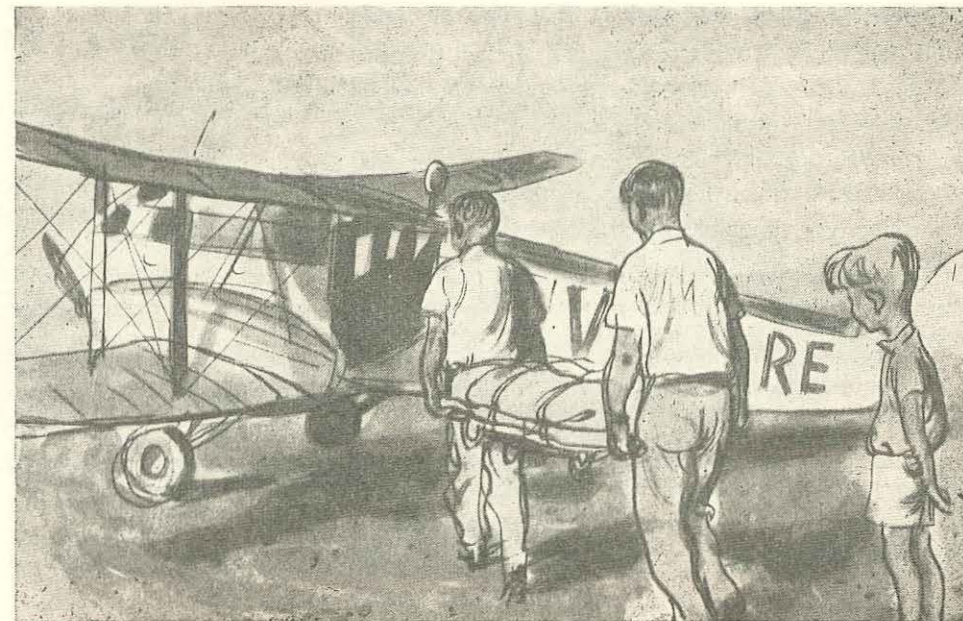
Swift Rescue

In the SAR operation which followed the loss of power and subsequent forced landing by a helicopter in a remote location in North Western Australia, the initiative and co-operation displayed by those involved was responsible for the crew being rescued in the evening of the same day.
