AVIATION SAFETY

DIGEST

No. 28, DEC., 1961

DEPARTMENT OF CIVIL AVIATION

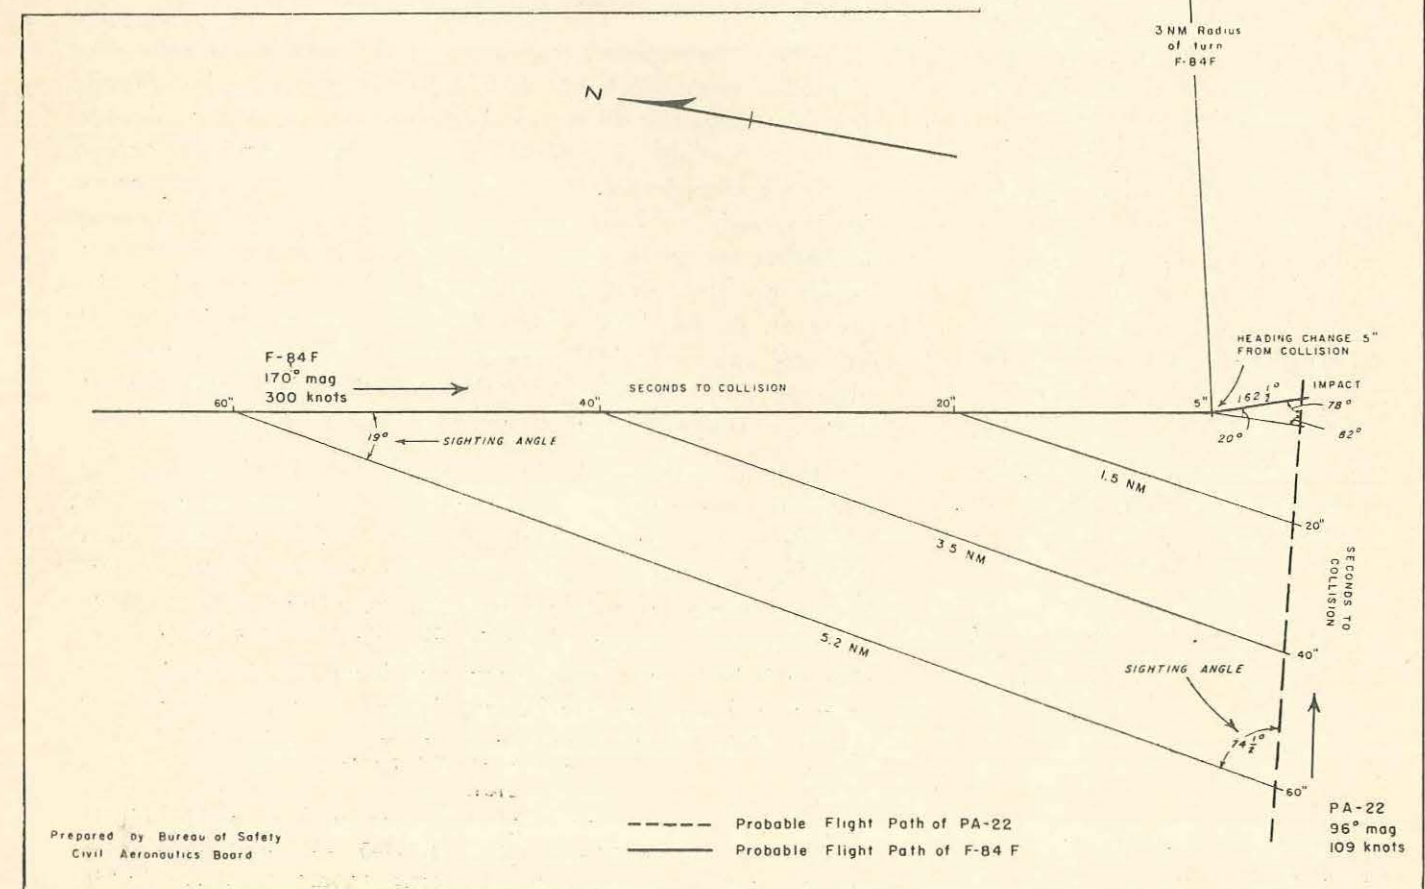
The collision occurred approximately two miles south of the Mansfield Airport, well within the control zone. The PA-22 was proceeding in a north-easterly direction and the F.84F in a southerly direction. The angle formed by the intersection of the flight paths was approximately 78 degrees. (See sketch). In addition, the F.84F was in an angle of left bank approximately 30 degrees relative to the longitudinal axis of the PA-22. These relative angles of impact were determined by evidence of deformation and damage to the PA-22 wings, cabin area, engine, and

The Board determines that the probable cause of this accident was the failure of the jet formation flight leader and the pilots of the PA-22 to see and avoid one another.

A contributing factor was the failure of the tower personnel to see the PA-22 and take appropriate action.

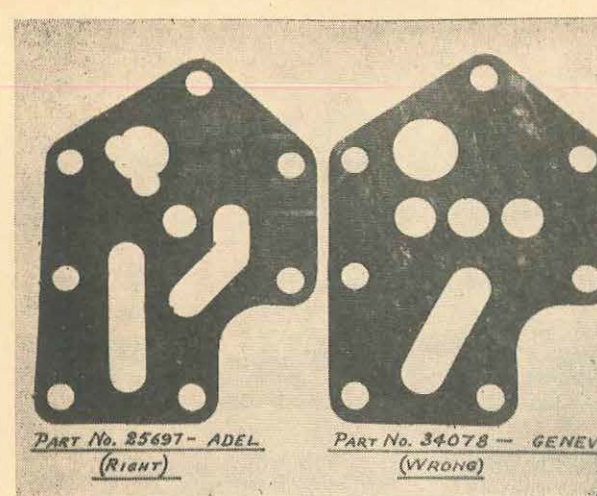
The incorrect gasket allowed oil pressure to be directed to the low ratio clutches at all times, irrespective of the position of the supercharger drive selector. Consequently, when high ratio drive was selected both the high and the low ratio clutches were engaged causing continuous wear on the low ratio cones and facings. These units eventually reached the stage where they were no longer capable of providing a continuously positive drive, even when the actuator was selected to low ratio. Hence, the surging manifold pressure and the fluctuating r.p.m. whilst cruising on low blower.

It is appreciated that isolation of redundant parts is not a simple matter and that there must occasionally be an overlapping period during which parts applicable to two slightly differing installations must be held available. Good housekeeping, however, will ensure that this overlap is kept to controllable proportions. Haphazard control of a progressive change is bad housekeeping and will inevitably leave the way open to another slant on Murphy's Law — "If a wrong part can be made to fit, sooner or later someone will fit it."

Surely it is reasonable to expect that the person ordering the disposal of the obsolete unit should also order the disposal of other related items that are no longer useful. We believe that this is an inescapable responsibility of supervisors and inspectors — particularly those directly connected with the movement of spare parts or the planning of progressive changes. The consequences of installing a wrong part in an aircraft can be just as drastic as the effects of an exploding time-bomb and it is of little consolation to the victims to know that the natures are different.

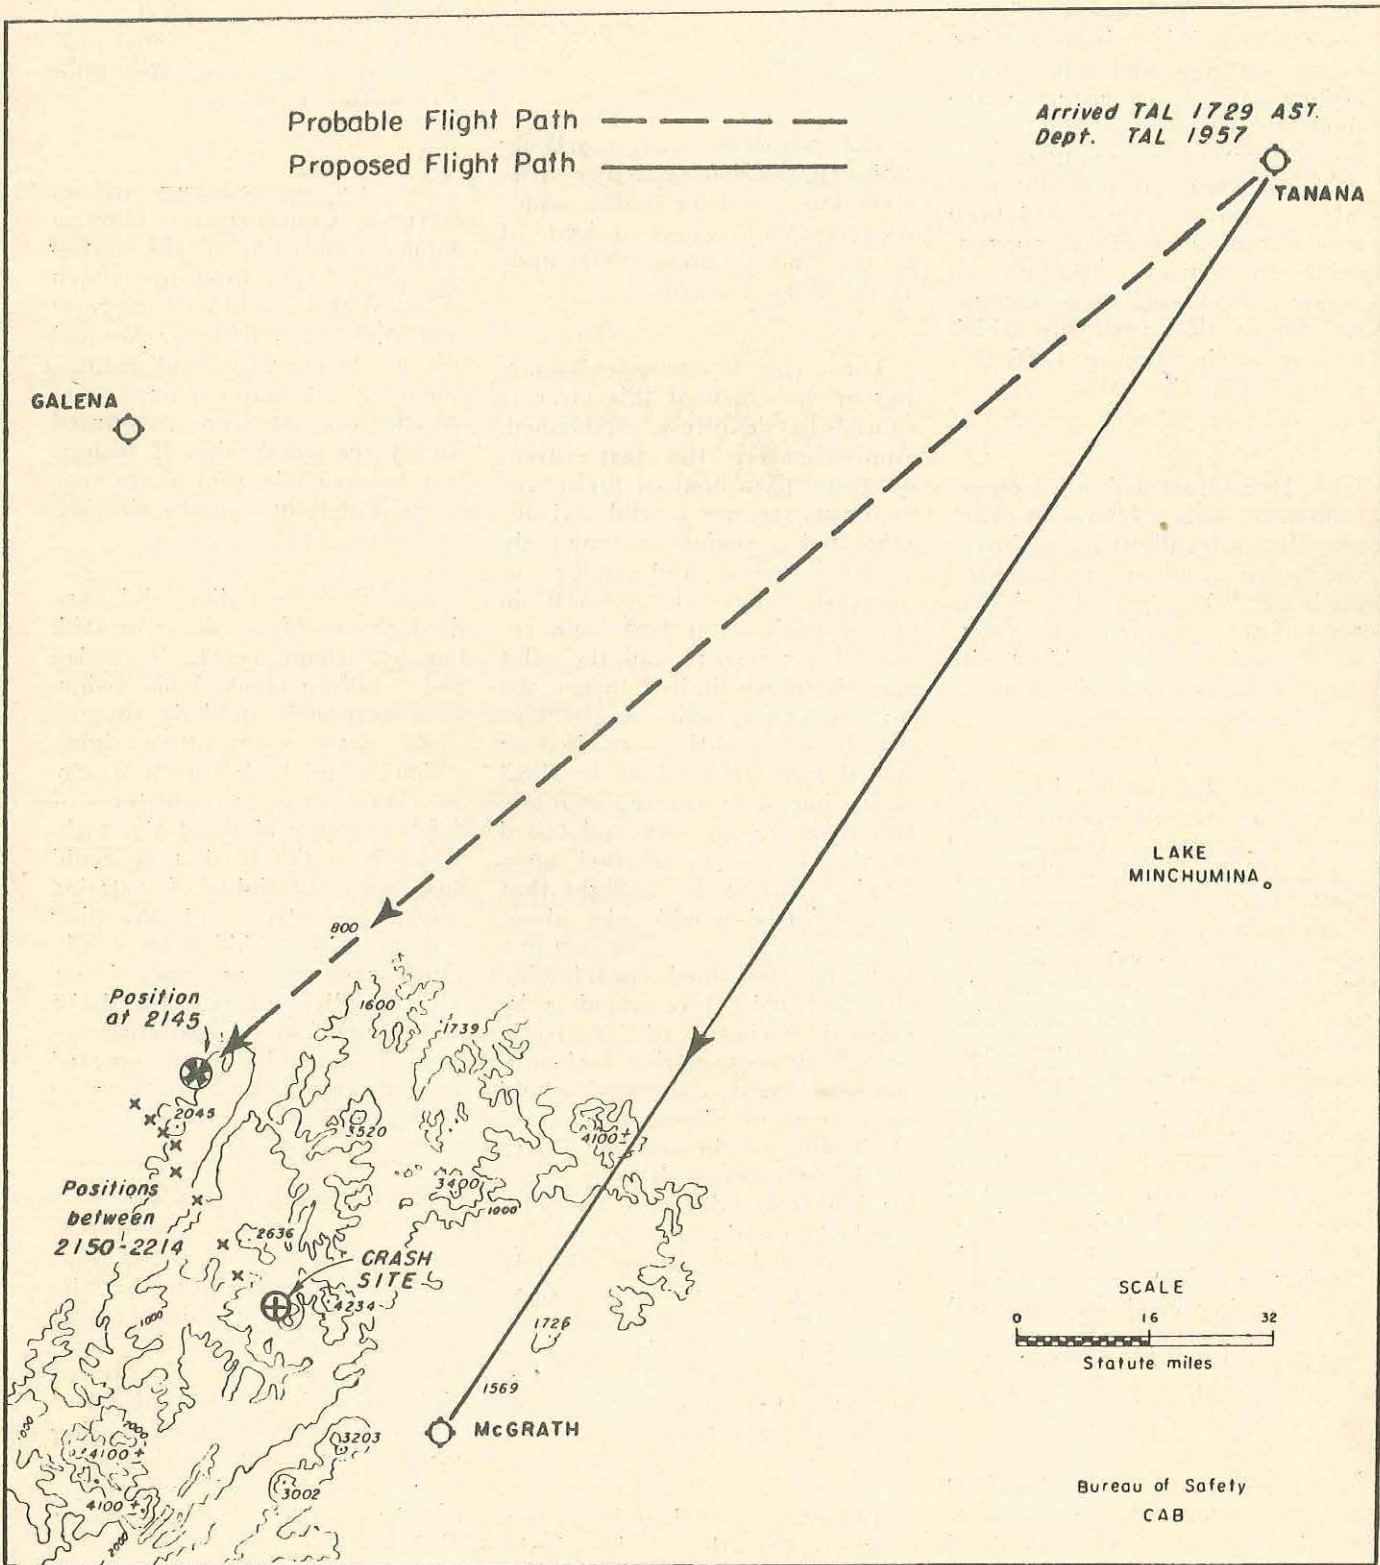
Tatalina radarscope. The aircraft wreckage was confined to a small area. At the time of the impact the nose was down sharply, the right wing was down appreciably; the direction of the impact was 227 degrees magnetic. Propeller pitch setting, power settings, and other information needed to reconstruct the final few seconds of flight were not determinable. Owing to severity of impact it was not possible to learn if there had been a malfunction of any component prior to impact, although all major components were accounted for at the crash site which was at an elevation of 1,800 feet above sea level.

The localised wreckage and its extreme disintegration confirm impact following a fast steep spiral. The very brief fire which followed the crash also suggests that there was little or no fuel left in Beechcraft's tanks. Inasmuch as all major components of the aircraft were accounted for at the crash site, it is logical to conclude that there was no inflight failure to the aircraft.

The Board determines that the probable cause of this accident was the pilot's loss of control while flying under instrument flight conditions, and failure to recover control. Contributing factors were poor flight planning, possible fuel exhaustion, and the pilot's lack of instrument proficiency.

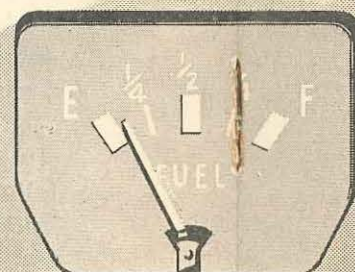
PIPER "PAWNEE". This aircraft was wrecked when the pilot attempted a forced landing, brought about by fuel exhaustion during the 24th flight after refueling. He forgot to consult the fuel gauge, which was tantamount to pulling the trigger. The rest was left to pure chance.
