AVIATION SAFETY DIGEST

No. 29

MARCH, 1962

Accident to DC.4 at Brisbane

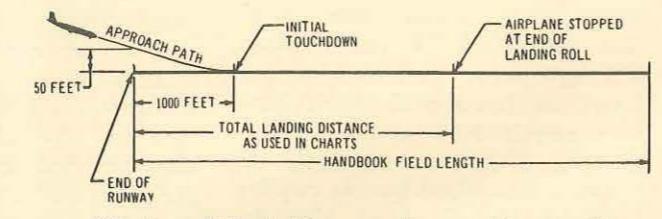
FIG. 1 — Defined distances and nomenclature used in the text. Total landing distance is based on a reference condition where the airplane is 50 feet over the end of the runway and touches down 1000 feet from the end. The term, total landing distance, should not be confused with handbook field length which is used for planning.

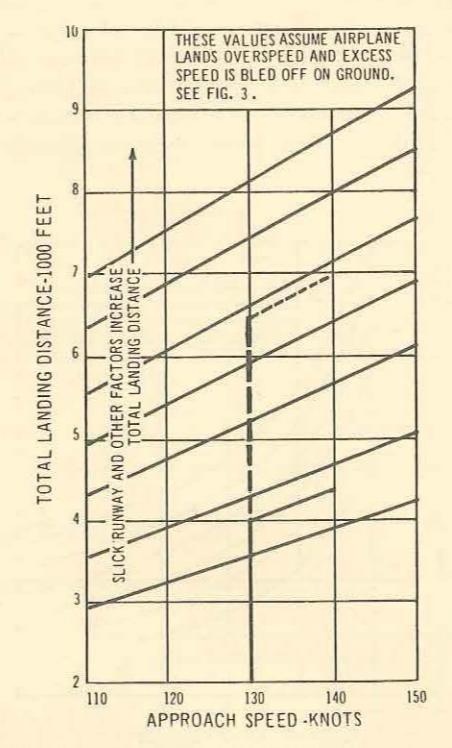
FIG. 2 — Trend lines for effect of varying approach speeds on landing distance. Example lines show how to use different trend lines when other conditions, such as slick runway, high approach, or other variables change landing distance from 4000 feet to 6500 feet.

normal landing distance at 4,000 feet. With other conditions constant, flying over the threshold with 10 knots excess speed at 140 and touching down 10 knots over-speed would increase total landing distance only 350 feet. If this 10 knots excess speed is bled off in the air before touchdown, landing distance will be increased by about 1,200 to 1,500 feet. See Fig 3. Under slick runway conditions, if 6,500 ieet total landing distance would be required at an approach speed of 130 KIAS, coming in at 140 knots and touch down 10 knots overspeed would increase distance by 500 feet in accordance with the dotted lines shown in Fig. 2.

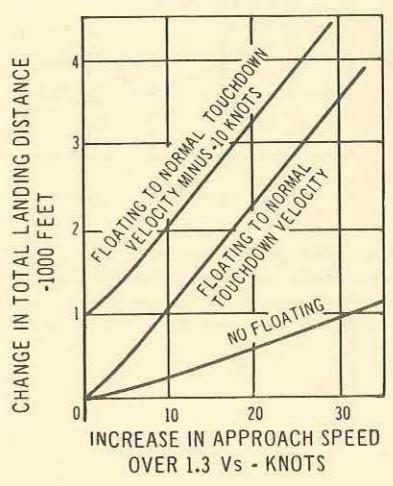
FIG. 3 — Floating before touchdown penalises landing distance. Bleeding 10 knots below correct speed in air before touchdown increases landing distance by 1000 feet. If approach is 10 knots overspeed, floating and touching down on speed uses 1100 feet compared to 350 feet if deceleration is on runway rather than in air.

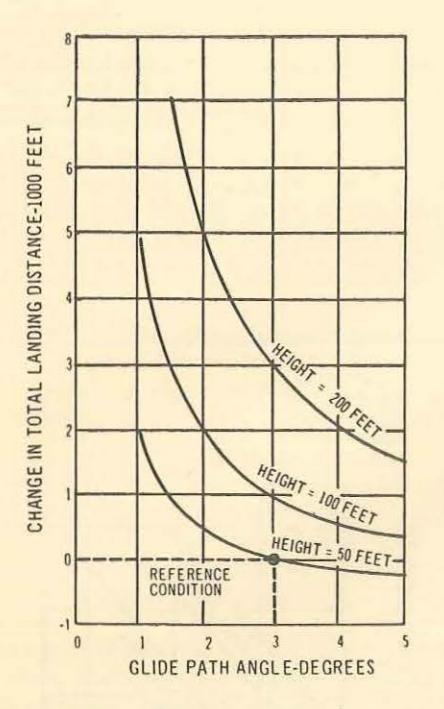
Height of the airplane over the end of the runway also has a very significant effect on total landing distance. The relatively steep trend lines of Fig. 4 show this effect for a range of glide slope paths. This chart indicates a change in total landing distance directly. Forexample, flying over the end of the runway at 100 feet altitude rather than 50 feet could increase the total landing distance by 950 feet on a 3-degree glide path. This change in total landing distance results primarily because of the length of runway used up before the aeroplane actually touches down. Glide path angle also affects total landing distance as shown in Fig. 4. Even while maintaining the 50 foot height over the end of the runway, total landing distance

FIG. 4 — Flat glide slope path and excessive height over end of runway combine to extend landing distance required due to runway used before touchdown. Reference conditions call for 50 feet over threshold while on 3 degree glide slope path.

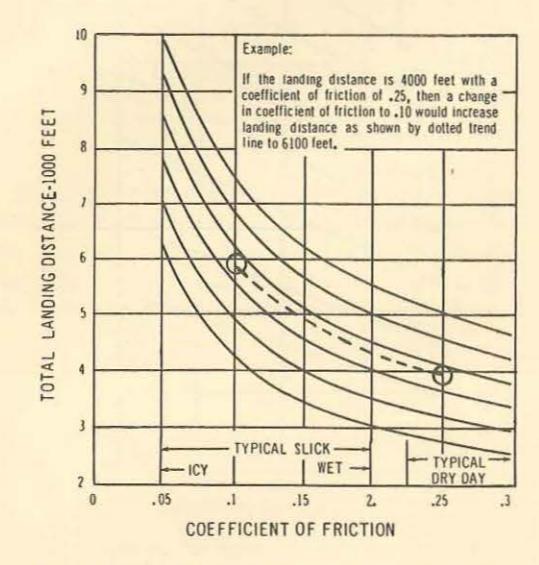
FIG. 5 — Trend lines for coefficient of friction show increase in stopping distance on wet or icy runway surfaces. Trend lines show only effect of friction. Which trend line used must be determined from length of runway required by variation of all other factors that affect distance.

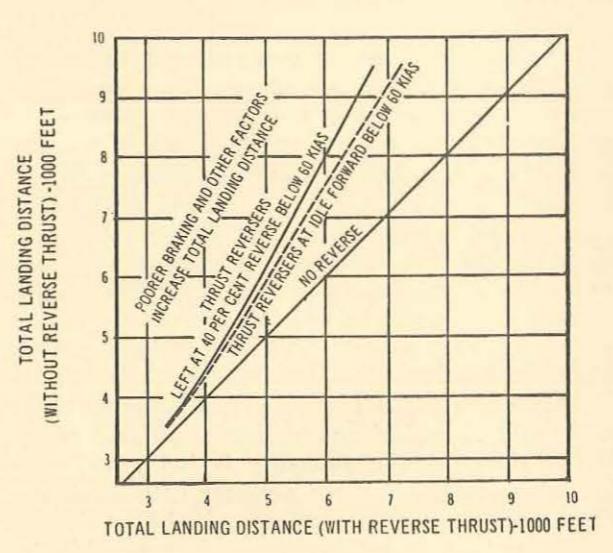
FIG. 6 — During normal landings, thrust reverses can reduce landing distance by differing amounts depending on whether thrust reverses are left in reverse or in idle when cut off below 60 knots. During emergency conditions, thrust reversers can be used below 60 knots, but effect on landing distance varies according to usage.

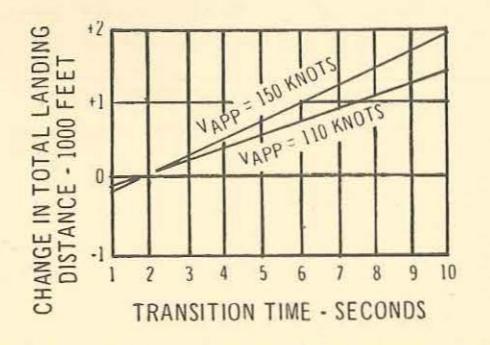
Transition time between touchdown and brake application affects total landing distance in accordance with the chart in Fig. 7.

FIG. 7 — Delay in applying brakes increases landing distance as shown for different speeds at touchdown. Normal time between wheels rolling on runway and brake application is two seconds.

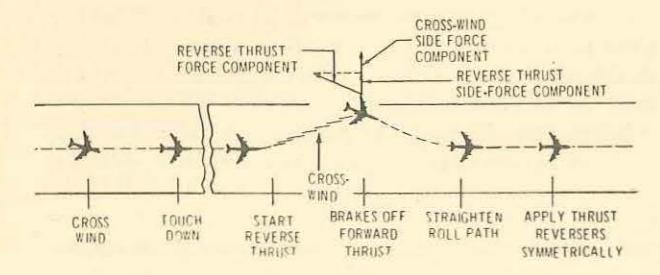
FIG. 8 — During cross-wind landing side thrust from thrust reversers, once aeroplane is canted to centreline, plus cross-wind can drive aeroplane off runway. To correct path, return all engines to forward thrust at low power to return to centre, use differential braking to straighten roll path then reverse thrust to stop.

forward thrust (to reduce the thrust element tending to drive the aeroplane to the side and to get the aeroplane back near the centre of the runway) and use differential wheel brakes and rudder to straighten the landing roll. Once the aeroplane is straight with the runway and near the centre, thrust reversers should again be set up symmetrically if needed.
